RE: 2021 Annual MS4 Status Report  
NPDES Permit No. PAG130006  
West Norriton Township, Montgomery County  
WNR-21-006

# **ANNUAL MUNICIPAL SEPARATE STORM SEWER SYSTEM (MS4) STATUS REPORT**

West Norriton Township  
Montgomery County, PA  
1630 W. Marshall Street  
Jeffersonville, PA 19403

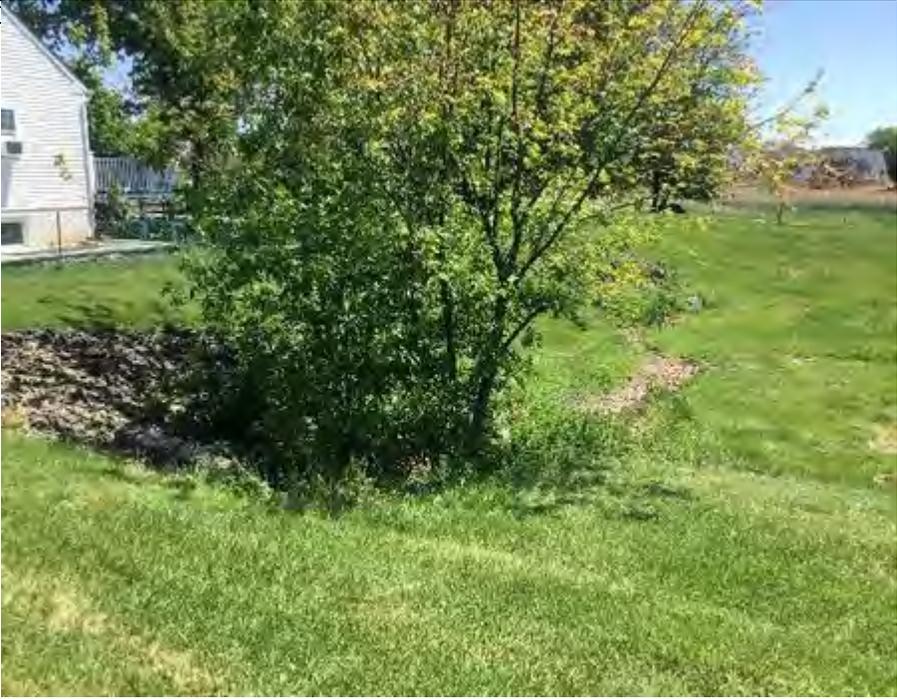
BMP #: 2		BMP Type: Detention basin	BMP Address:
Photo No. 3	Date: 05/13/2021

Description			
Inflow to the basin.			
Violation Type (if applicable): Large woody plants blocking the view to the basin

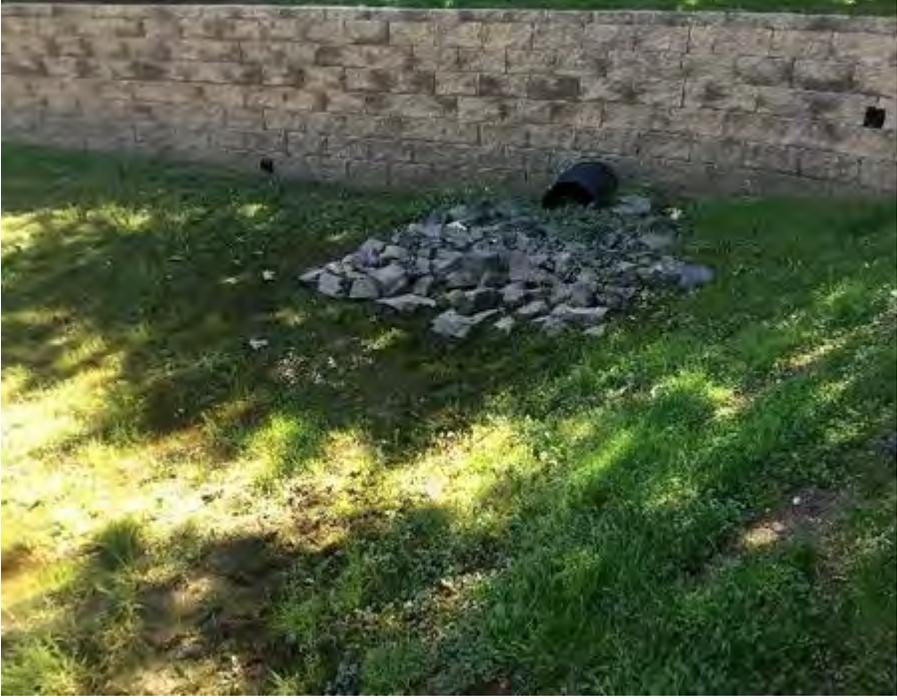
Description			
Info to the basin with minor ponded water.			
Violation Type(if applicable):
