RE: West Norriton Township Annual MS4 Status Report
NPDES Permit No. PAG130006
West Norriton Township, Montgomery County
233-22-0007

ANNUAL MUNICIPAL SEPARATE STORM SEWER SYSTEM (MS4) STATUS REPORT

West Norriton Township

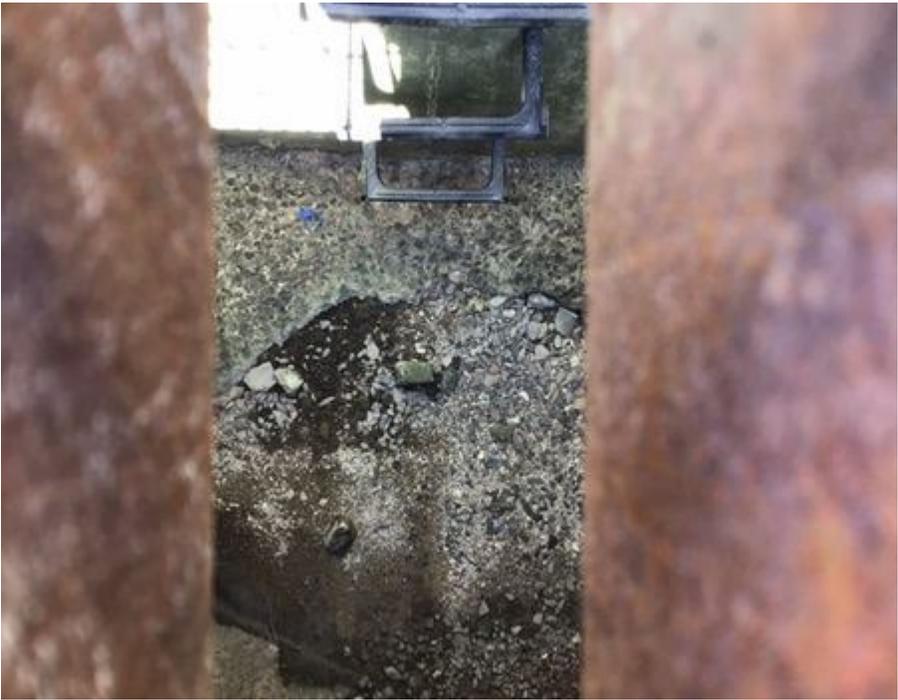
Description			
Observation and inlet is clear of water or debris.			
Violation Type (if applicable):

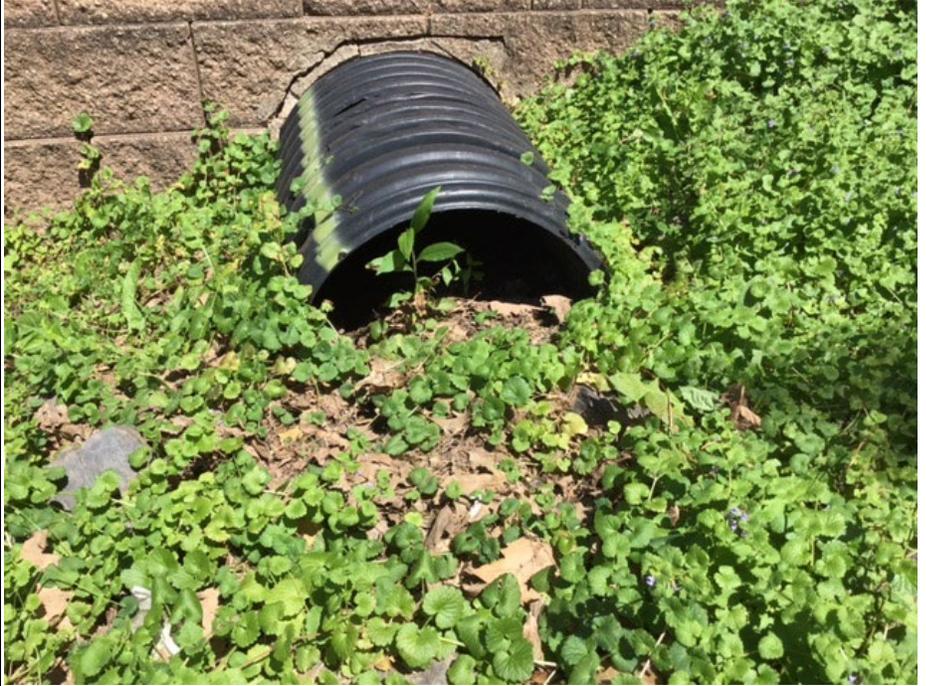
View of the structure leading to the BMP.			
Violation Type (if applicable): Excessive sediment/vegetation blocking inlet.			
Photo No. 6	Date: 06/06/2022	Date:	
Description

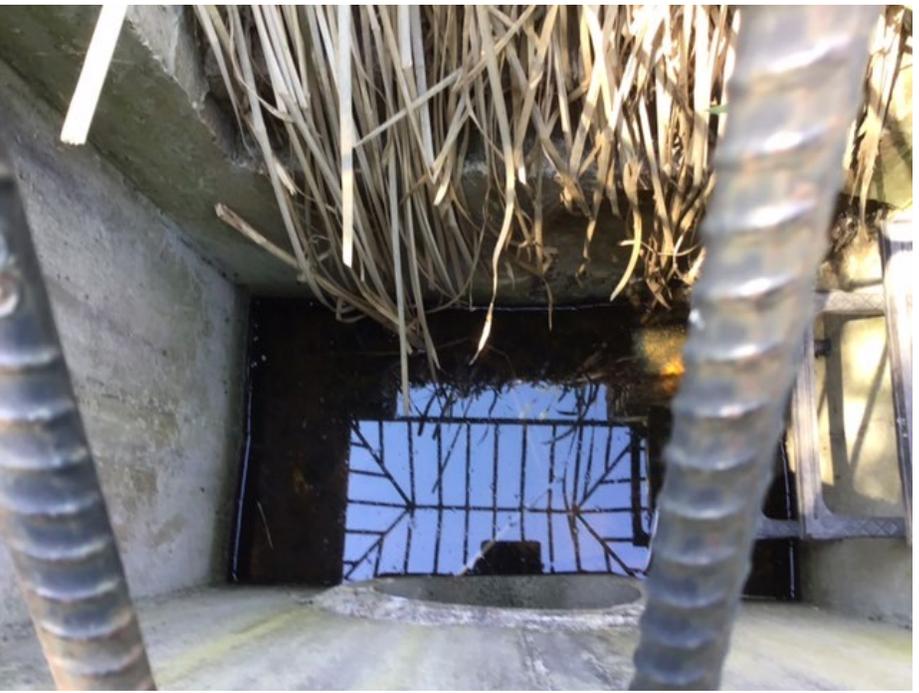
View of inside the outlet riser.			
Violation Type (if applicable): Vegetation should be removed from the riser.

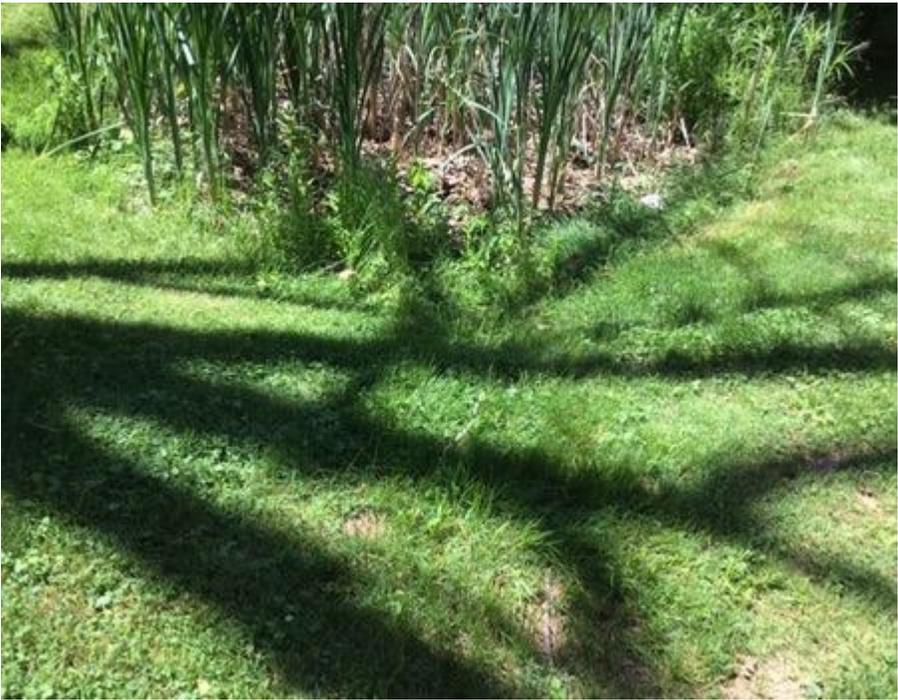
Description			
Inflow unable to be located.			
Violation Type (if applicable):

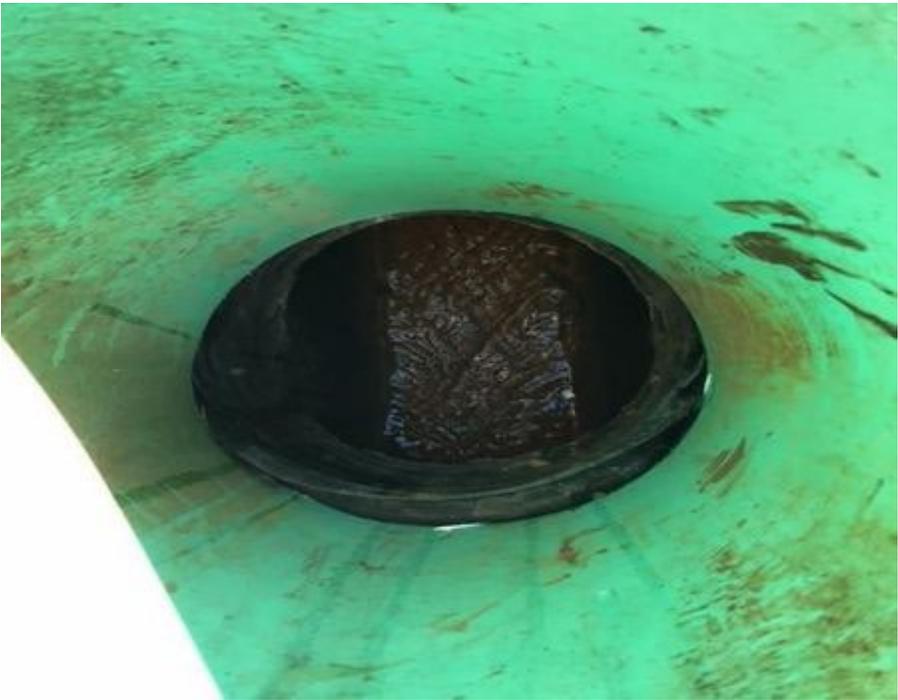
Description			
View of the cleanout. Running water appears to be coming from ground water source.			
Violation Type (if applicable):			
Photo No. 4	Date: 06/06/2022

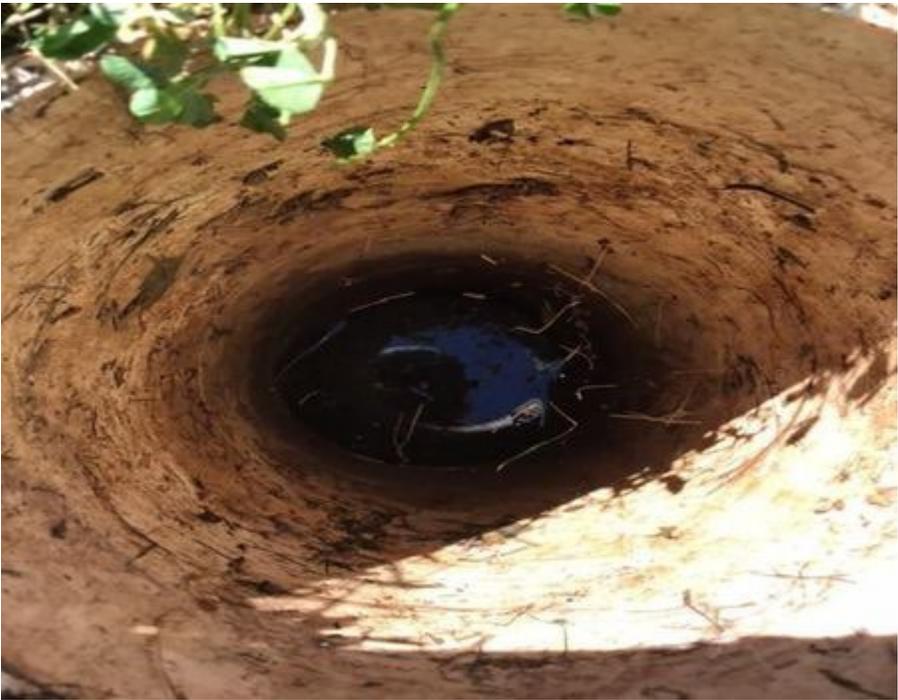
Description			
View of the well closest to road.			
Violation Type (if applicable): Standing water present.			
Photo No. 4	Date: 06/06/2022

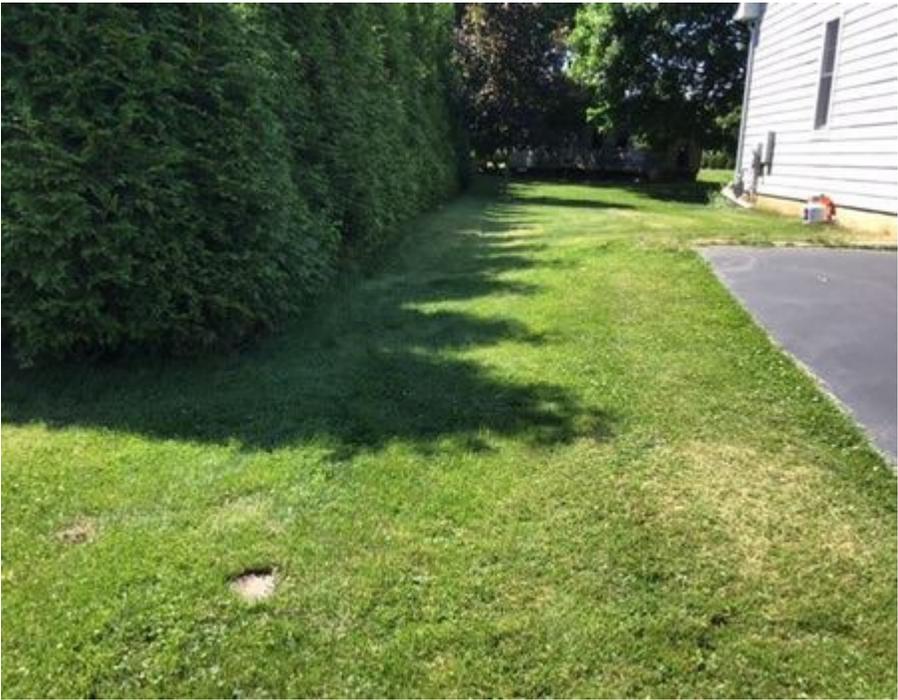
Description			
Overview of bmp and observation wells.			
Violation Type (if applicable): Standing water present.

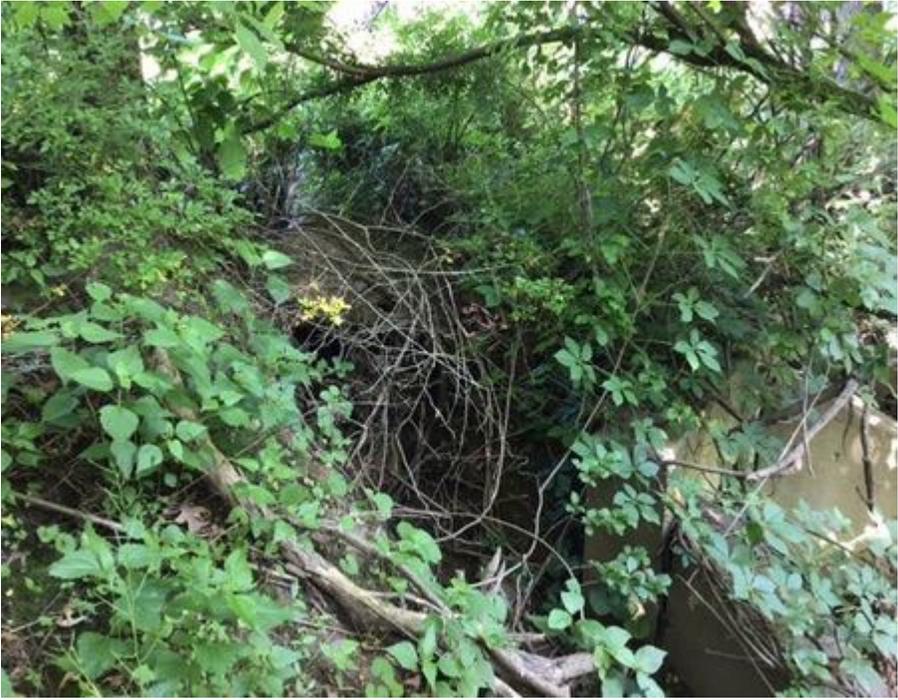
Description			
View of outflow erosion.			
Violation Type (if applicable):

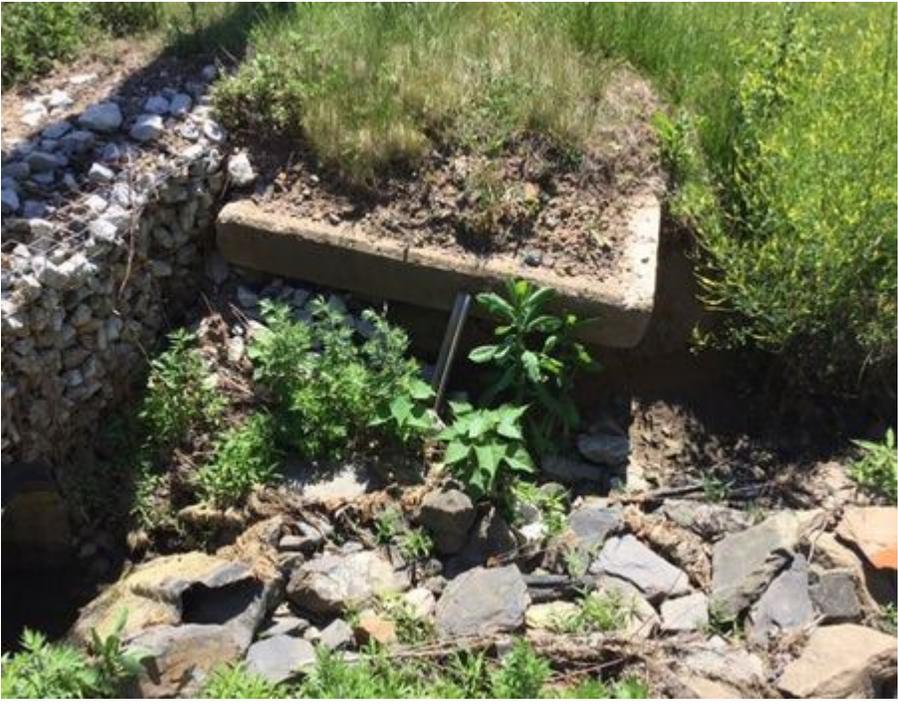
Description			
View of accelerated erosion along inflow.			
Violation Type (if applicable):
