RE: West Norriton Township – NPDES Annual MS4 Status Report – Year 2
NPDES Permit No. PAG130006
WNR-20-002

ANNUAL MUNICIPAL SEPARATE STORM SEWER SYSTEM (MS4) STATUS REPORT

West Norriton Township
Montgomery County, PA
1630 W. Marshall Street
Jeffersonville, PA 19403

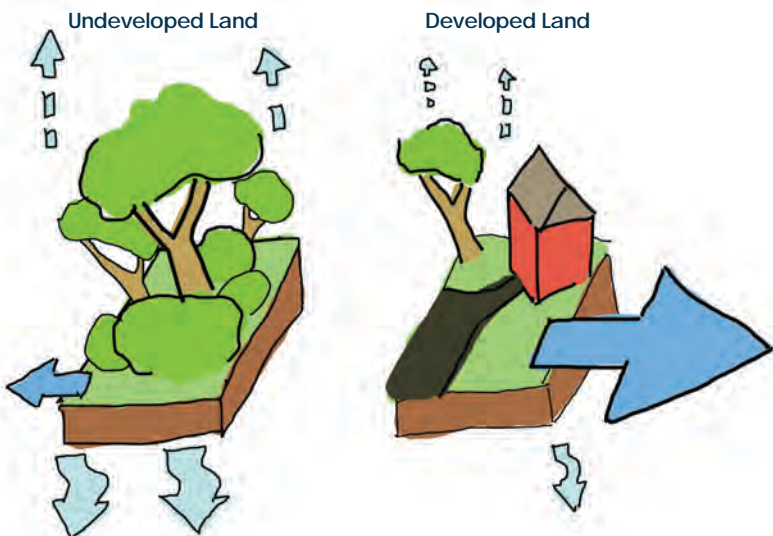
When it rains on an undeveloped piece of property, much of the rainwater infiltrates into the soil or is evaporated back into the atmosphere. When vegetation is replaced with streets, driveways, sidewalks, houses, and lawns, less rainwater is able to infiltrate or return to the atmosphere, and more of the rain turns into runoff.

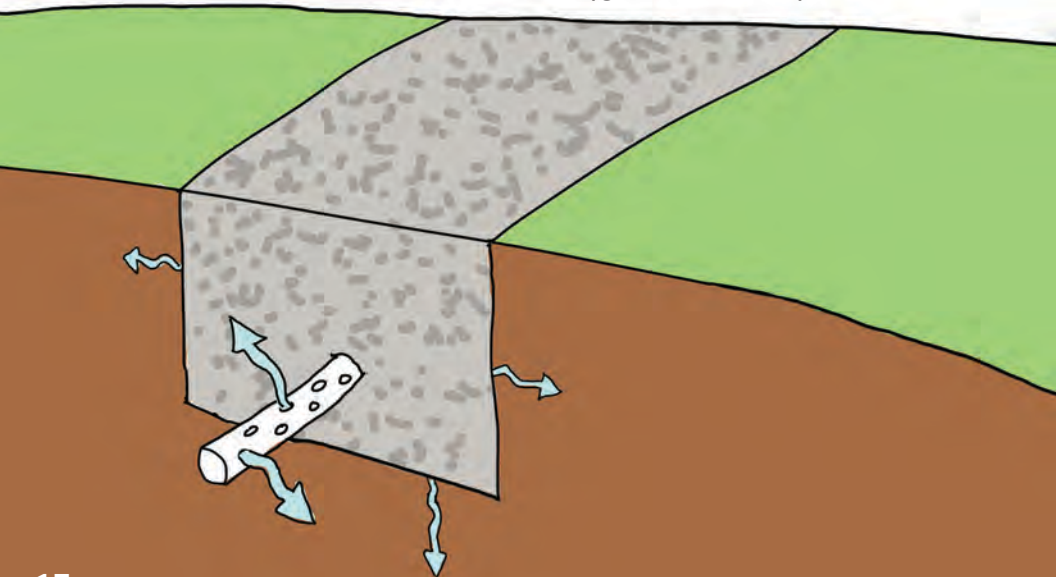
During small rain events with a small amount of runoff, stormwater flows out of the pipe through the perforations into the gravel and then into the soil. During larger storms that produce more runoff, some stormwater will be stored in the stone trench, but water will also flow through the pipe to a larger BMP or SCM. Runoff that moves into the soil can help recharge aquifers (ground water) and wells.

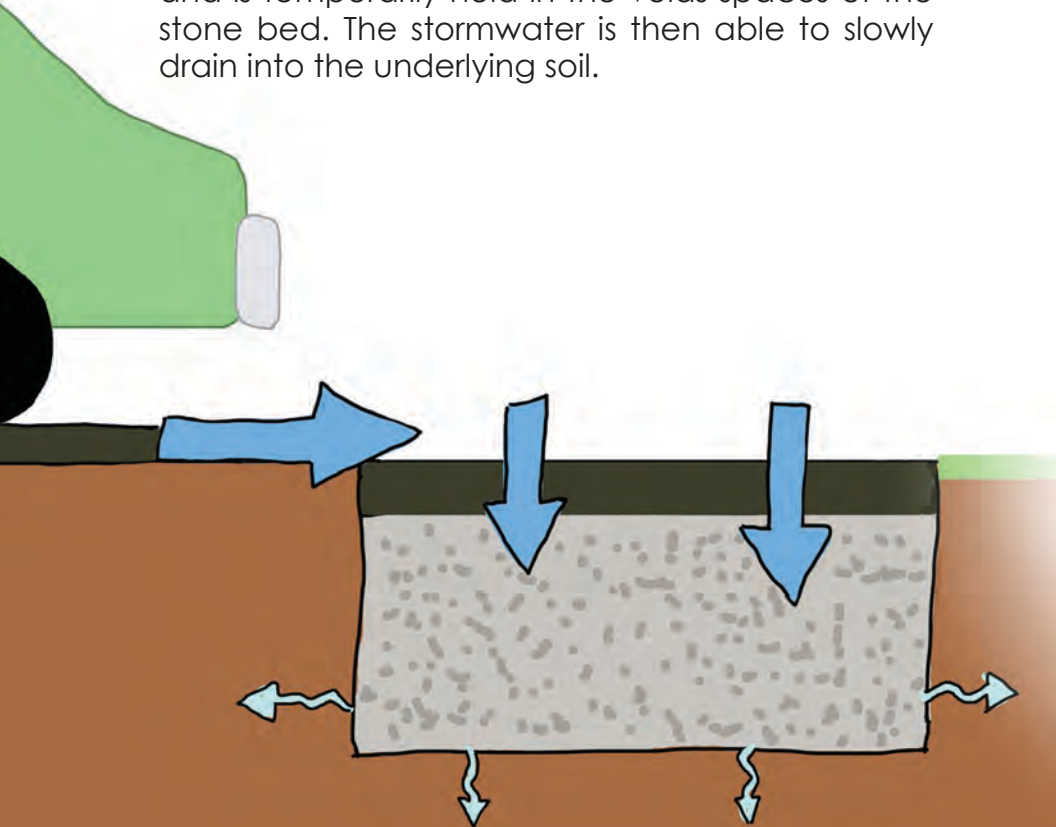
Stormwater drains through the pervious surface and is temporarily held in the voids spaces of the stone bed. The stormwater is then able to slowly drain into the underlying soil.

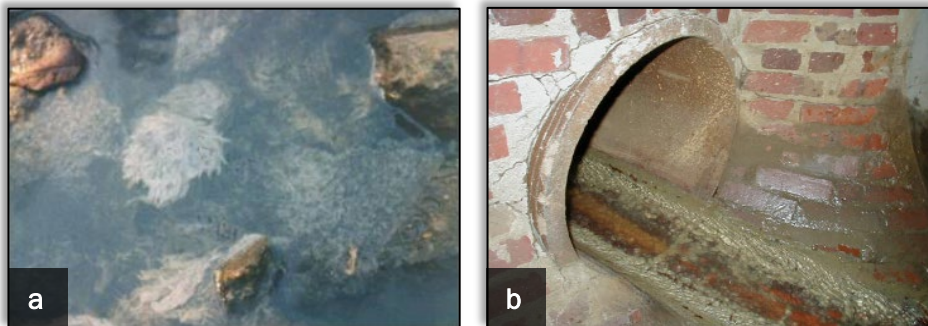
Figure 2 - Sewage. A strong organic or sewage-like odor can indicate a sanitary sewer leak or overflow. Indicators of sewage discharge can include (a) sewage fungus and (b) bacteria growth in outfall.

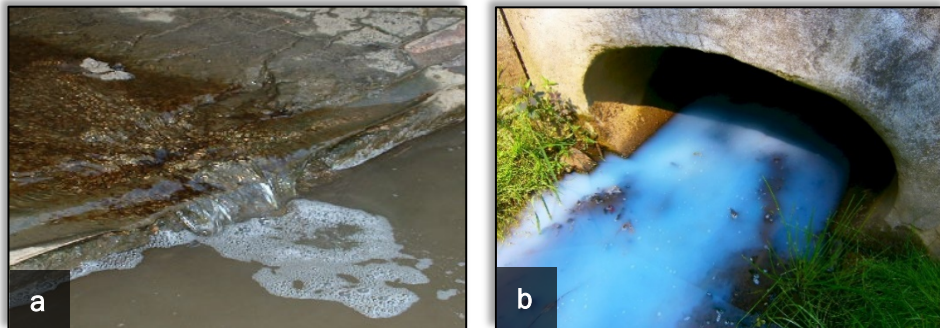
Figure 3 - Suds. Suds should be rated based on their foaminess and staying power. Picture (a) shows a low severity, naturally occurring suds. Suds that travel several feet before breaking up should be considered as high severity suds and a possible illicit discharge (b). In some cases, foam and suds can give off an odor. A fragrant or sweet-smelling odor can indicate the presence of laundry water or similar wash waters.

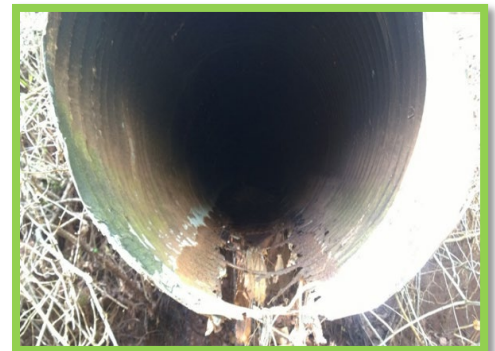
Figure 4. Outfall pipe damage (could indicate the presence of contaminated discharges).

The physical condition of an outfall can provide strong clues about the history of discharges passing through it. Over time, intermittent discharges can cause outfall damage (Figure 4) or leave behind remnants in the form of deposits or stains which can help an inspector determine what type of discharge traveled through the area. Field inspectors should document that a deposit or stain is present even if there is no dry weather discharge observed.

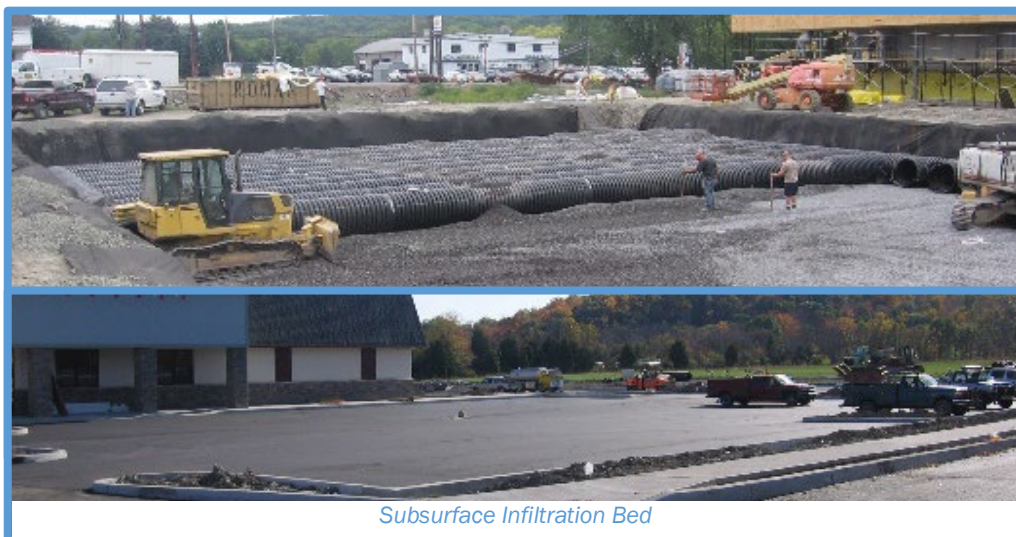
A subsurface infiltration bed consists of a vegetated, highly pervious soil media underlain by a uniformly graded aggregate bed for temporary storage and infiltration of stormwater runoff. It provides temporary storage and infiltration of runoff in subsurface storage media. However, in some cases, runoff may also be temporarily stored on the surface to enhance volume capacity of the system. Maintenance activities required for subsurface infiltration beds focus on regular sediment and debris removal. The Manual recommends regular maintenance be conducted by the BMP owner/responsible party, as detailed in **Table 3** below.
