RE: West Norriton Township Annual MS4 Status Report
NPDES Permit No. PAG130006
West Norriton Township, Montgomery County, PA

ANNUAL MS4 STATUS REPORT 2024

WEST NORRITON TOWNSHIP

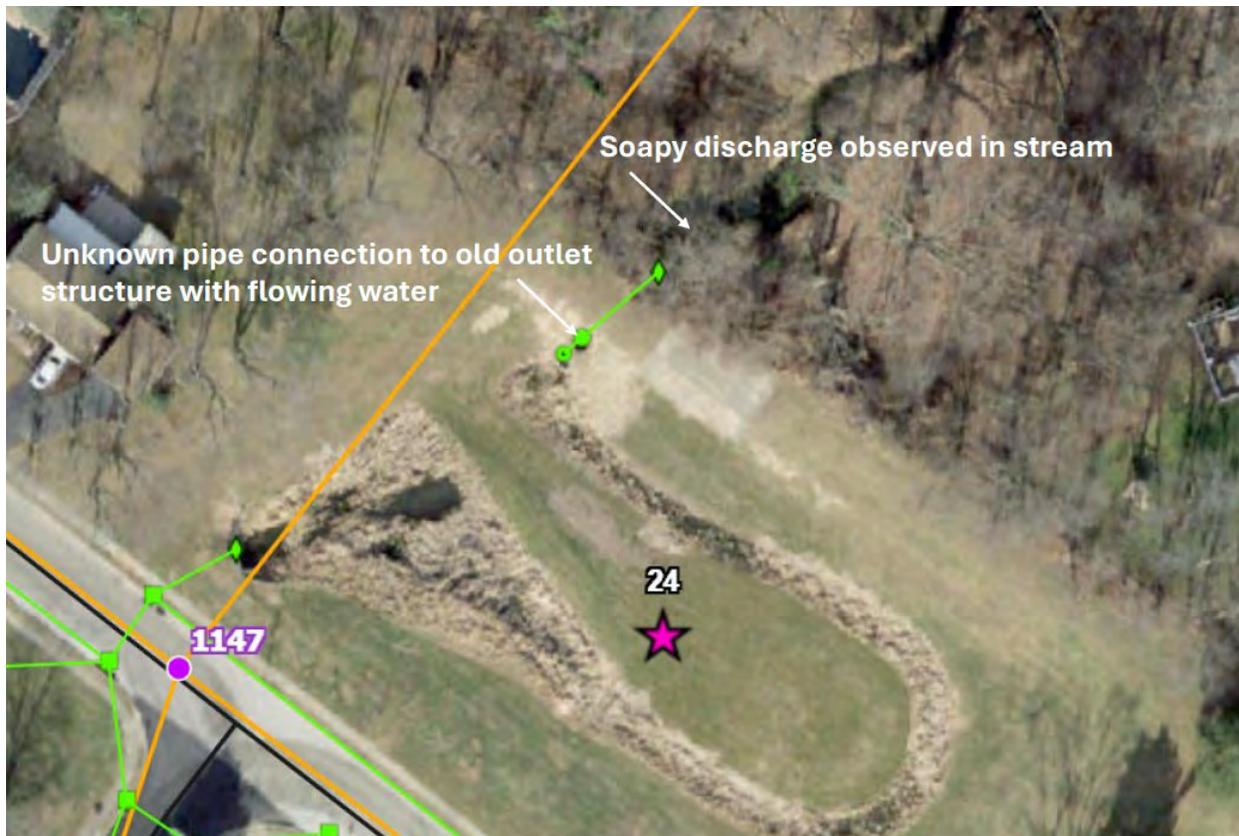
Figure 1 Location of the observed foam at Outfall #33.

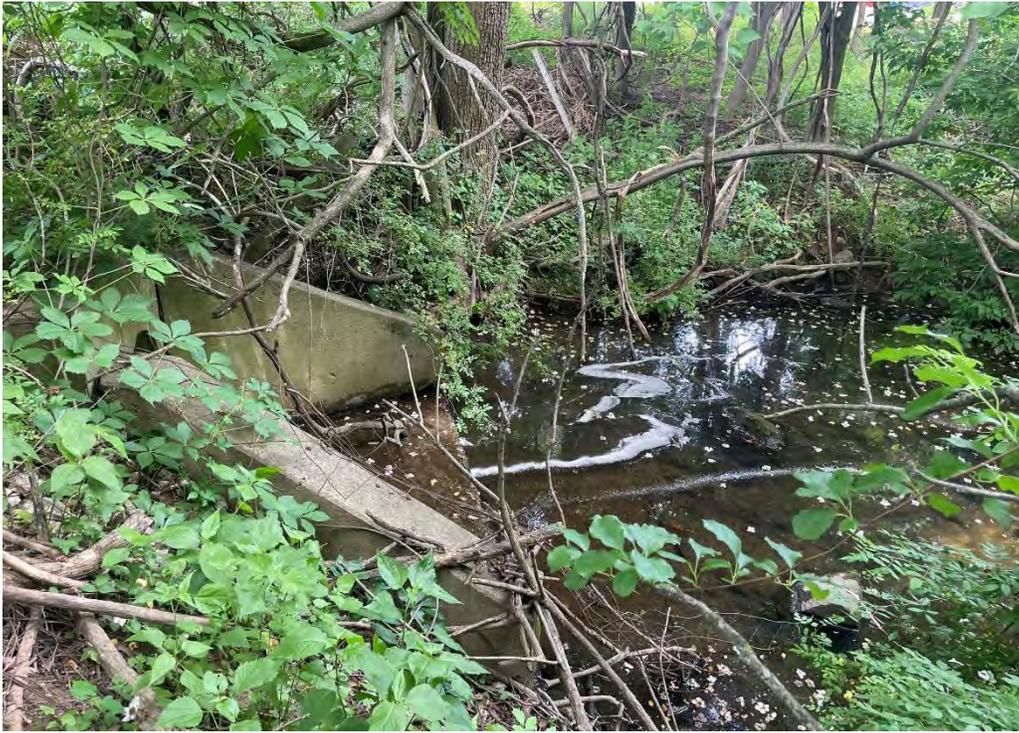
Figure 2 White foam observed at Outfall #33.

CWP recommended the following:

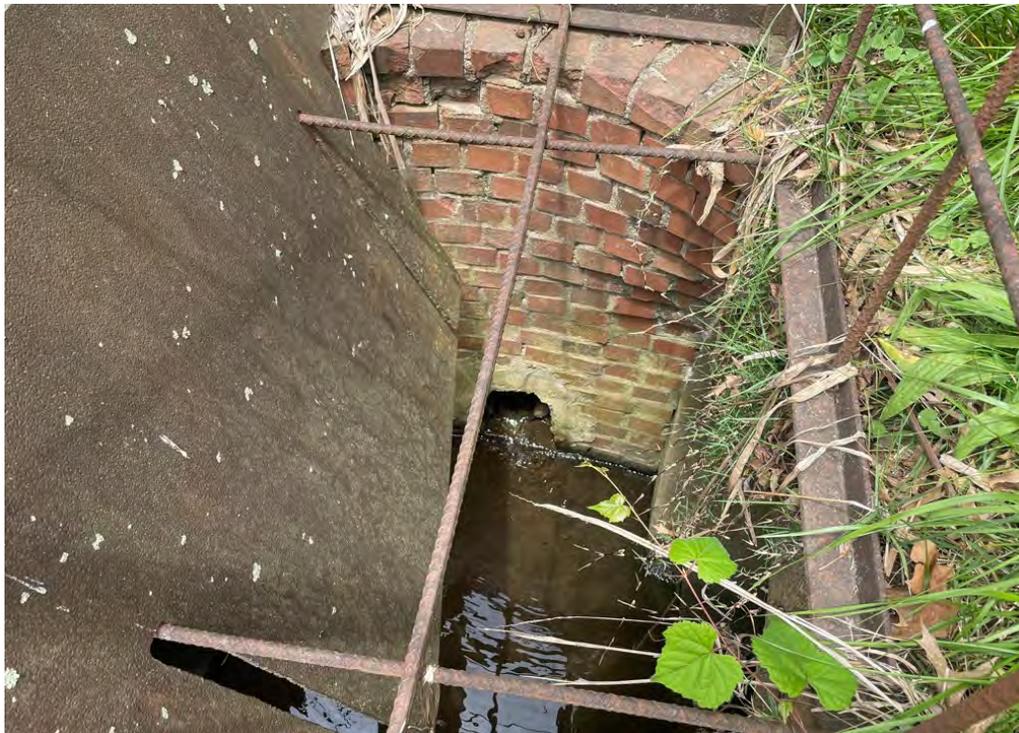
There is a small pipe connected to the original basin outlet structure that had flow at the time of the site visit (Figure 3). This pipe is not shown in the Township infrastructure mapping. There is also a small manhole just upslope that is labeled "SEWER" that is also not mapped.

Figure 3 Small pipe entering original basin outlet structure.

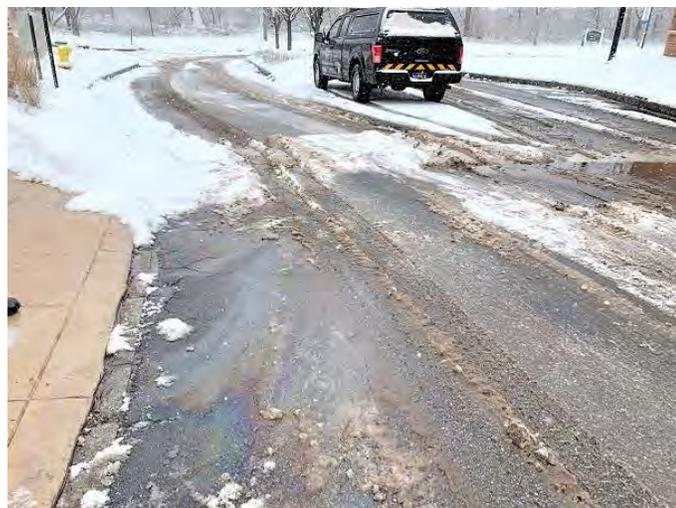
Residual oil on Patriots Lane looking towards the River

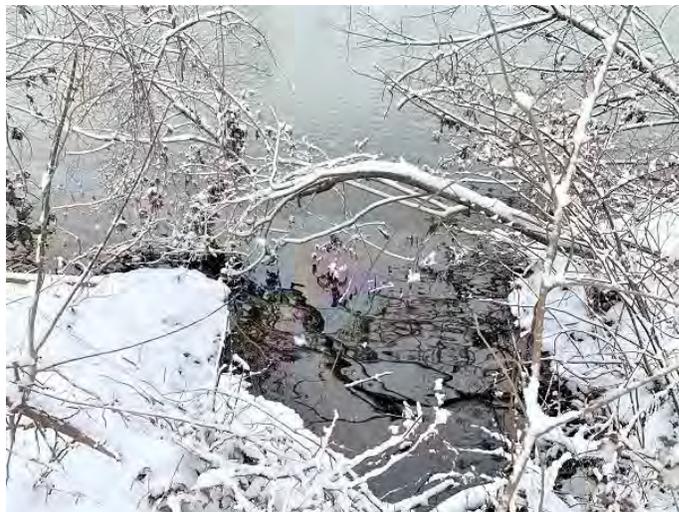
Sheen discharging into the River

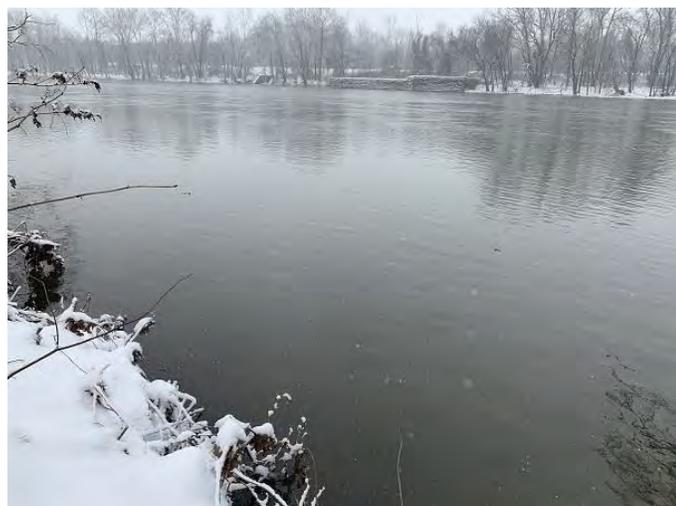
Downstream isolated spots of sheen

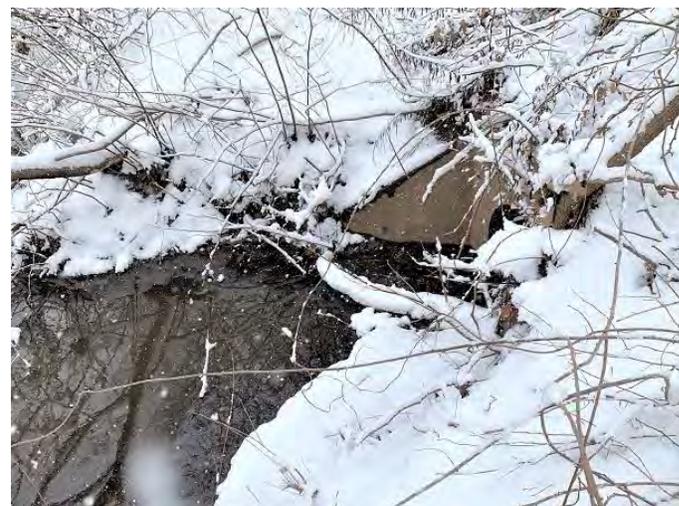
Dissipated sheen at the discharge point

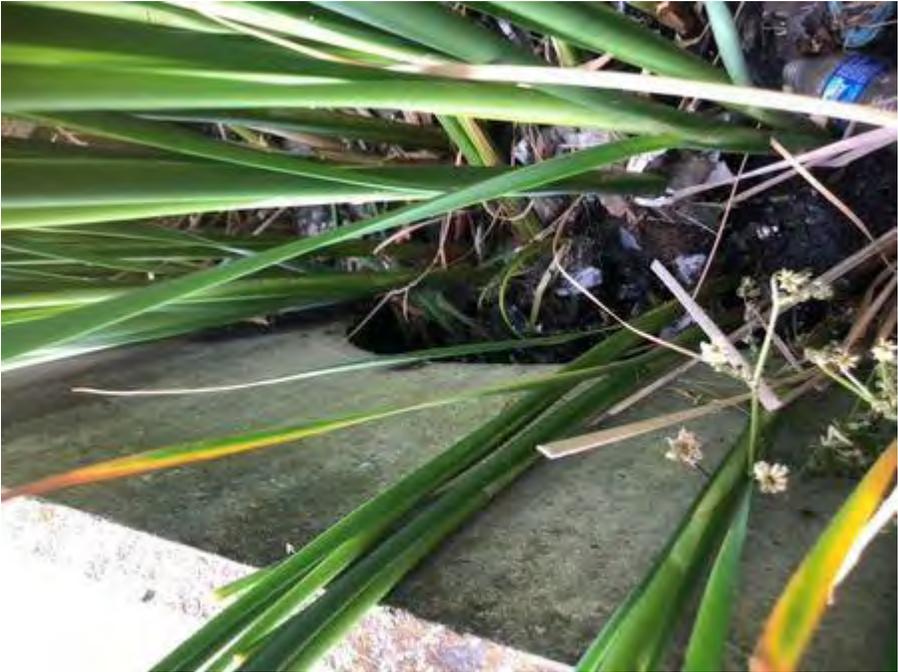
Excessive vegetation & sediment buildup at outlet. View of inlet orifice.

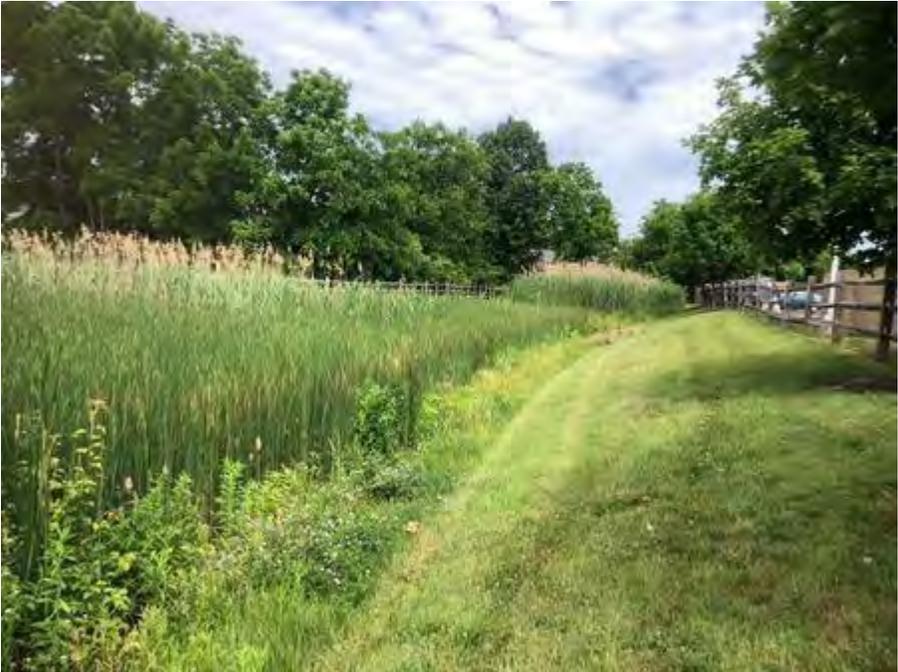
Photo No. 4	Date: 06/03/2024
-------------	---------------------

Looking towards dumpster area, mowed side slopes, cattails in basin.

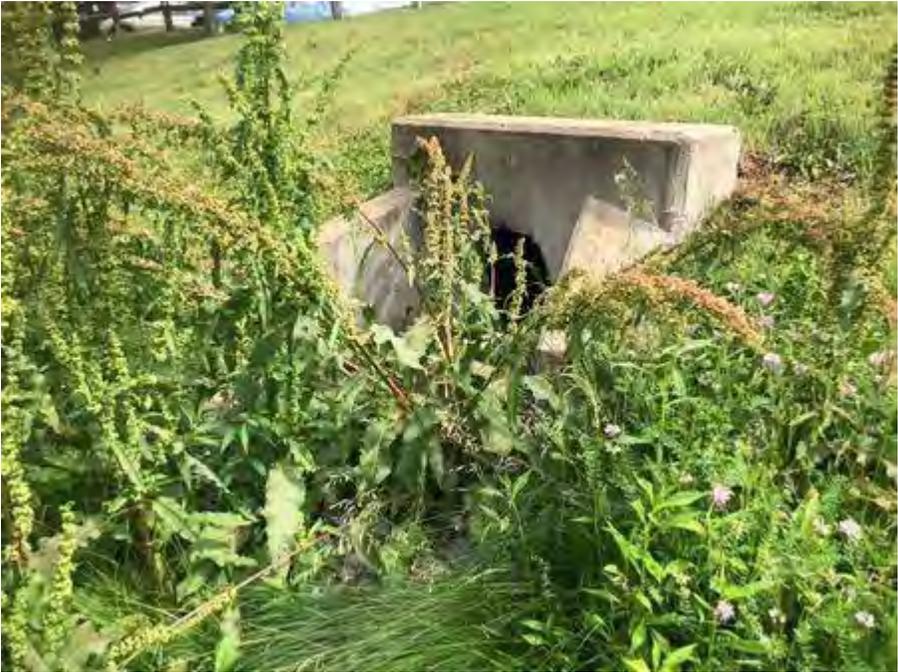
BMP #: 14		BMP Type: Detention Basin	BMP Address: 2544 W. Main Street
Photo No. 5	Date: 06/03/2024	Date:	
Description

Inflow pipe			
Violation Type (if applicable):			
Photo No. 6	Date: 06/03/2024	Date:	
Description

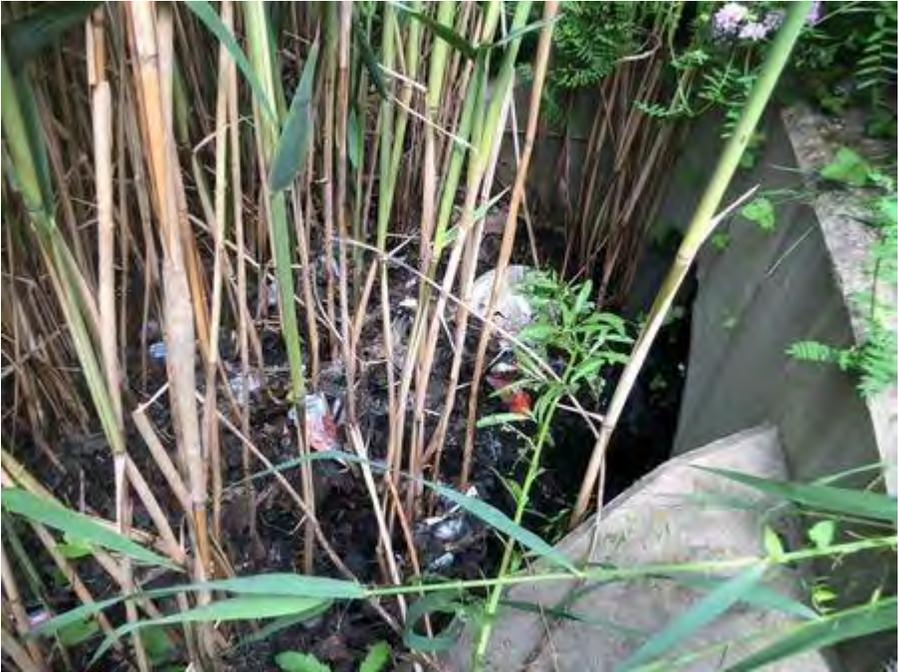
Inflow orifice with sediment, trash, and excessive vegetation- cattails.			
Violation Type (if applicable): Vegetation, sediment and trash

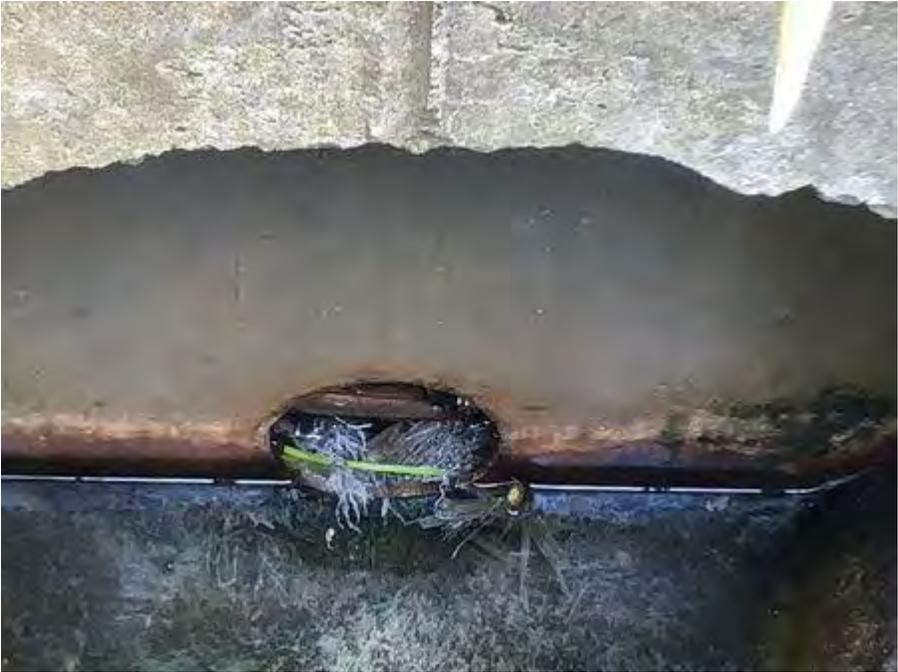
Outlet orifice clogged with roots and debris.			
Violation Type (if applicable): Low flow orifice clogged			
Photo No. 8	Date: 06/03/2024	Date:	
Description

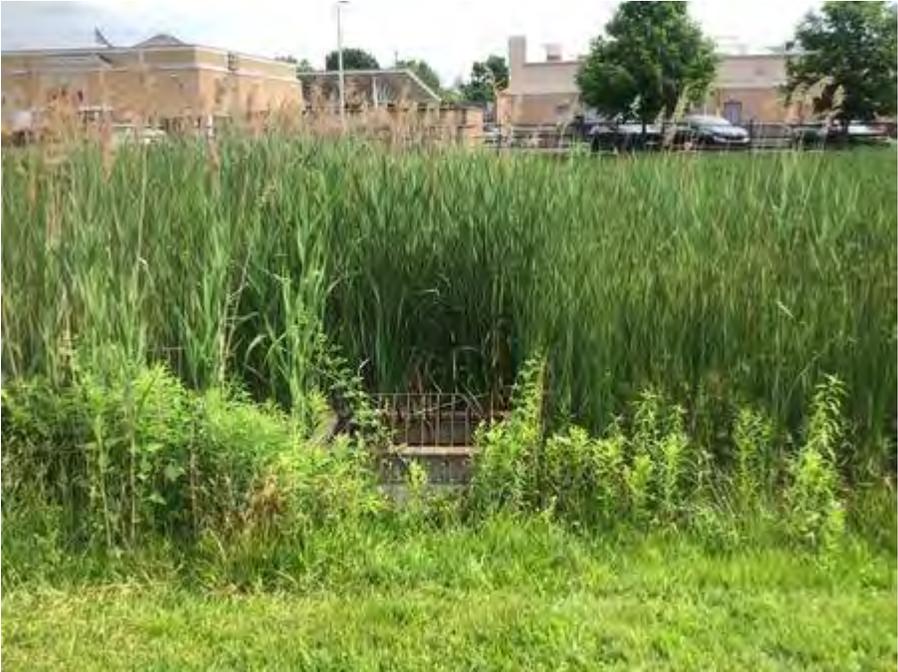
Outlet structure, presence of excessive vegetation- cattails.			
Violation Type (if applicable):

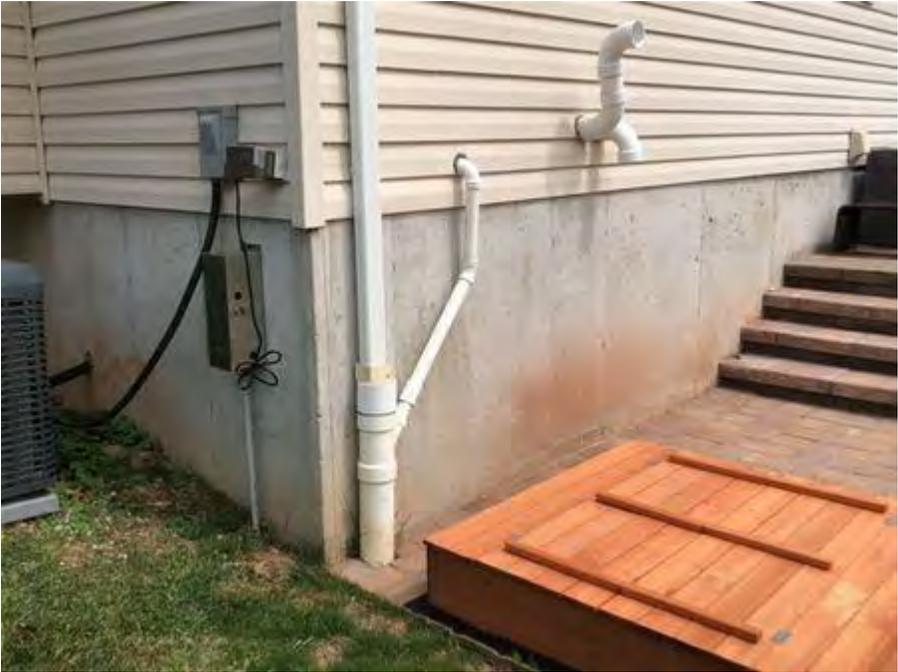
BMP #: 16		BMP Type: Underground infiltration pit	BMP Address: 139 Clemons Cir
Photo No. 1	Date: 06/03/2024	Date:	
Description

Roof drain connection			
Violation Type (if applicable):			
Photo No. 2	Date: 06/03/2024	Date:	
Description

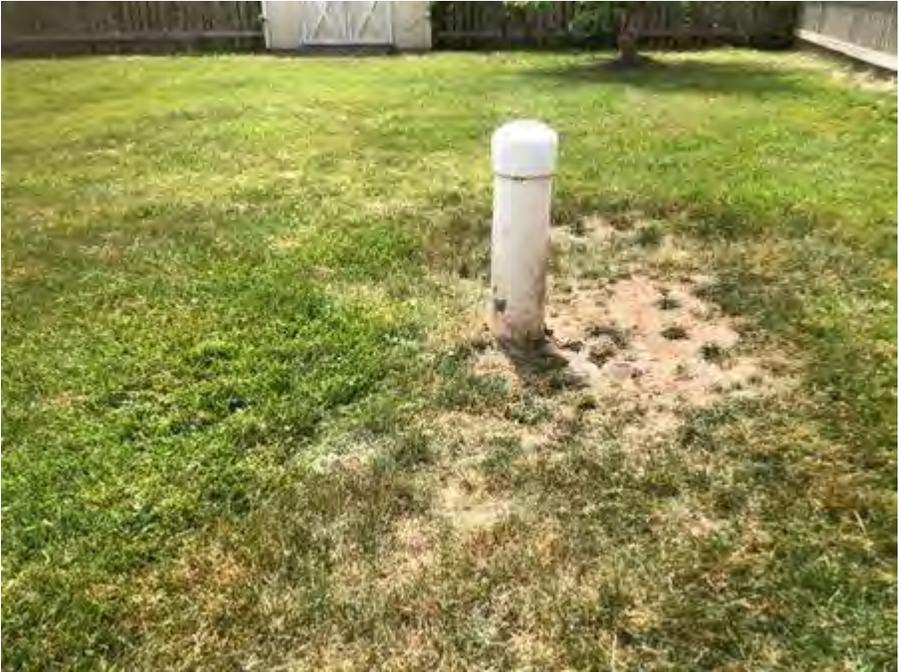
Possible cleanout, cleanout cap tightly secured and unable to be removed for inspection.			
Violation Type (if applicable):

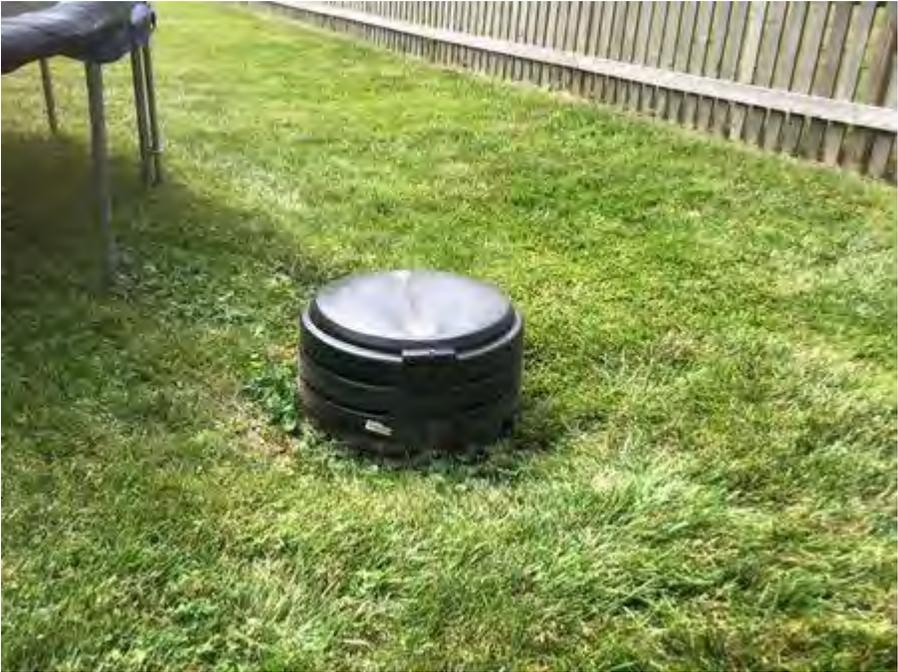
Other potential cleanout or inspection well with cover zip-tied on. Unable to be removed.			
Violation Type (if applicable):

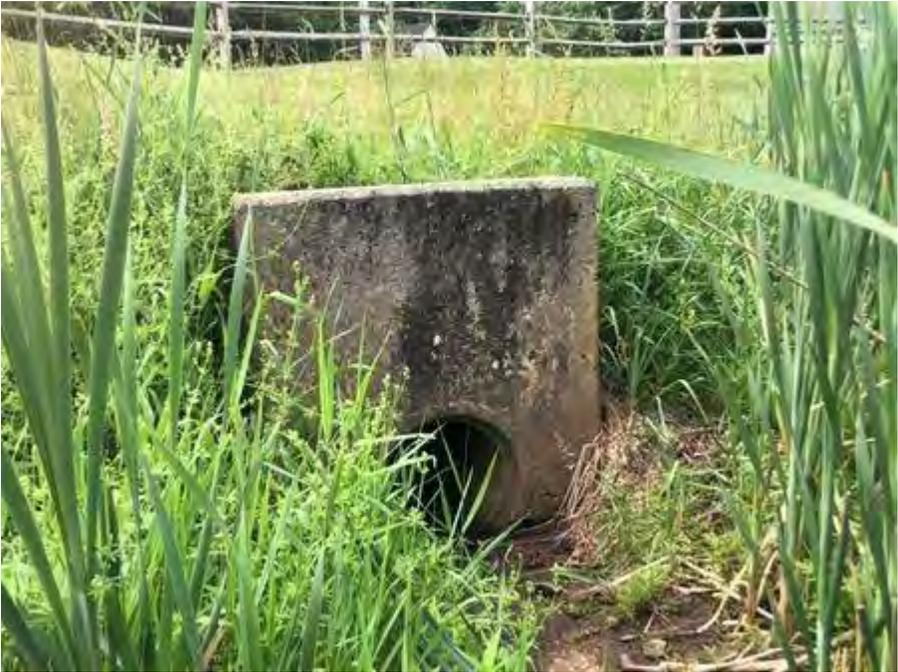
BMP #: 2		BMP Type: Detention Basin	BMP Address: Wagon Wheel Rd
Photo No. 5	Date: 06/03/2024	Date:	
Description

Inlet structure.			
Violation Type (if applicable):			
Photo No. 6	Date: 06/03/2024	Date:	
Description

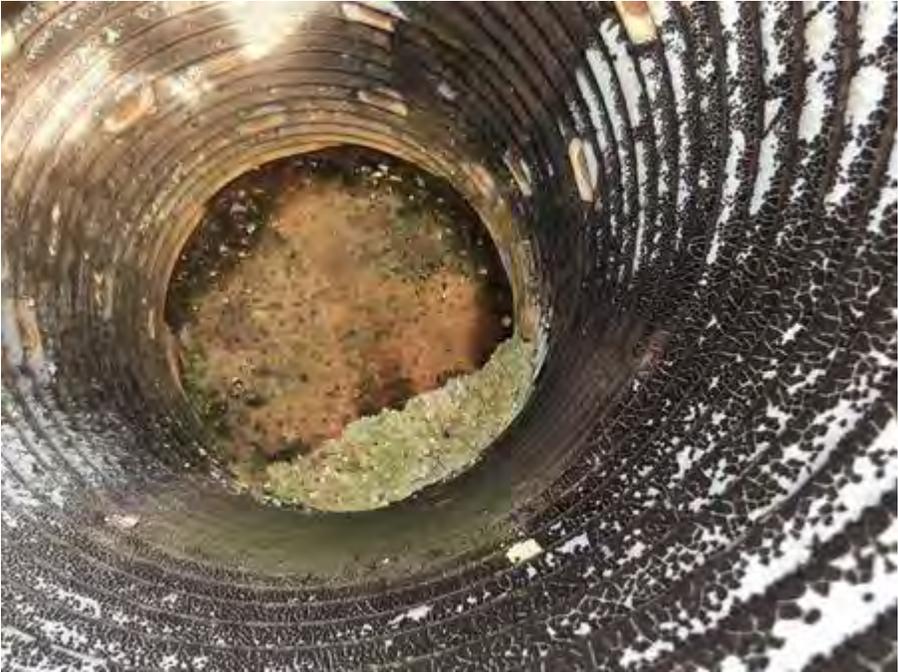
Orifice holes in metal corrugated pipe plugged up, concrete outlet pipe			
Violation Type (if applicable):

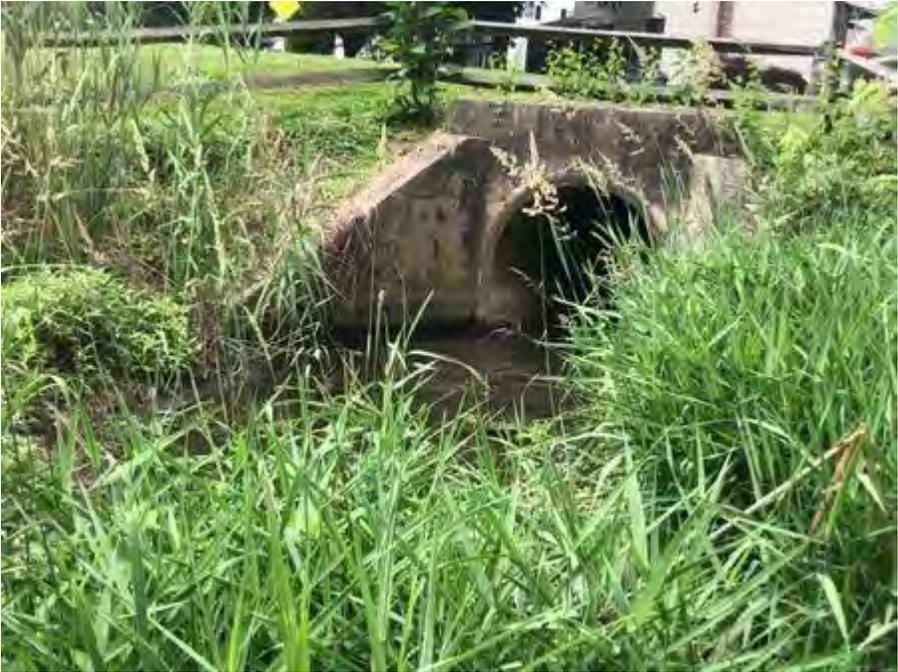
Large inlet with standing water, low flow to no flow.			
Violation Type (if applicable):			
Photo No. 2	Date: 06/03/2024	Date:	
Description

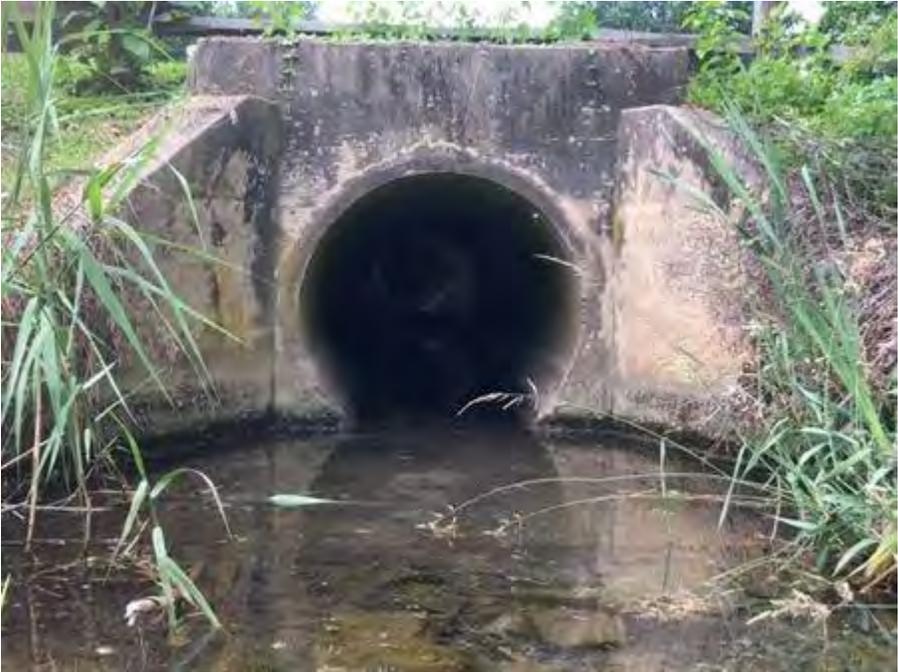
Large concrete inlet pipes			
Violation Type (if applicable):

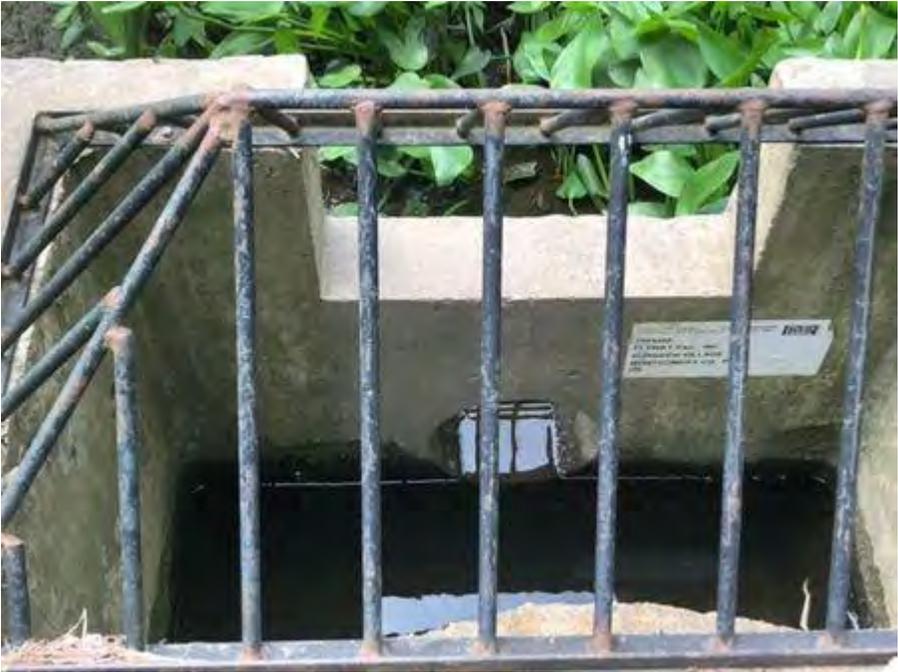
<p>Outlet structure (new) low-flow orifice, constructed in front of older/outdated brick outlet structure.</p>			
Violation Type (if applicable):			
Photo No. 6	Date: 06/03/2024	Date:	
Description

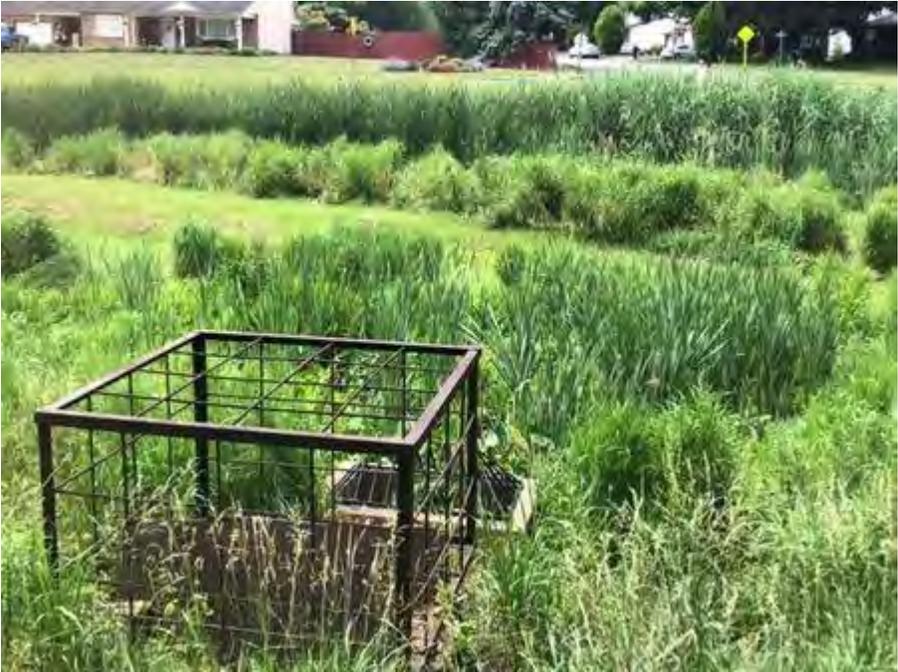
<p>View of new and old outlet structures in line.</p>			
Violation Type (if applicable):

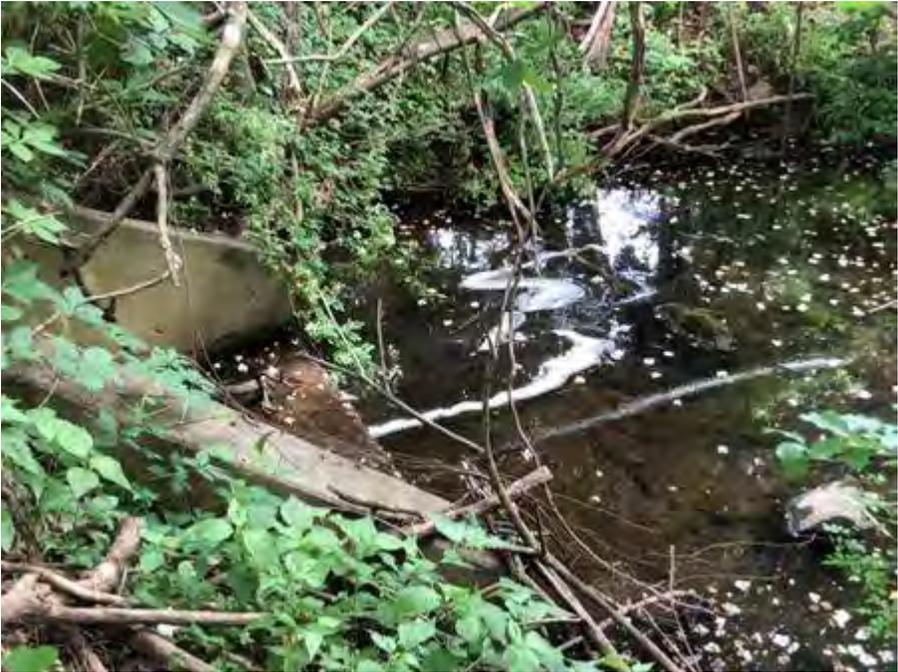
<p>Additional investigation recommended. Pipe coming from homeowners yard-connecting to old outlet structure has flowing water before discharging here. Water flowing with no recent rainfall. Illicit discharge?</p>			
Violation Type (if applicable):			
Photo No. 8	Date: 06/03/2024	Date:	
Description

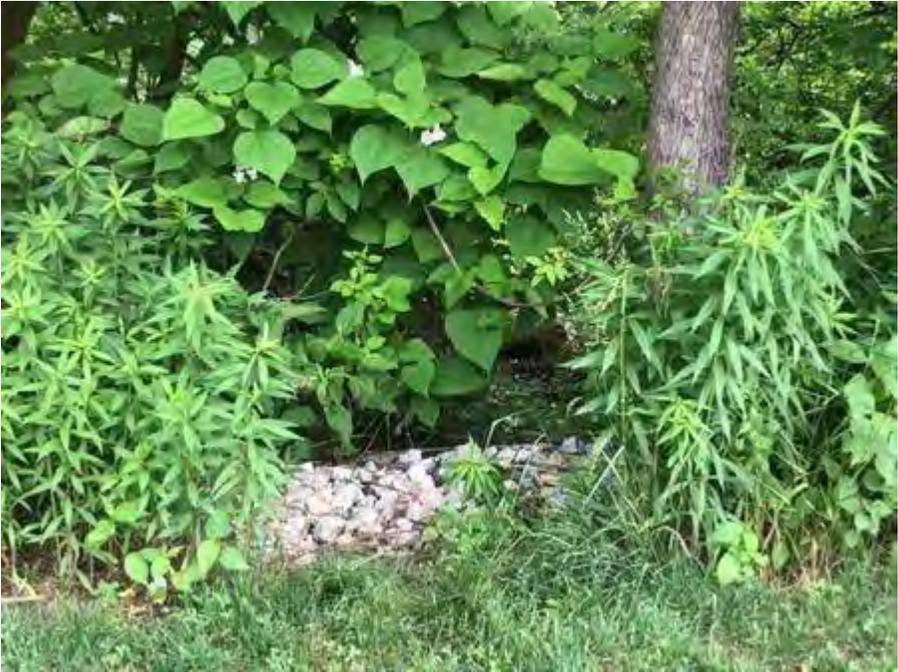
<p>Rip-rap reinforced spillway, fixed from prior floods and erosion noted in previous inspections.</p>			
Violation Type (if applicable):

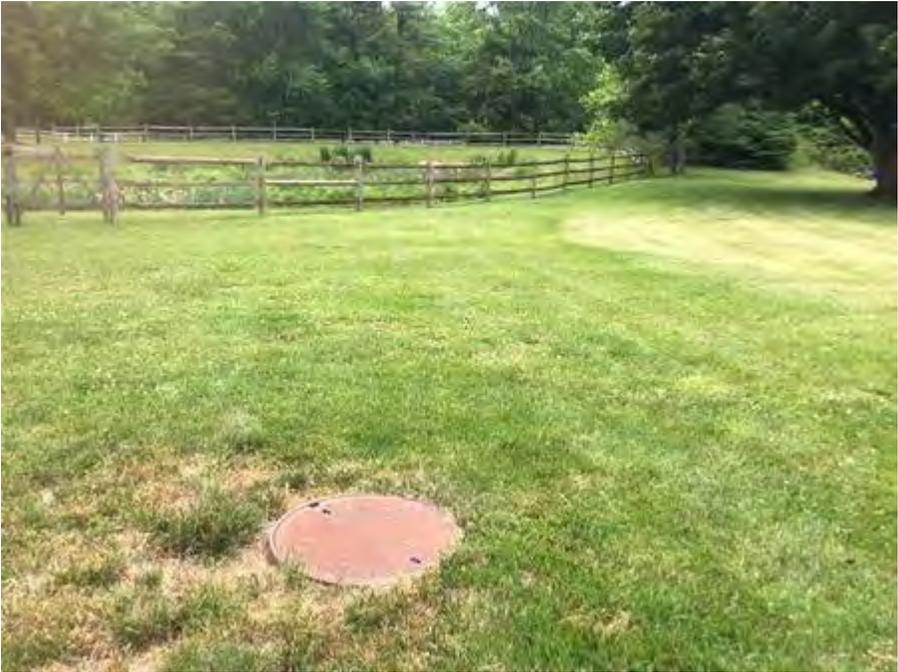
BMP #: PRP		BMP Type: Dry Extended Detention	BMP Address: Alexander Dr
Photo No. 1	Date: 06/03/2024	Date:	
Description

Man hole with sump to capture sediment before entering basin			
Violation Type (if applicable):			
Photo No. 2	Date: 06/03/2024	Date:	
Description

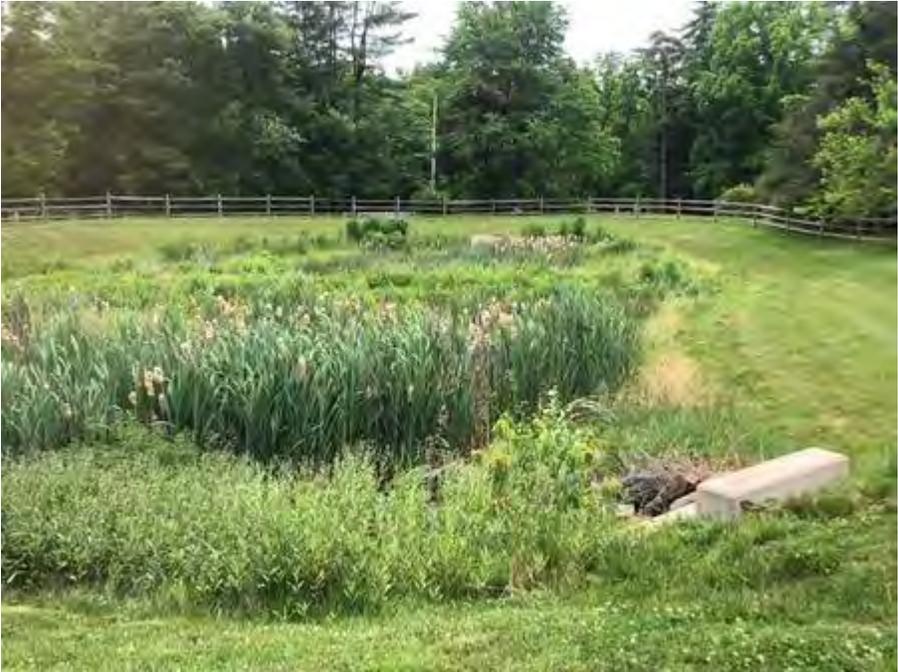
Overall view of basin			
Violation Type (if applicable):

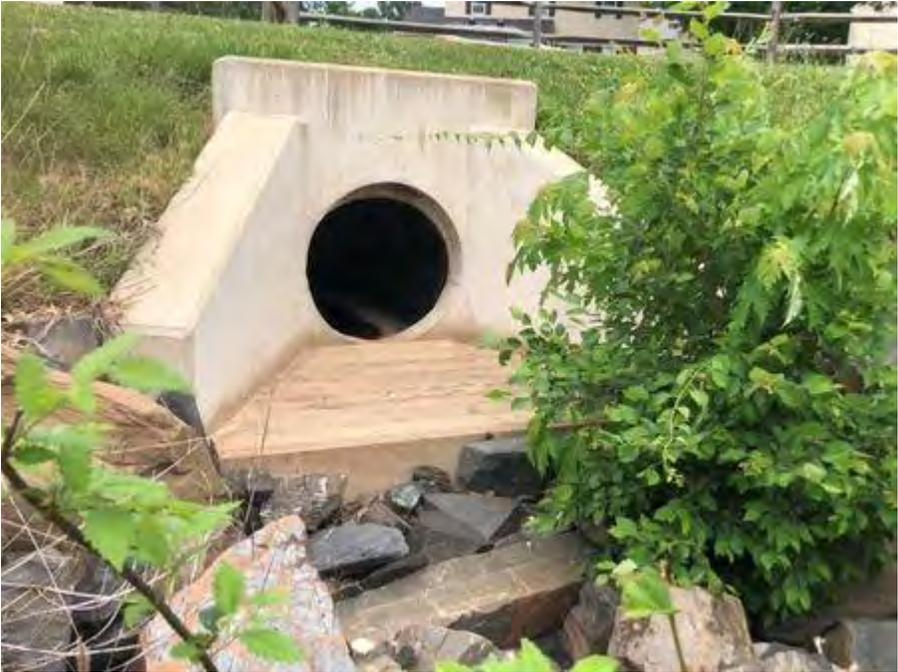
BMP #: PRP		BMP Type: Dry Extended Detention	BMP Address: Alexander Dr
Photo No. 3	Date: 06/03/2024	Date:	
Description

Removed birch and silver maple from inlet			
Violation Type (if applicable):			
Photo No. 4	Date: 06/03/2024	Date:	
Description

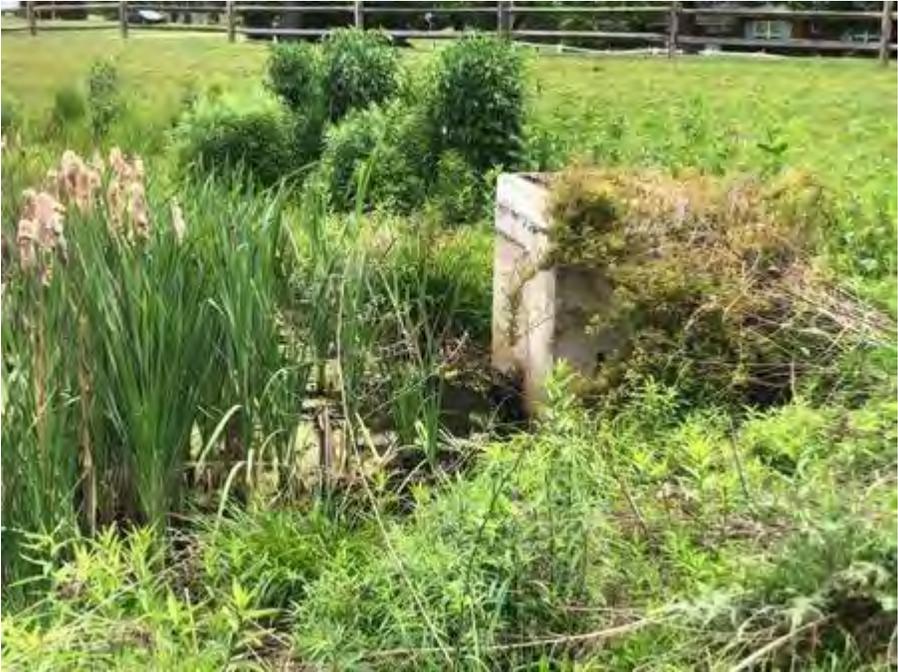
Orifice clogged with debris, standing water, presence of cattails, remove multiflora rose over top of structure.			
Violation Type (if applicable):

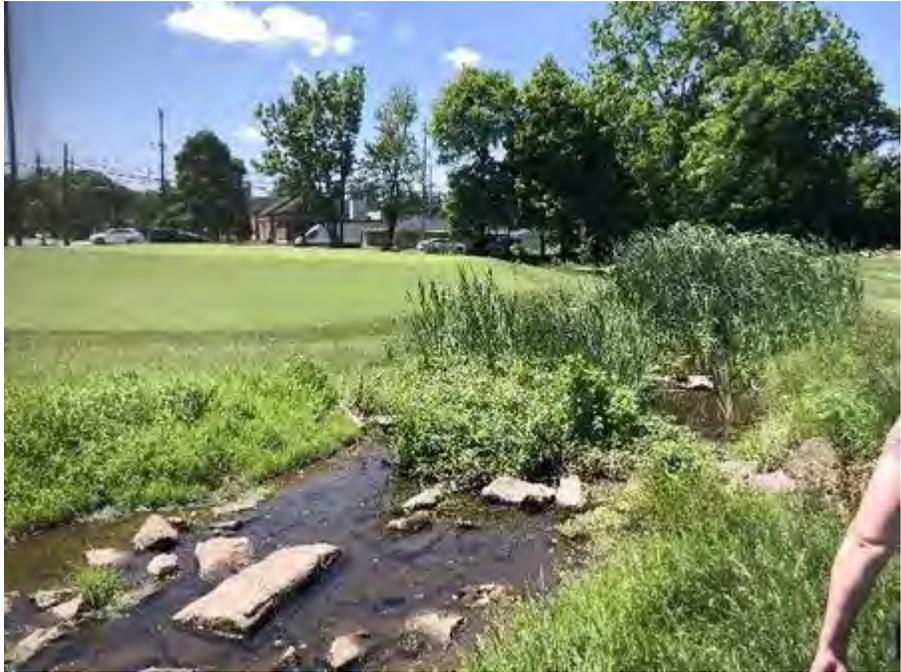
Stream channel has widened due to erosion. Cattails present.

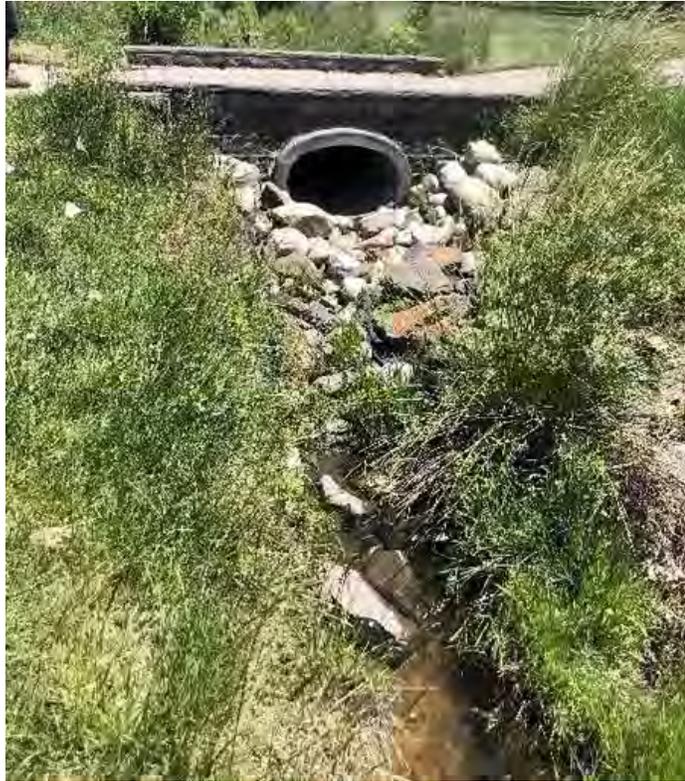
Stream crossing. Erosion present.

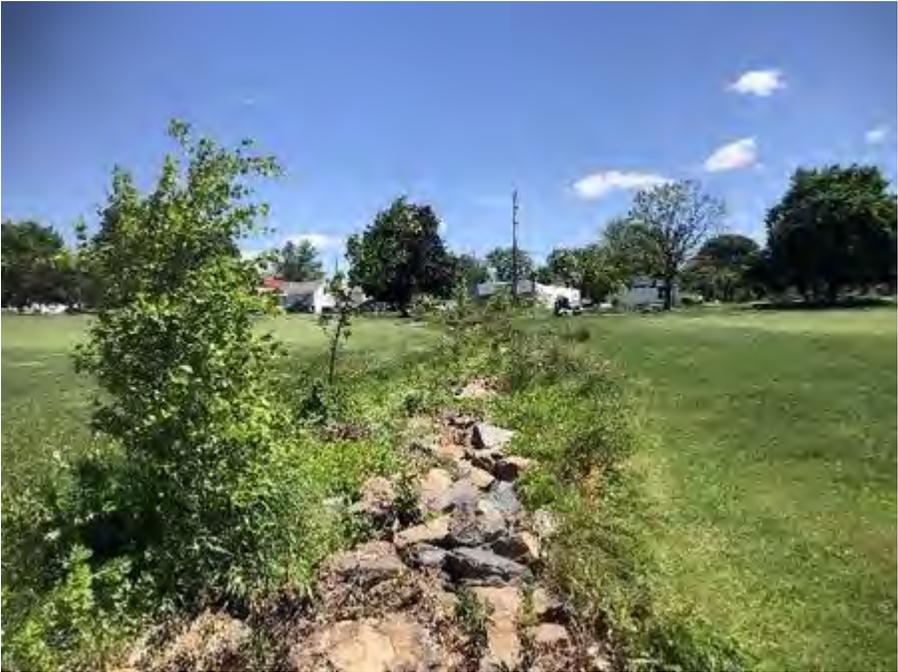
Excessive stone in stream channel. Narrow vegetation strips on either side of stream channel. Discussed increasing planting width.			
Violation Type (if applicable):			
Photo No. 6	Date: 06/03/2024	Date:	
Description

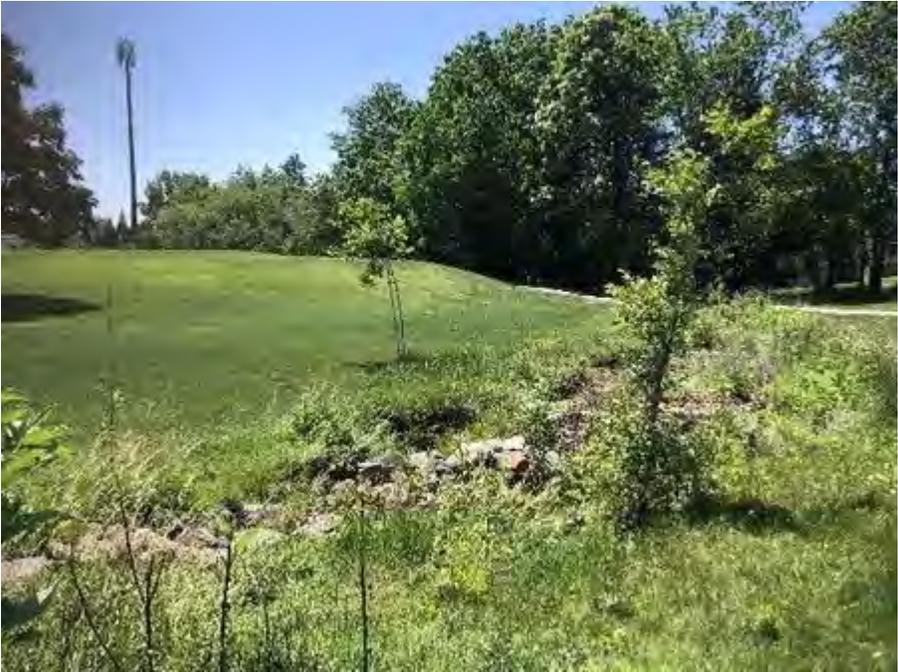
Excessive stone in stream channel. Evidence of stream bank erosion as flow is directed around excess stone.			
Violation Type (if applicable):

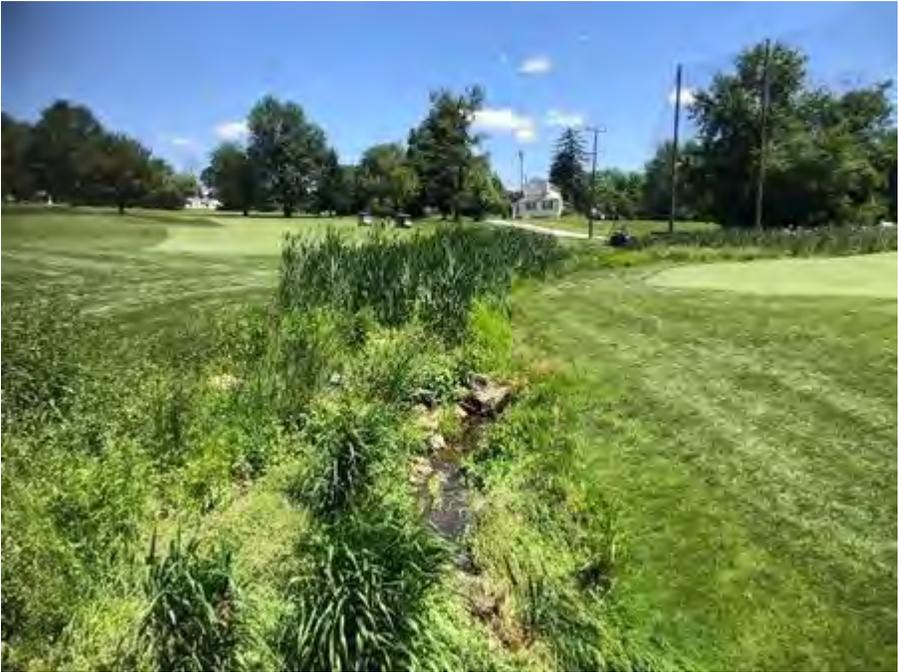
Stream bank erosion as stream channel flows around rip rap and cuts into banks. Cattails present in stream channel.			
Violation Type (if applicable):			
Photo No. 8	Date: 06/03/2024	Date:	
Description

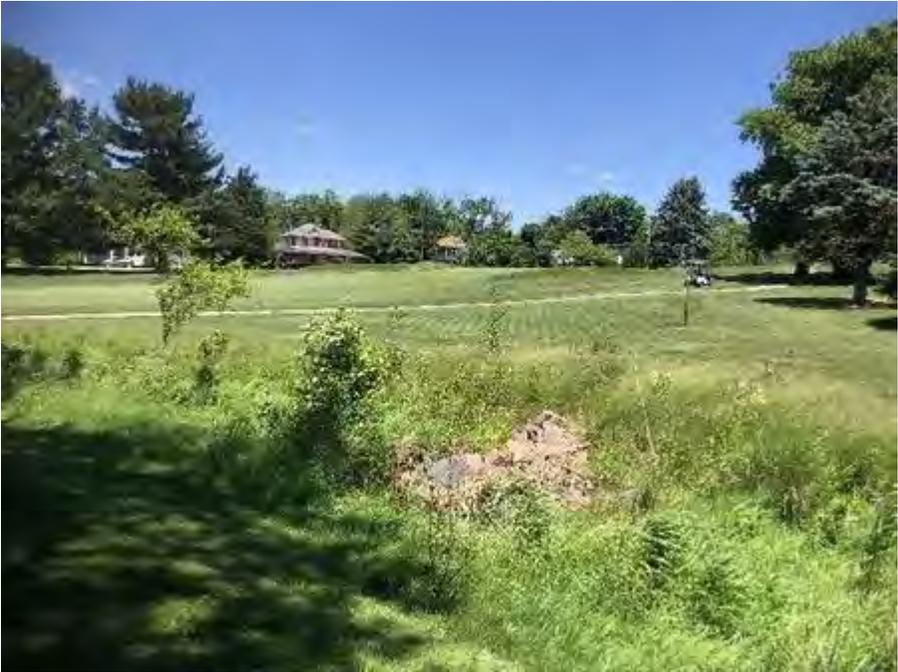
Rip rap check dam in stream channel. Narrow vegetated strips on either side of stream. Discussed increasing buffer width.			
Violation Type (if applicable):
