RE: 2021 Annual MS4 Status Report  
NPDES Permit No. PAG130006  
West Norriton Township, Montgomery County  
WNR-21-006

# **ANNUAL MUNICIPAL SEPARATE STORM SEWER SYSTEM (MS4) STATUS REPORT**

West Norriton Township  
Montgomery County, PA  
1630 W. Marshall Street  
Jeffersonville, PA 19403

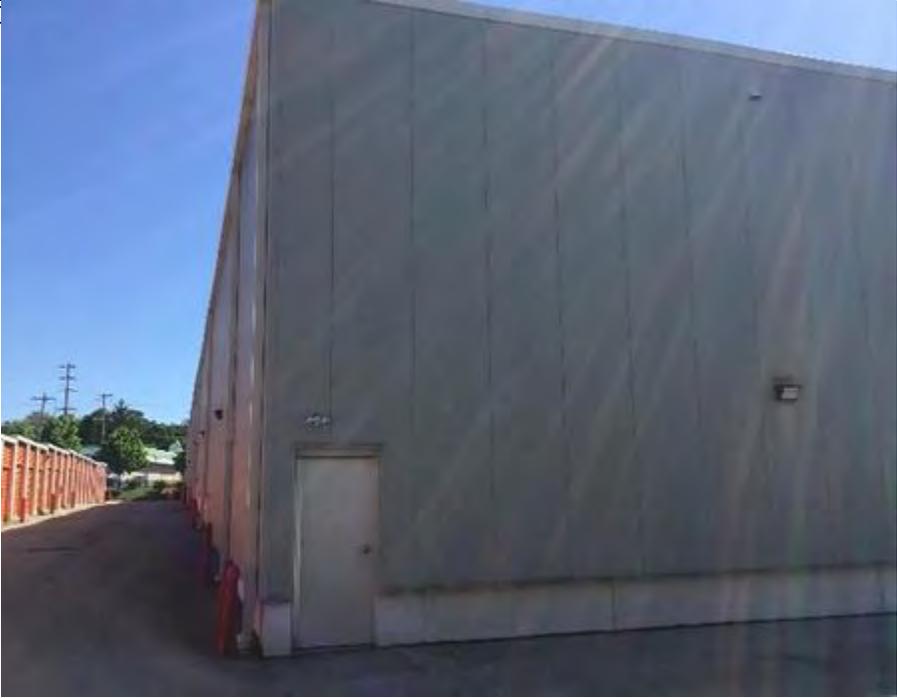
Description			
View of the contributing drainage area.			
Violation Type (if applicable):			
Photo No. 4	Date: 05/13/2021

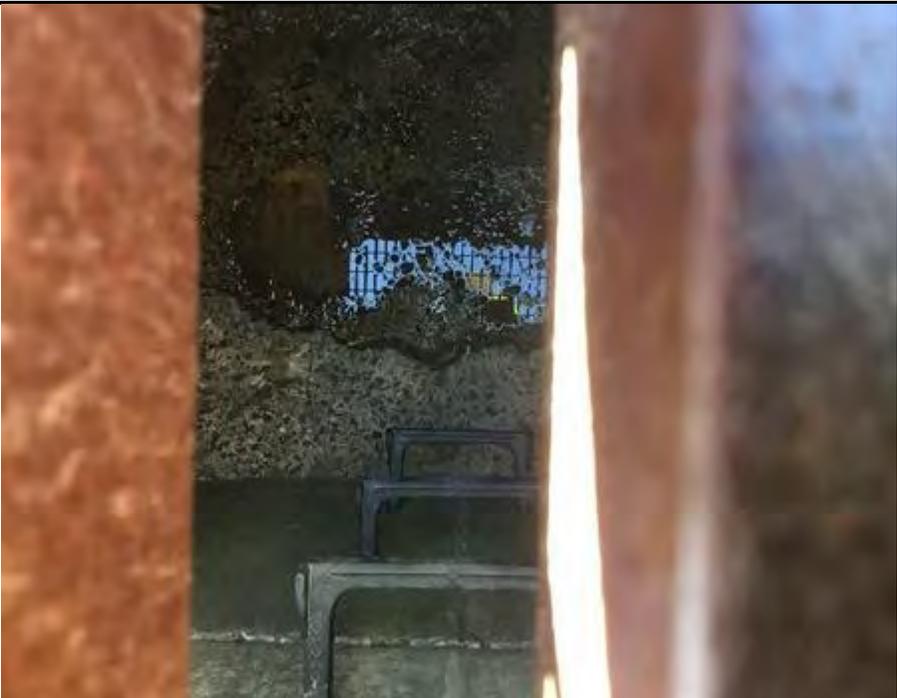
Description			
Observation inlet is clear of water or debris.			
Violation Type (if applicable):

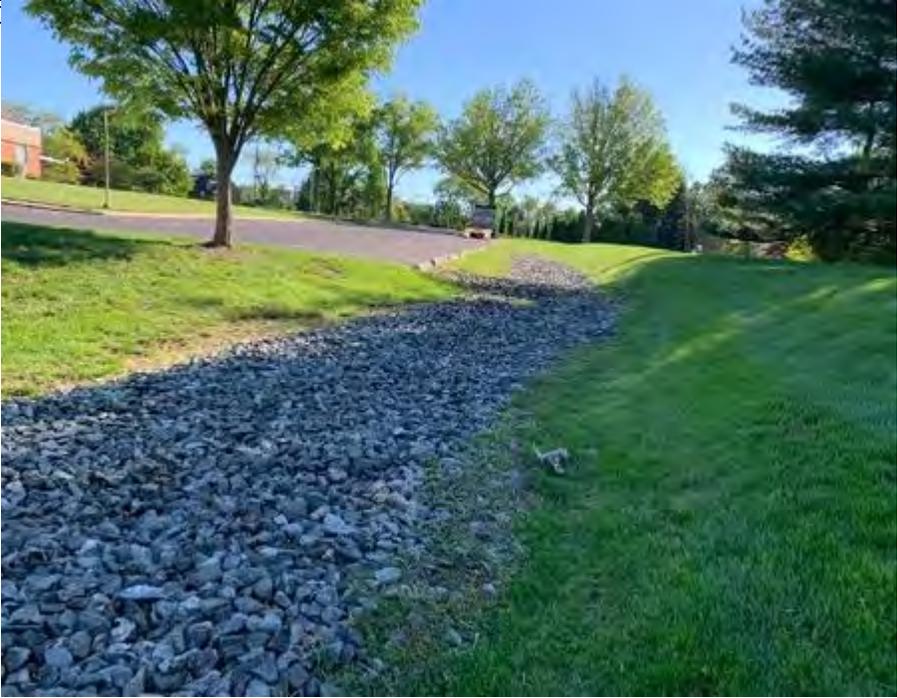
BMP #: 3A		BMP Type: Detention Basin	BMP Address: 2500 Stinson Ln, Norristown, PA 19403
Photo No. 3	Date: 05/12/2021

Description			
View of the swale leading to the BMP.			
Violation Type (if applicable):			
Photo No. 4	Date: 05/12/2021

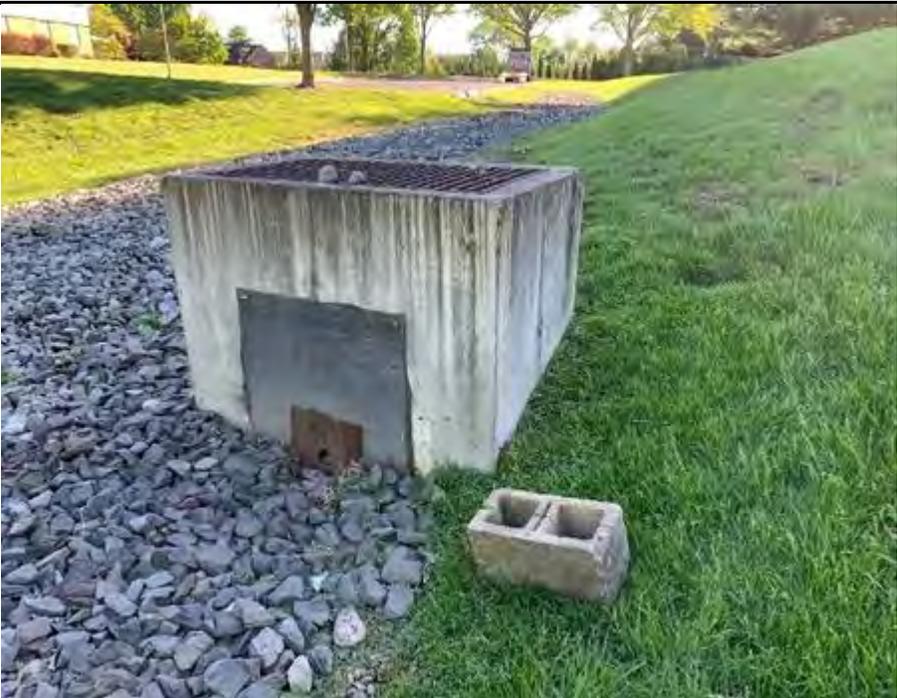
Description			
View of the riser structure.			
Violation Type (if applicable):

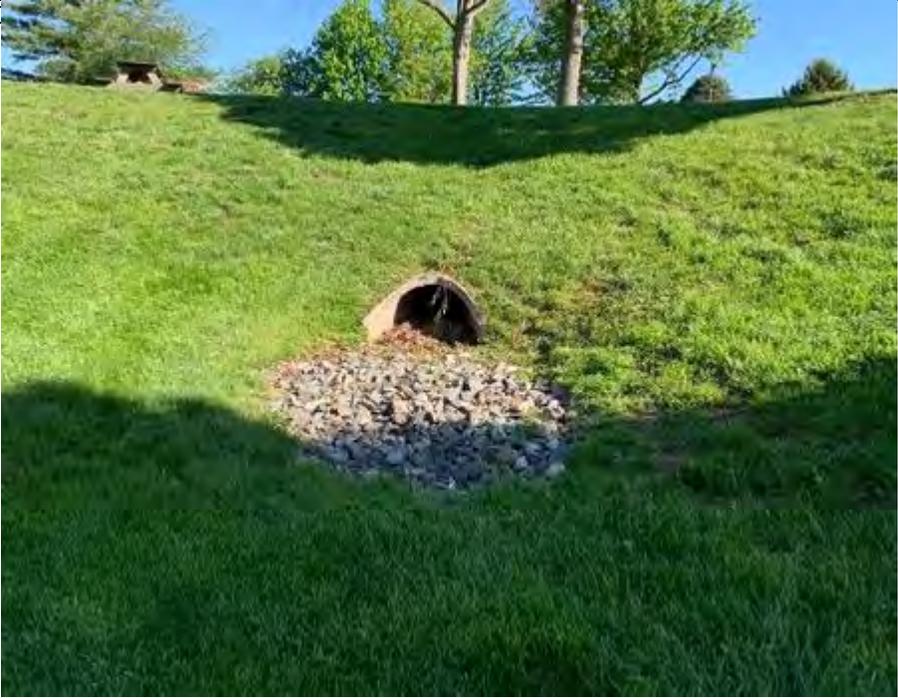
BMP #: 3A		BMP Type: Detention Basin	BMP Address: 2500 Stinson Ln, Norristown, PA 19403
Photo No. 5	Date: 05/12/2021

Description			
View of the inflow to the basin.			
Violation Type (if applicable):

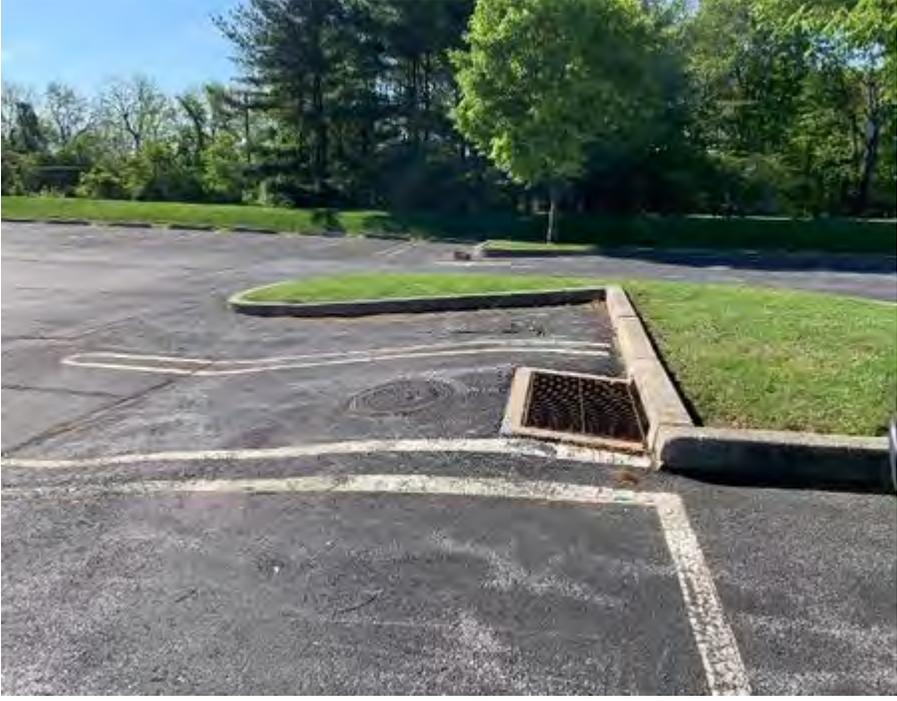
BMP #: 3B		BMP Type: Snout	BMP Address: 2500 Stinson Ln, Norristown, PA 19403
Photo No. 1	Date: 05/12/2021	Date:	
Description

View of the inlet.			
Violation Type (if applicable):

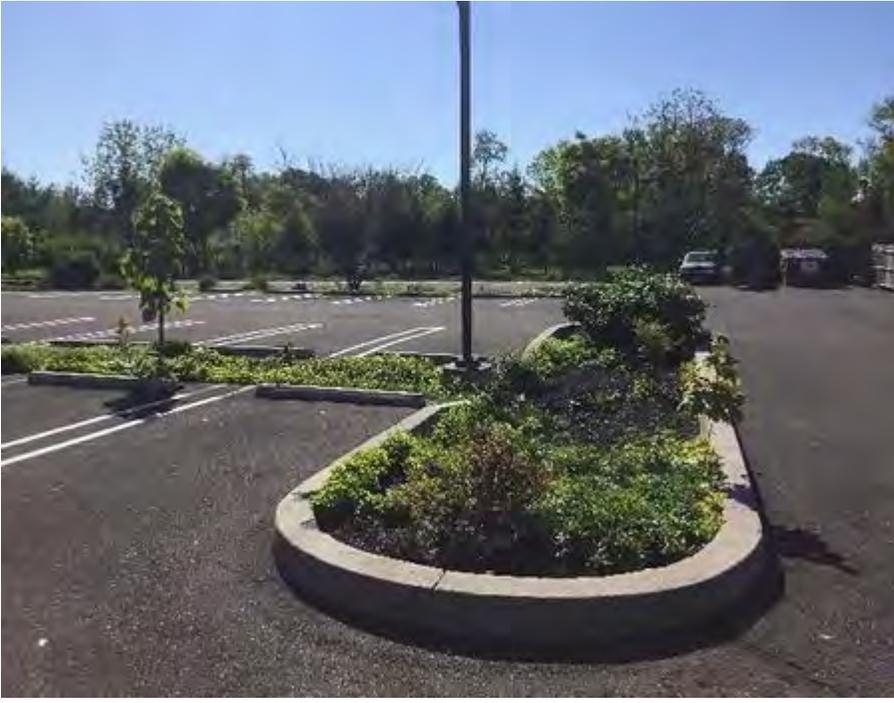
BMP #: 4A1		BMP Type: Rain Garden	BMP Address: 1911 W. Marshall St, Norristown, PA 19403
Photo No. 1	Date: 05/13/2021	Date:	
Description

Overall view of the BMP.			
Violation Type (if applicable):			
Photo No. 2	Date: 05/13/2021	Date:	
Description

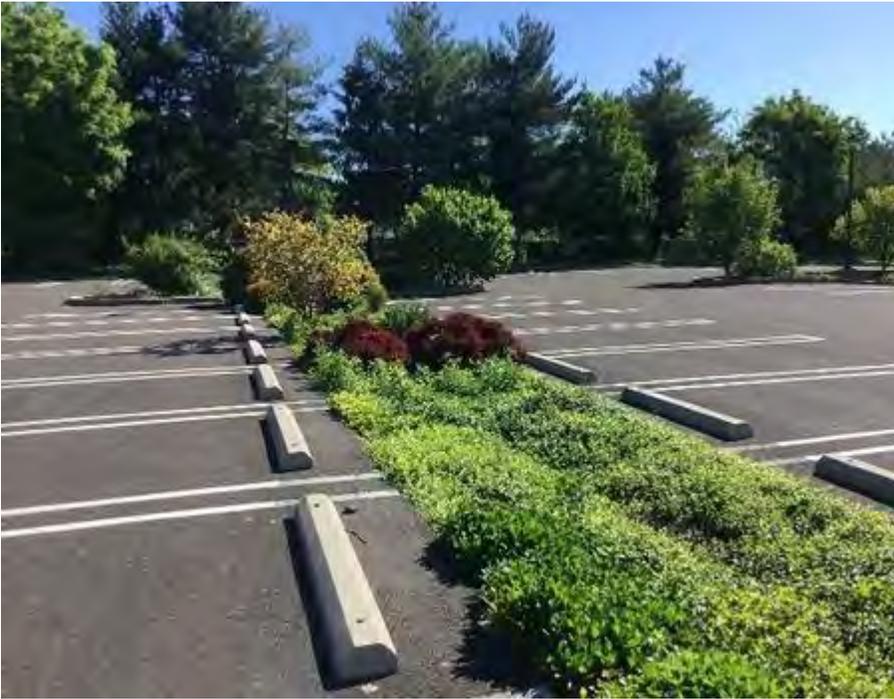
Overall view of the BMP.			
Violation Type (if applicable):

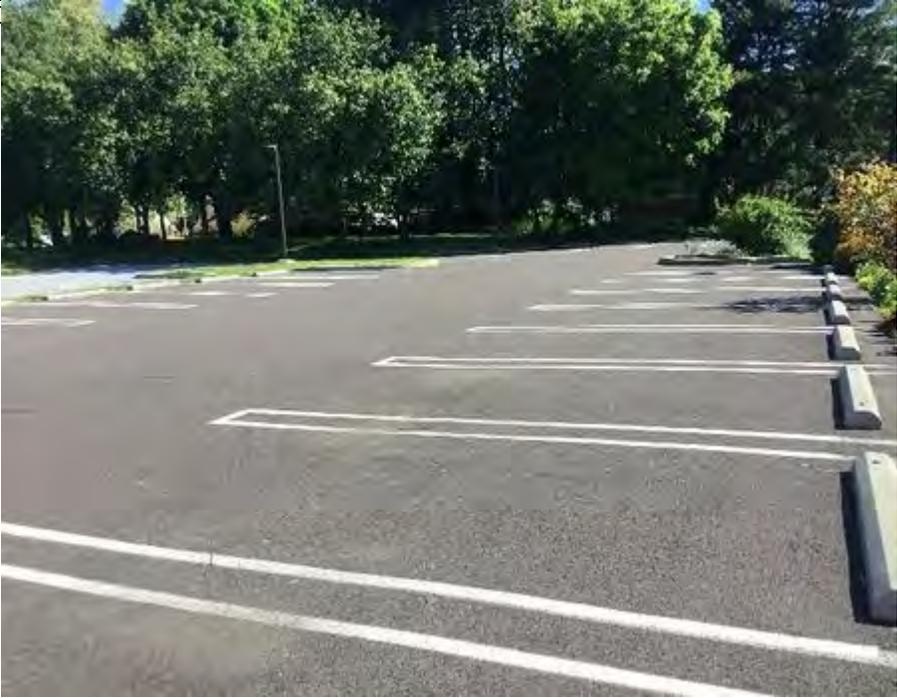
BMP #: 4A1		BMP Type: Rain Garden	BMP Address: 1911 W. Marshall St, Norristown, PA 19403
Photo No. 3	Date: 05/13/2021

Description			
View of the contributing drainage area.			
Violation Type (if applicable):			
Photo No. 4	Date: 05/13/2021

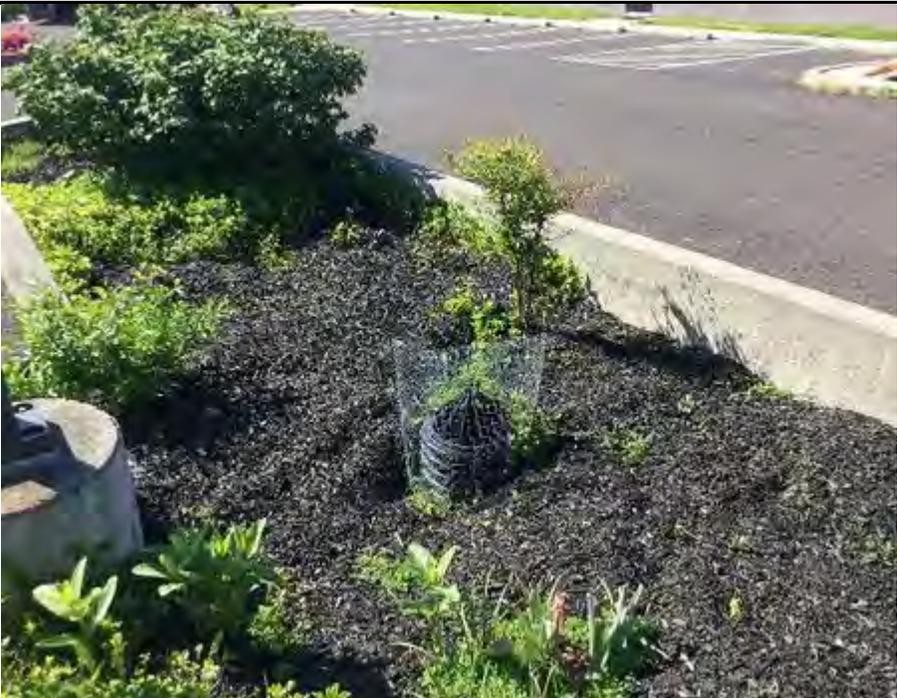
Description			
View of the riser in the BMP.			
Violation Type (if applicable):

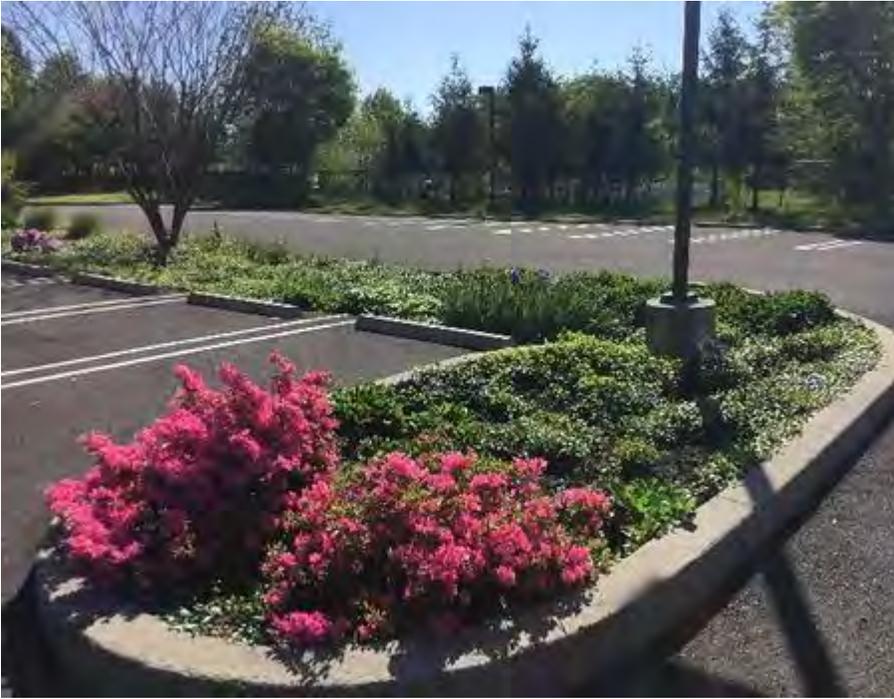
BMP #: 4A2		BMP Type: Rain Garden	BMP Address: 1911 W. Marshall St, Norristown, PA 19403
Photo No. 1	Date: 05/13/2021	Date:	
Description

Overall view of the BMP.			
Violation Type (if applicable):			
Photo No. 2	Date: 05/13/2021	Date:	
Description

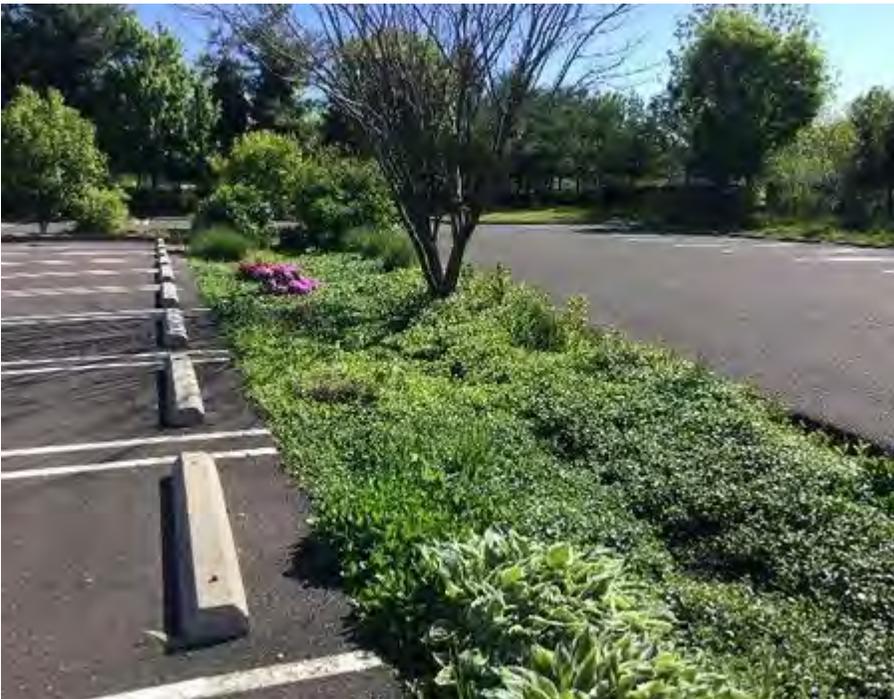
Overall view of the BMP.			
Violation Type (if applicable):

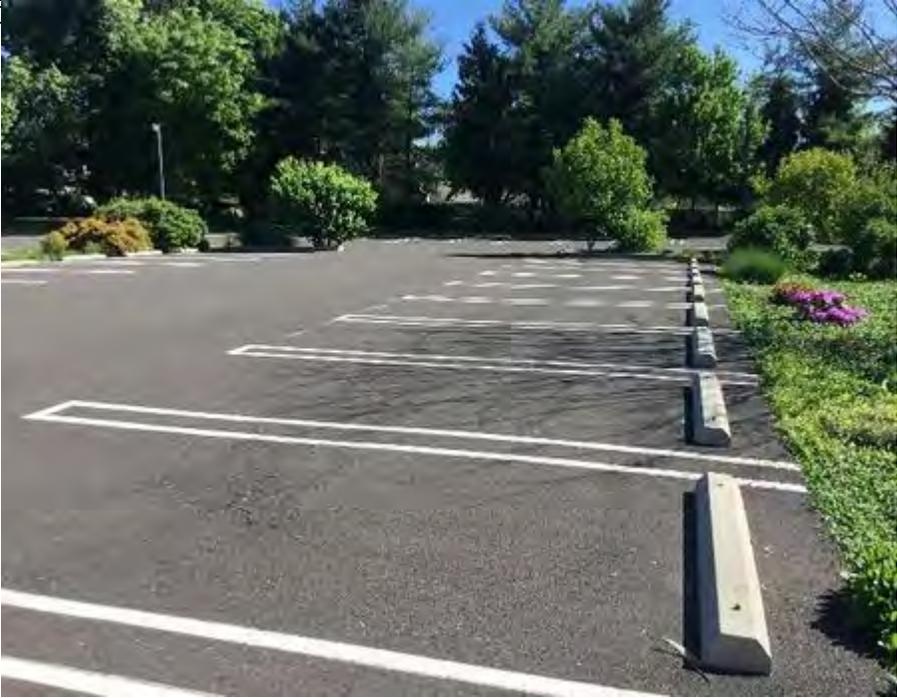
BMP #: 4A2		BMP Type: Rain Garden	BMP Address: 1911 W. Marshall St, Norristown, PA 19403
Photo No. 3	Date: 05/13/2021

Description			
View of the contributing drainage area.			
Violation Type (if applicable):			
Photo No. 4	Date: 05/13/2021

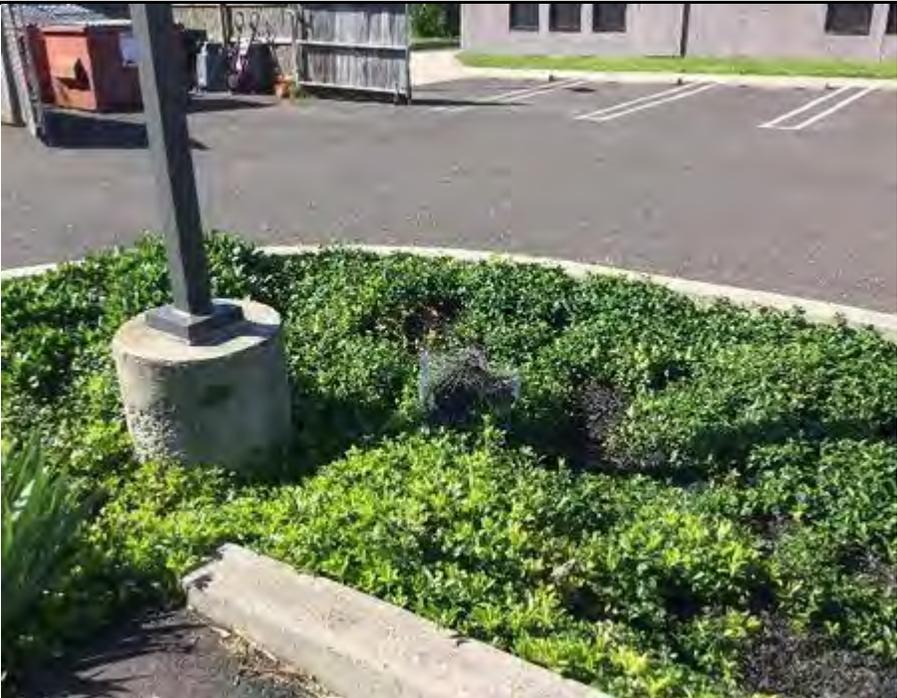
Description			
View of the riser in the BMP.			
Violation Type (if applicable):

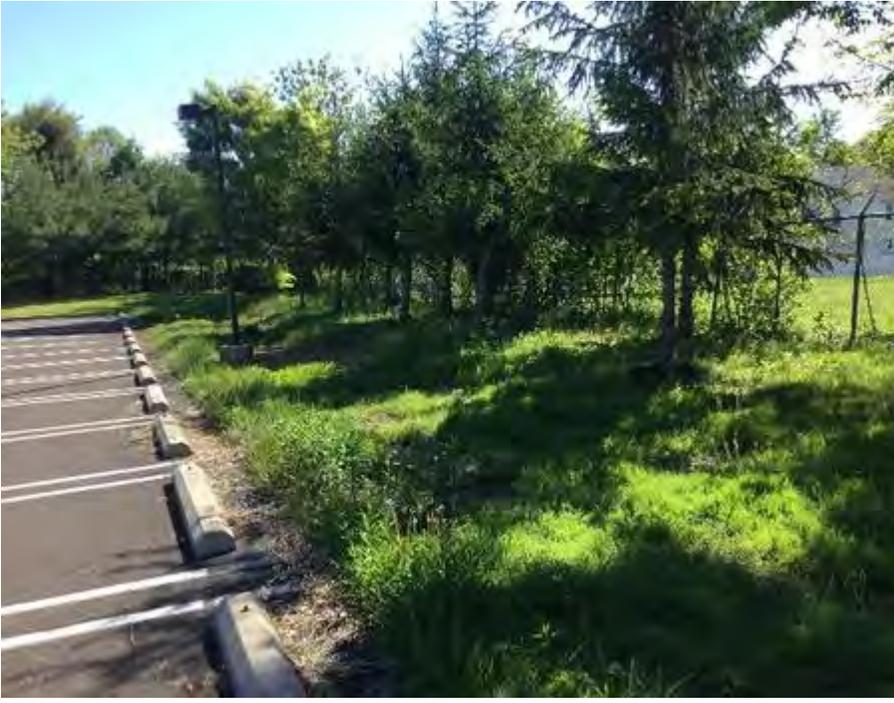
BMP #: 4A3		BMP Type: Rain Garden	BMP Address: 1911 W. Marshall St, Norristown, PA 19403
Photo No. 1	Date: 05/13/2021	Date:	
Description

Overall view of the BMP.			
Violation Type (if applicable):			
Photo No. 2	Date: 05/13/2021	Date:	
Description

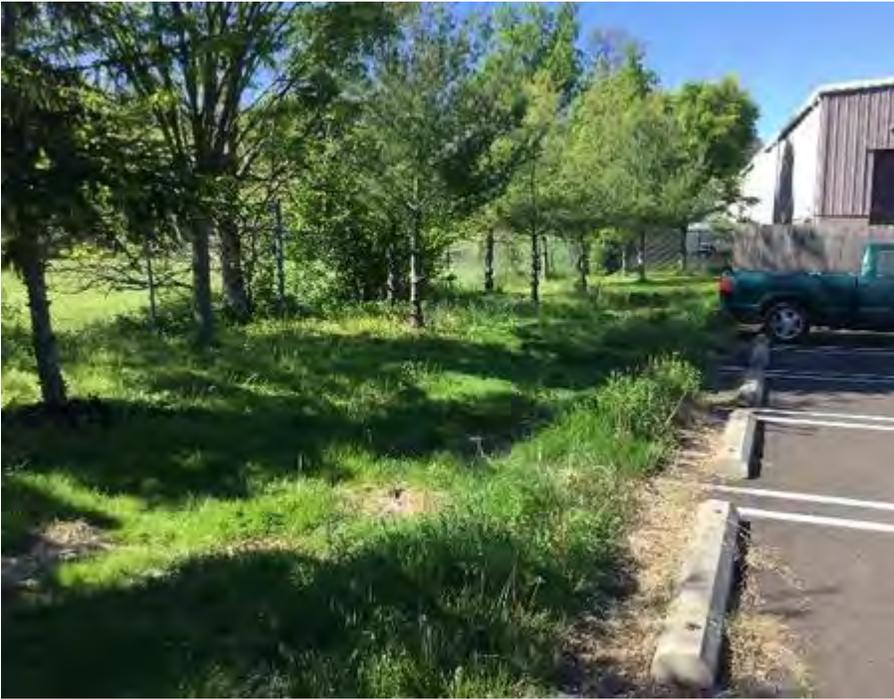
Overall view of the BMP.			
Violation Type (if applicable):

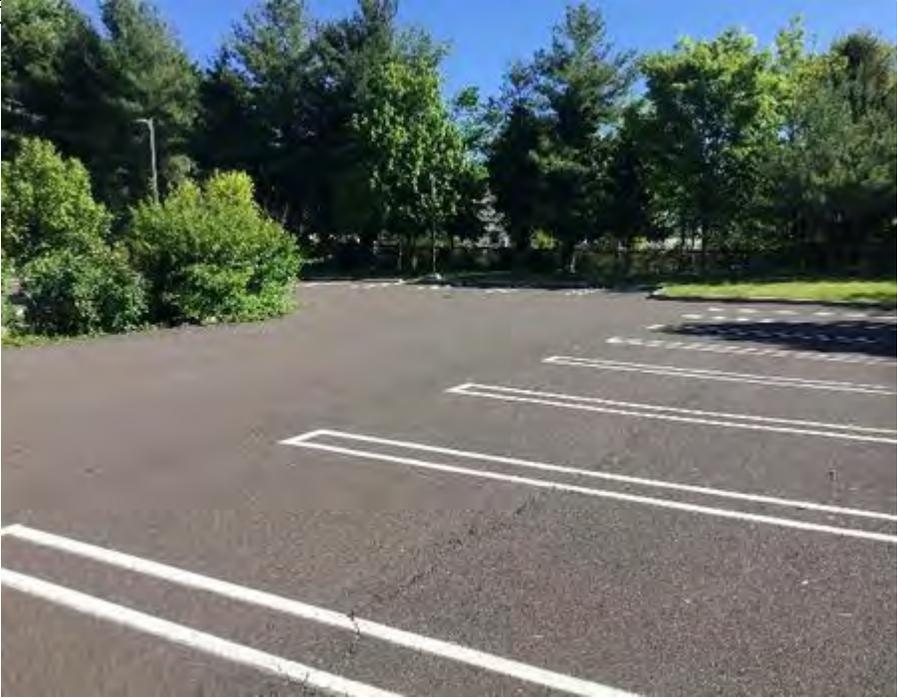
BMP #: 4A3		BMP Type: Rain Garden	BMP Address: 1911 W. Marshall St, Norristown, PA 19403
Photo No. 3	Date: 05/13/2021

Description			
View of the contributing drainage area.			
Violation Type (if applicable):

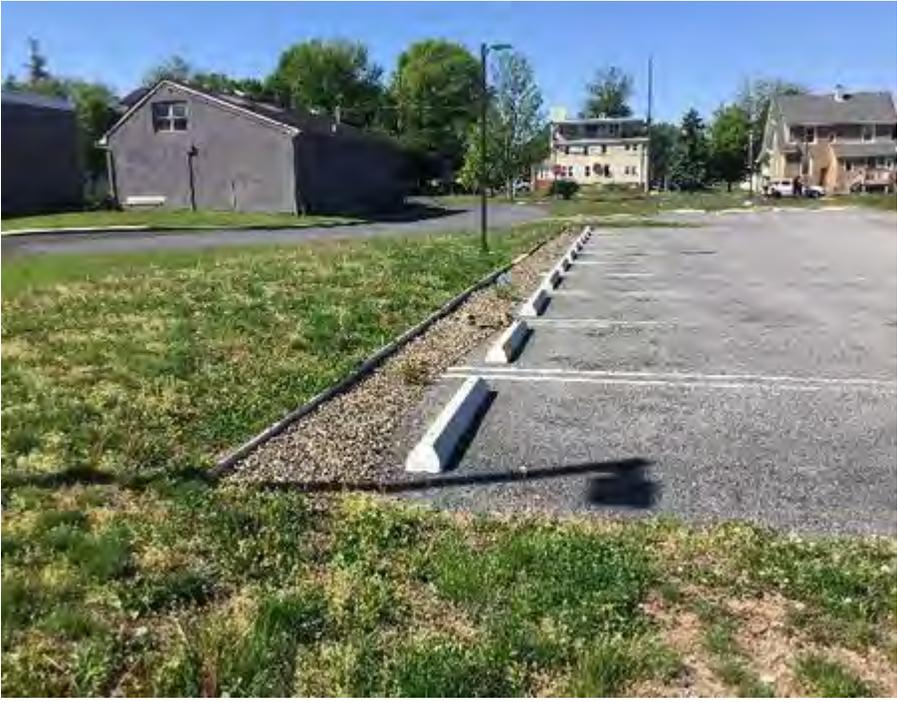
BMP #: 4B1		BMP Type: Infiltration Trench	BMP Address: 1911 W. Marshall St, Norristown, PA 19403
Photo No. 1	Date: 05/13/2021	Date:	
Description

Overall view of the BMP.			
Violation Type (if applicable):			
Photo No. 2	Date: 05/13/2021	Date:	
Description

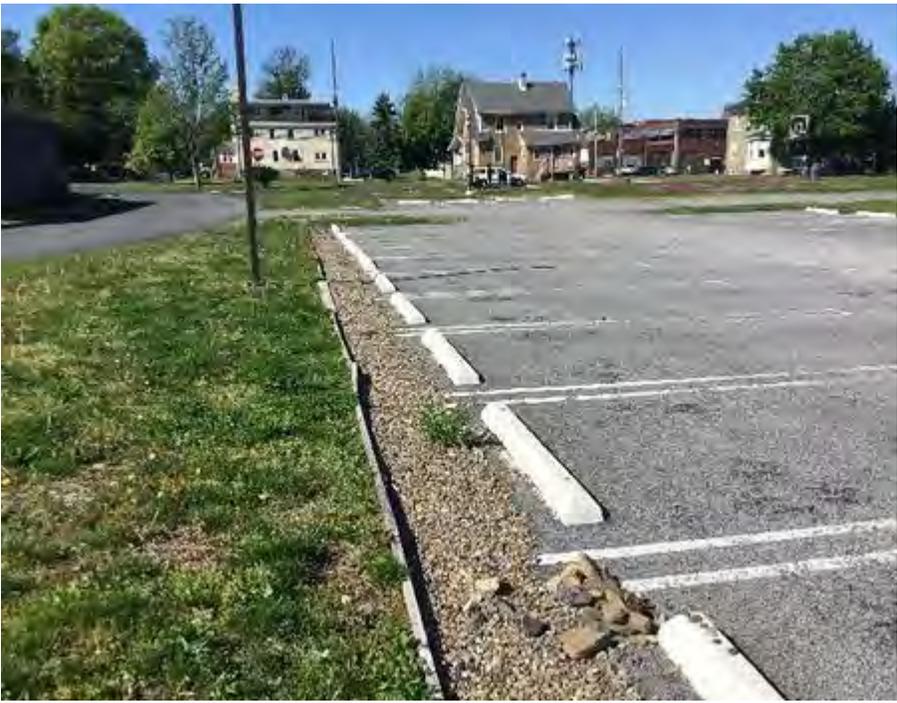
Overall view of the BMP.			
Violation Type (if applicable):

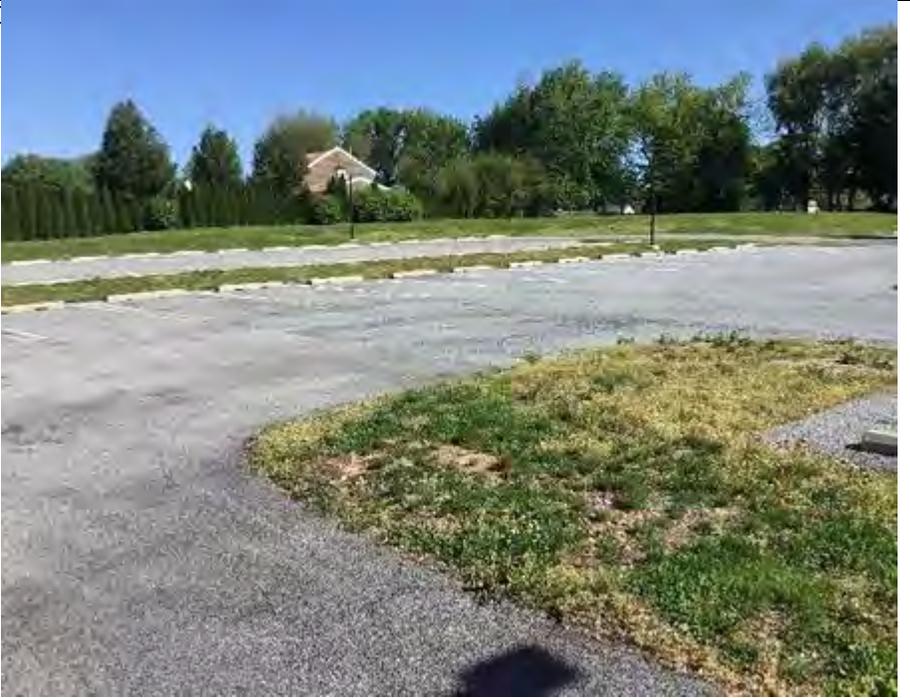
BMP #: 4B1		BMP Type: Infiltration Trench	BMP Address: 1911 W. Marshall St, Norristown, PA 19403
Photo No. 3	Date: 05/13/2021

Description			
View of the contributing drainage area.			
Violation Type (if applicable):

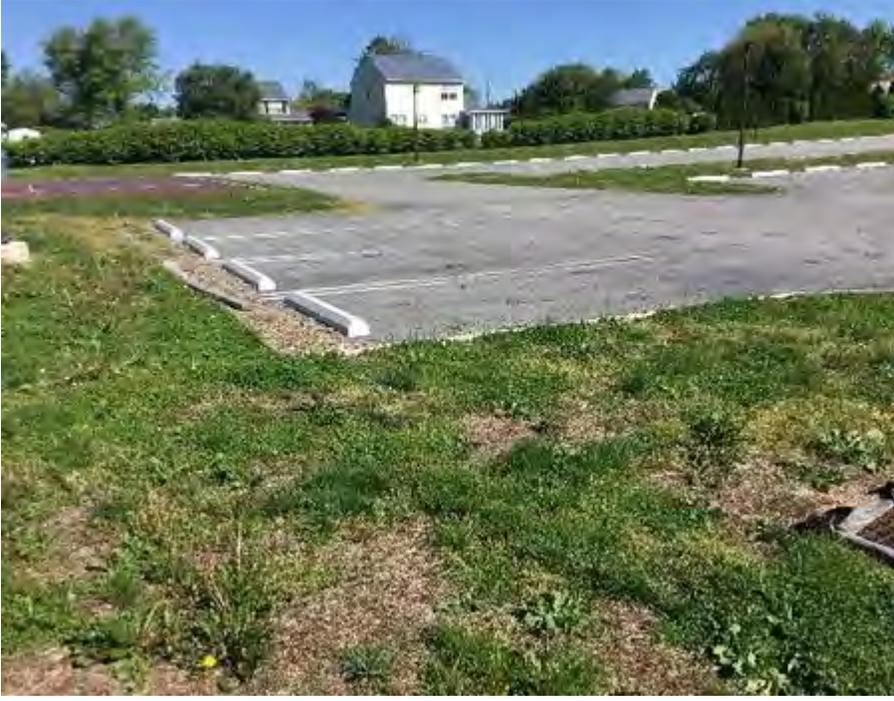
BMP #: 4B2		BMP Type: Infiltration Trench	BMP Address: 1911 W. Marshall St, Norristown, PA 19403
Photo No. 1	Date: 05/13/2021	Date:	
Description

Overall view of the BMP.			
Violation Type (if applicable):			
Photo No. 2	Date: 05/13/2021	Date:	
Description

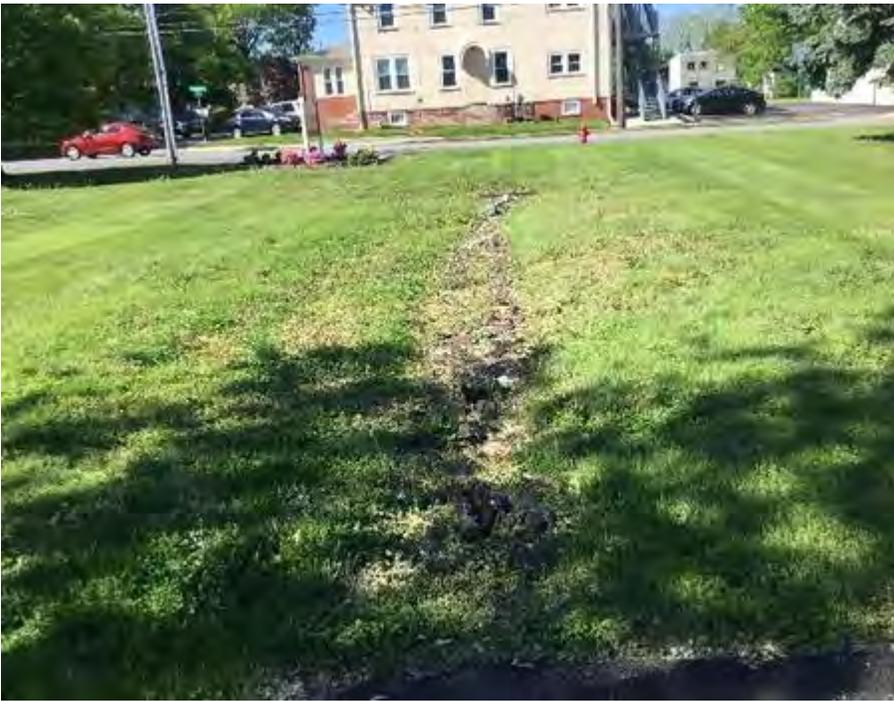
Overall view of the BMP.			
Violation Type (if applicable):

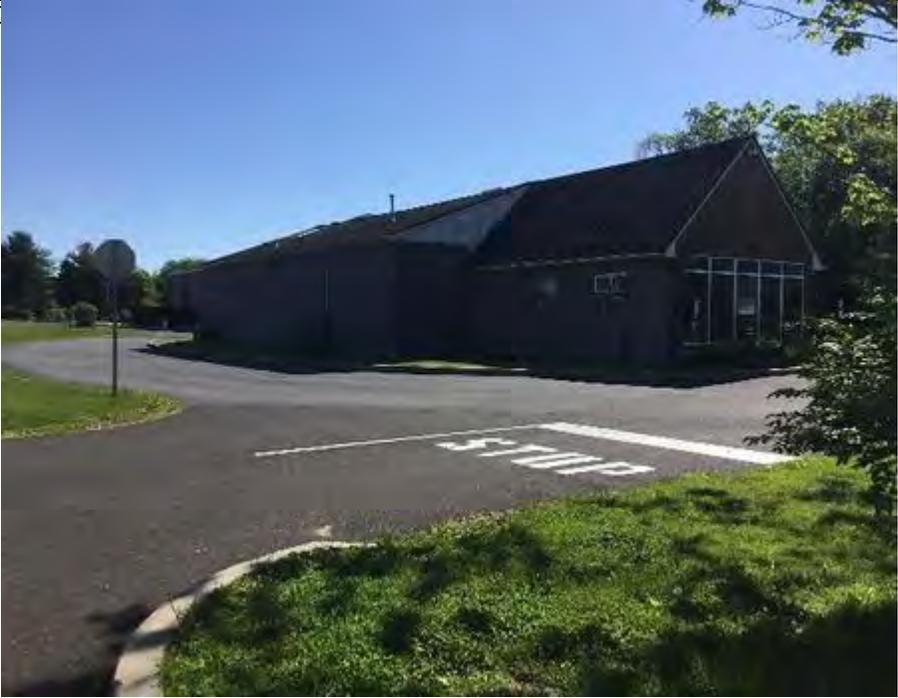
BMP #: 4B2		BMP Type: Infiltration Trench	BMP Address: 1911 W. Marshall St, Norristown, PA 19403
Photo No. 3	Date: 05/13/2021

Description			
View of the contributing drainage area.			
Violation Type (if applicable):			
Photo No. 4	Date: 05/13/2021

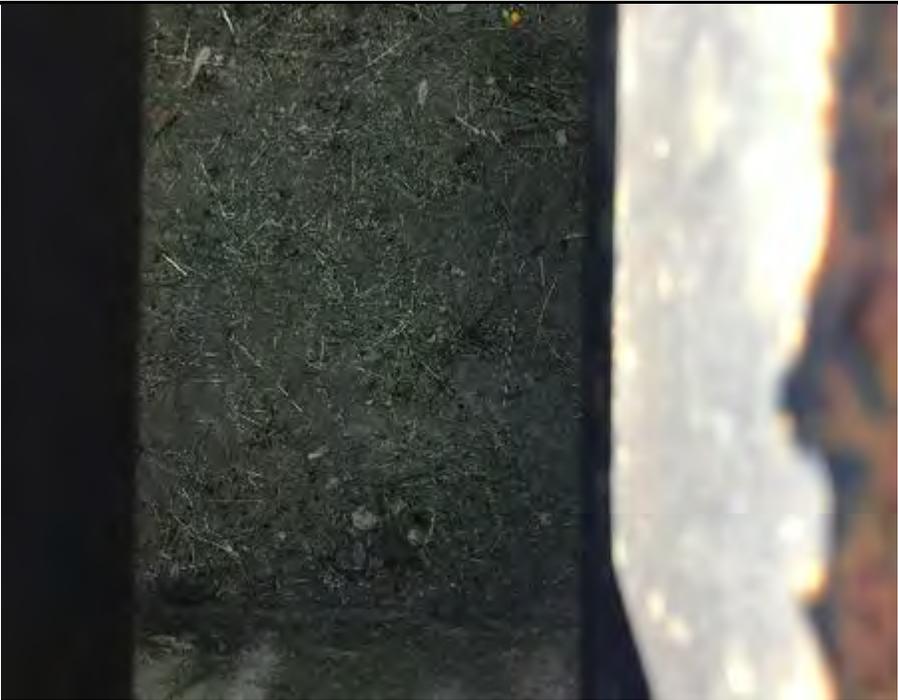
Description			
View of the inlet from the infiltration trench.			
Violation Type (if applicable):

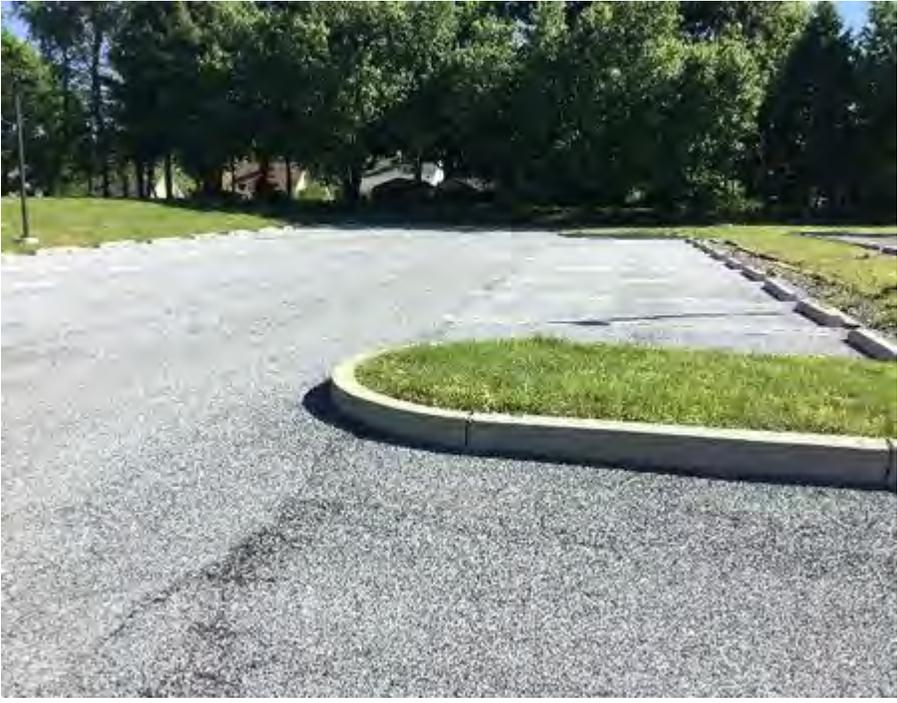
BMP #: 4C		BMP Type: Porous Paving	BMP Address: 1911 W. Marshall St, Norristown, PA 19403
Photo No. 1	Date: 05/13/2021	Date:	
Description

Overall view of the BMP.			
Violation Type (if applicable):			
Photo No. 2	Date: 05/13/2021	Date:	
Description

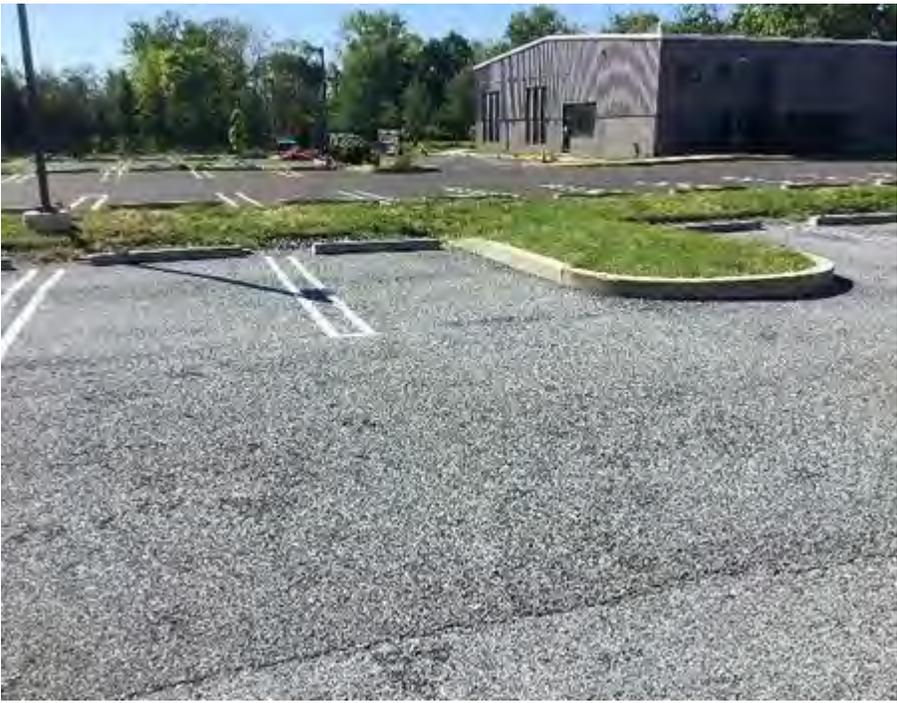
Overall view of the BMP.			
Violation Type (if applicable):

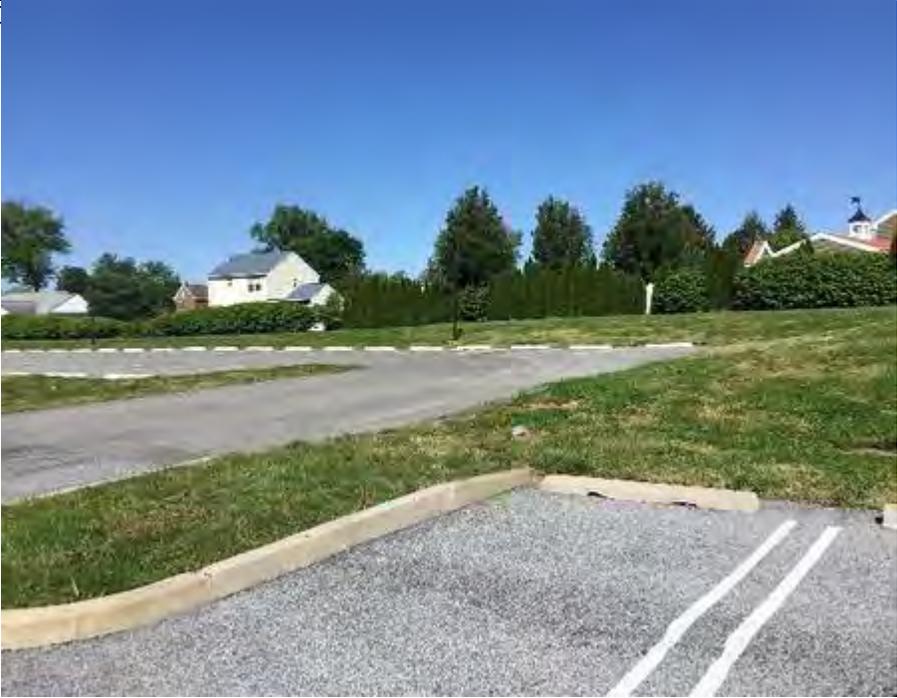
BMP #: 4C		BMP Type: Porous Paving	BMP Address: 1911 W. Marshall St, Norristown, PA 19403
Photo No. 3	Date: 05/13/2021

Description			
View of the contributing drainage area.			
Violation Type (if applicable):			
Photo No. 4	Date: 05/13/2021

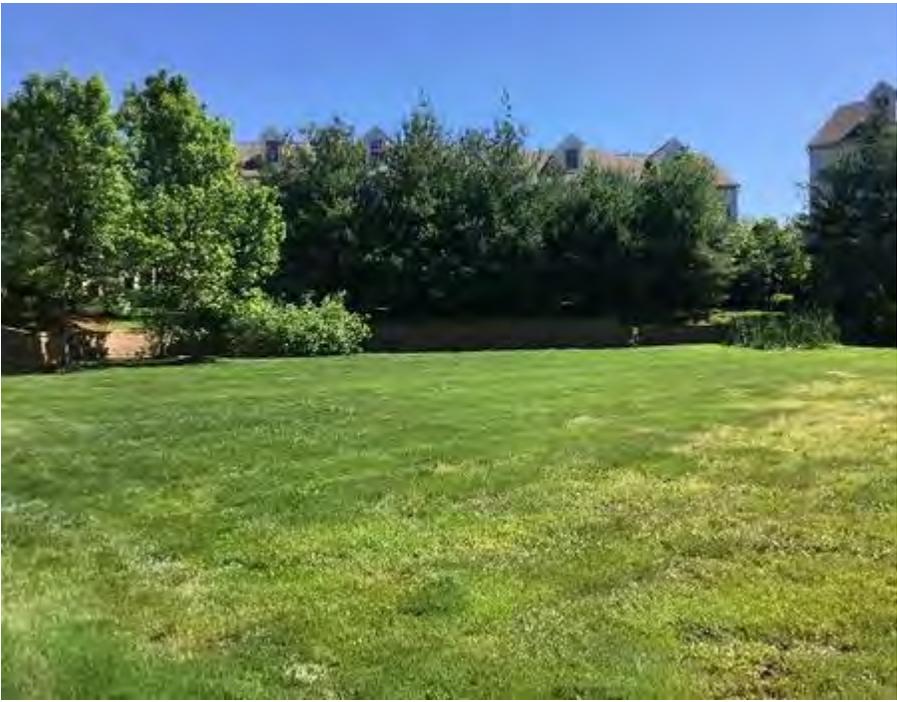
BMP #: 6		BMP Type: Detention Basin	BMP Address:
Photo No. 1	Date: 05/12/2021	Date:	
Description

Overall view of the BMP.			
Violation Type (if applicable):			
Photo No. 2	Date: 05/12/2021	Date:	
Description

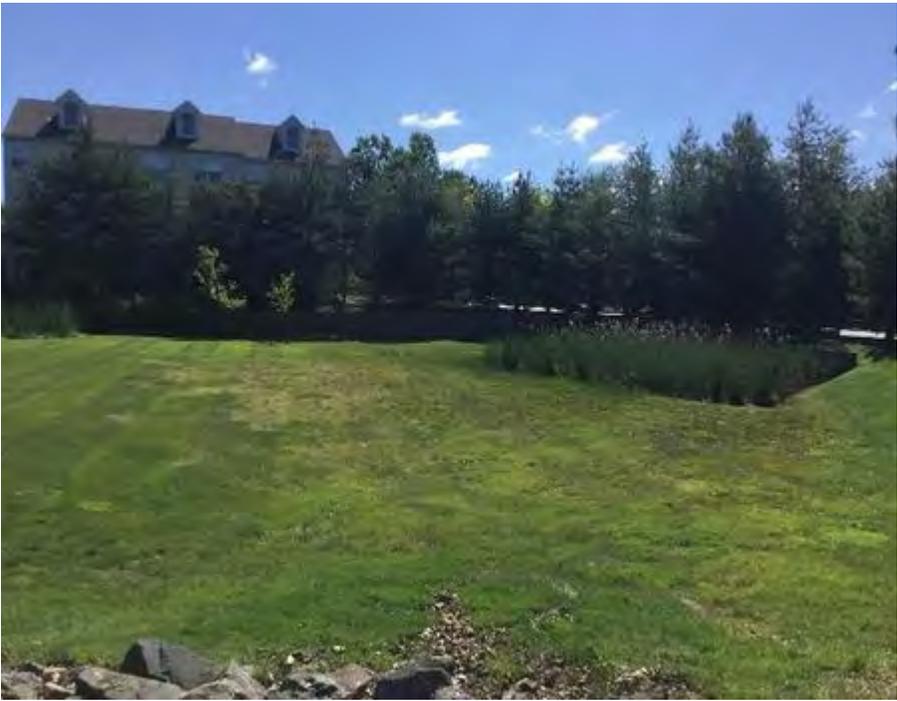
Overall view of the BMP.			
Violation Type (if applicable):

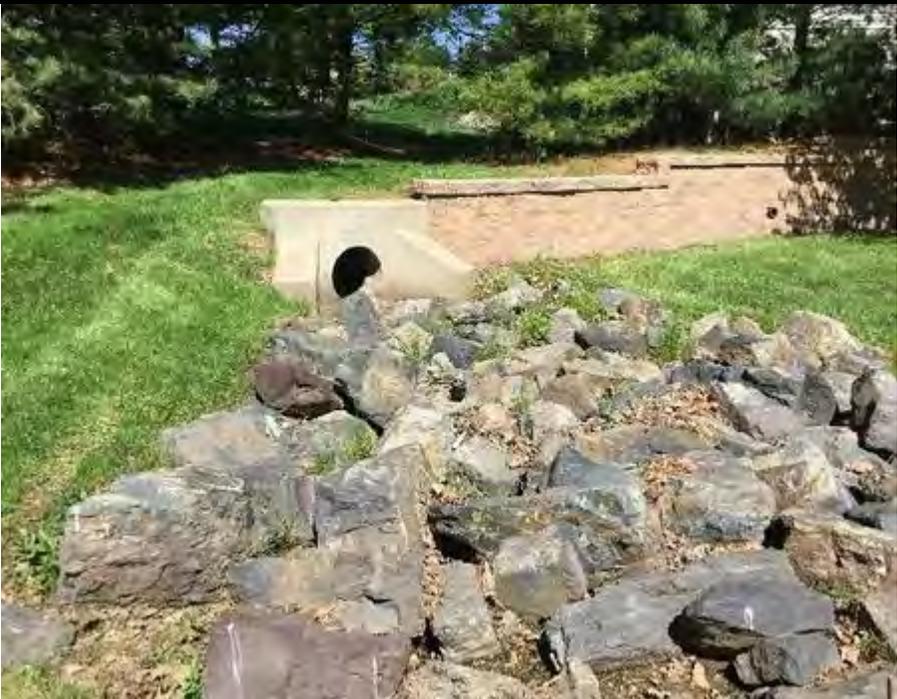
Description			
View of the structure leading to the BMP.			
Violation Type (if applicable):			
BMP #: 6		BMP Type: Detention Basin	BMP Address:

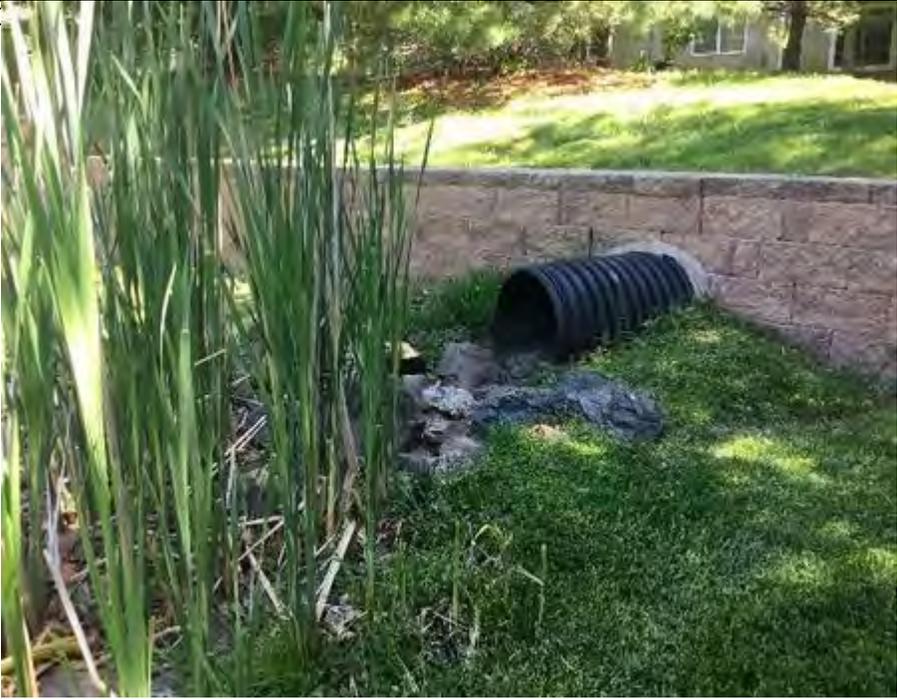
Photo No. <b>5</b>	Date: 05/12/2021

Description		
View of the structure leading to the BMP.		
Violation Type (if applicable):		
Photo No. <b>6</b>	Date: 05/12/2021

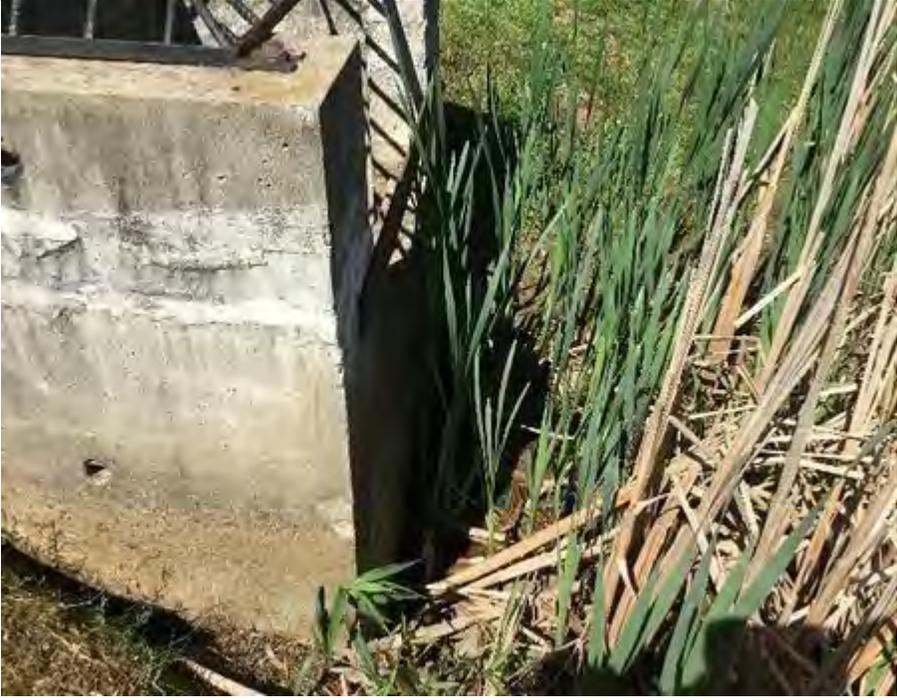
Description		
View of the riser.		
Violation Type(if applicable):

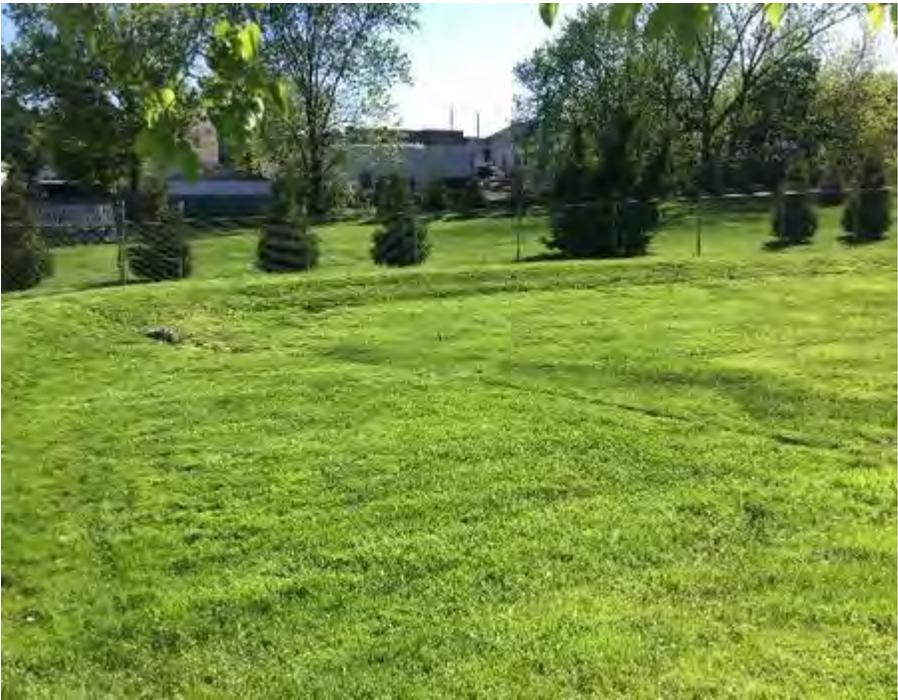
BMP #: 7		BMP Type: Detention Basin	BMP Address:
Photo No. 1	Date: 05/13/2021	Date:	
Description

Overall view of the BMP.			
Violation Type (if applicable):			
Photo No. 2	Date: 05/13/2021	Date:	
Description

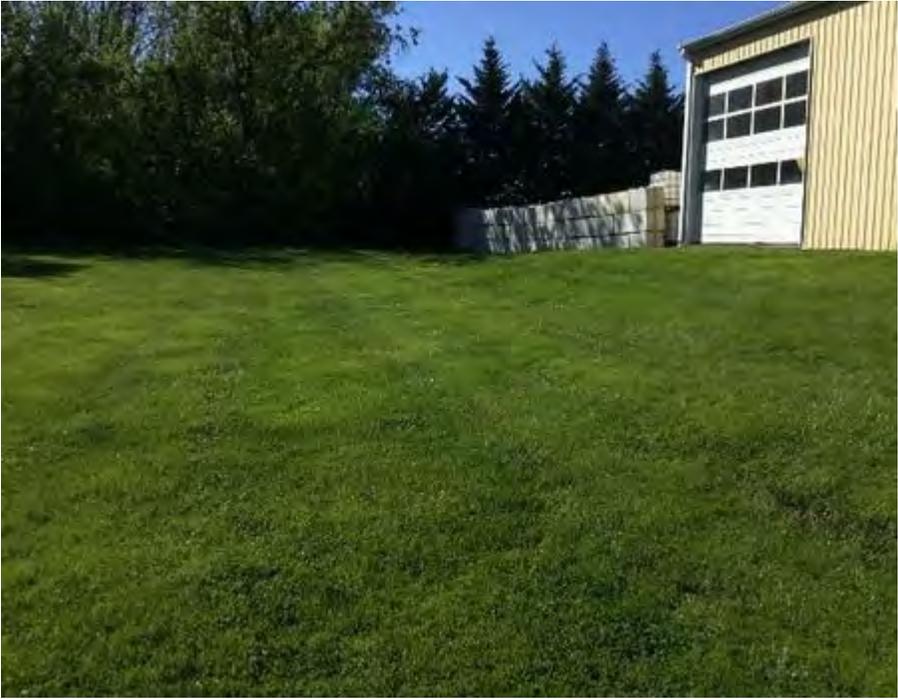
Overall view of the BMP.			
Violation Type (if applicable):
