RE: 2021 Annual MS4 Status Report  
NPDES Permit No. PAG130006  
West Norriton Township, Montgomery County  
WNR-21-006

# **ANNUAL MUNICIPAL SEPARATE STORM SEWER SYSTEM (MS4) STATUS REPORT**

West Norriton Township  
Montgomery County, PA  
1630 W. Marshall Street  
Jeffersonville, PA 19403

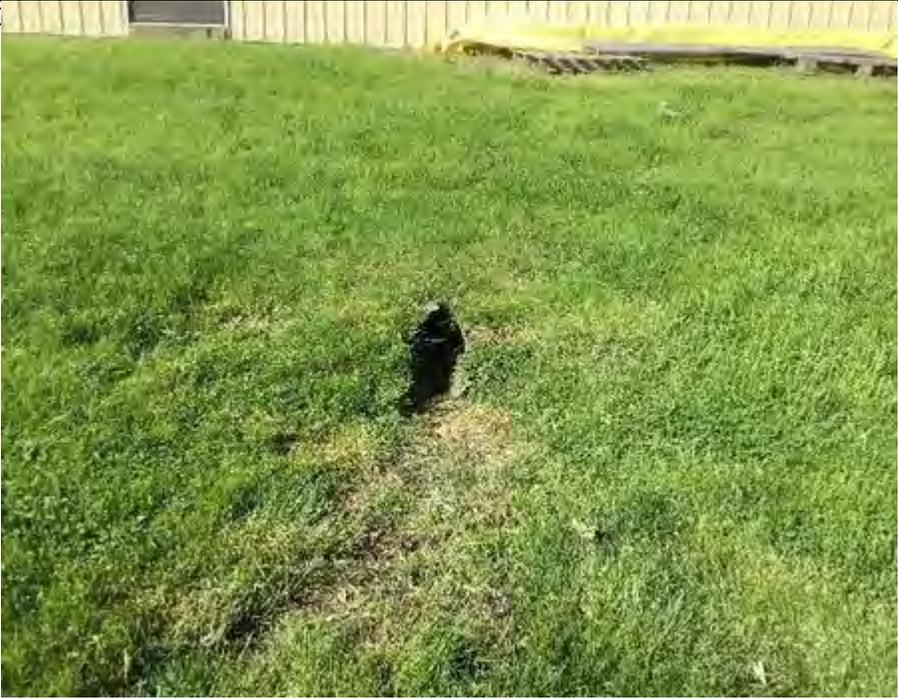
Photo No. <b>5</b>	Date: 05/13/2021

Description		
View of the inlet to the basin.		
Violation Type (if applicable):		
Photo No. <b>6</b>	Date: 05/13/2021

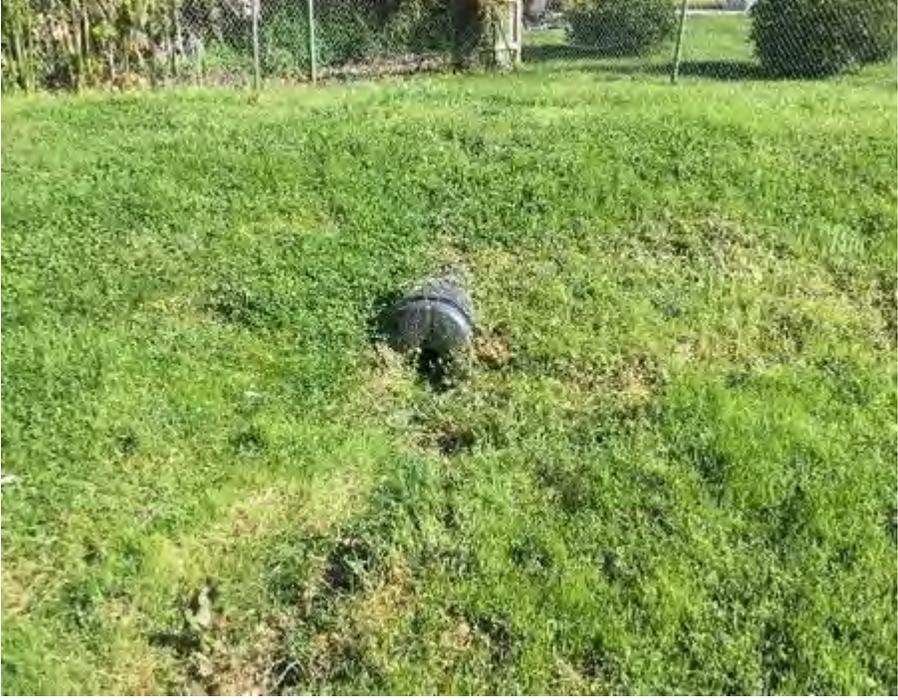
Description		
View of the outlet structure.		
Violation Type(if applicable):

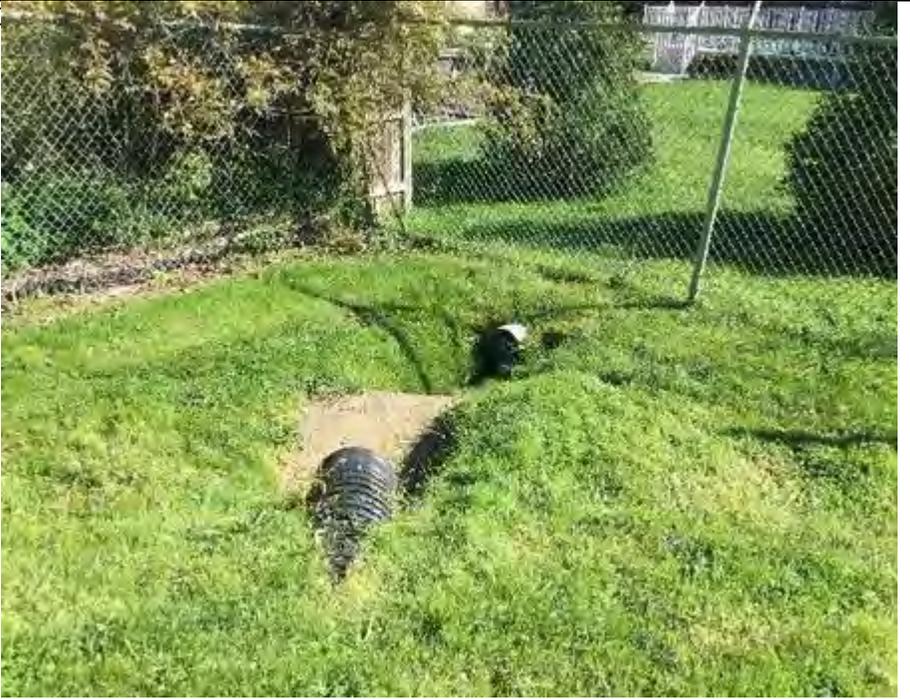
Photo No. <b>7</b>	Date: 05/13/2021

Description		
View of the outfall pipe from the basin.		
Violation Type (if applicable):		
Photo No. <b>8</b>	Date: 05/13/2021

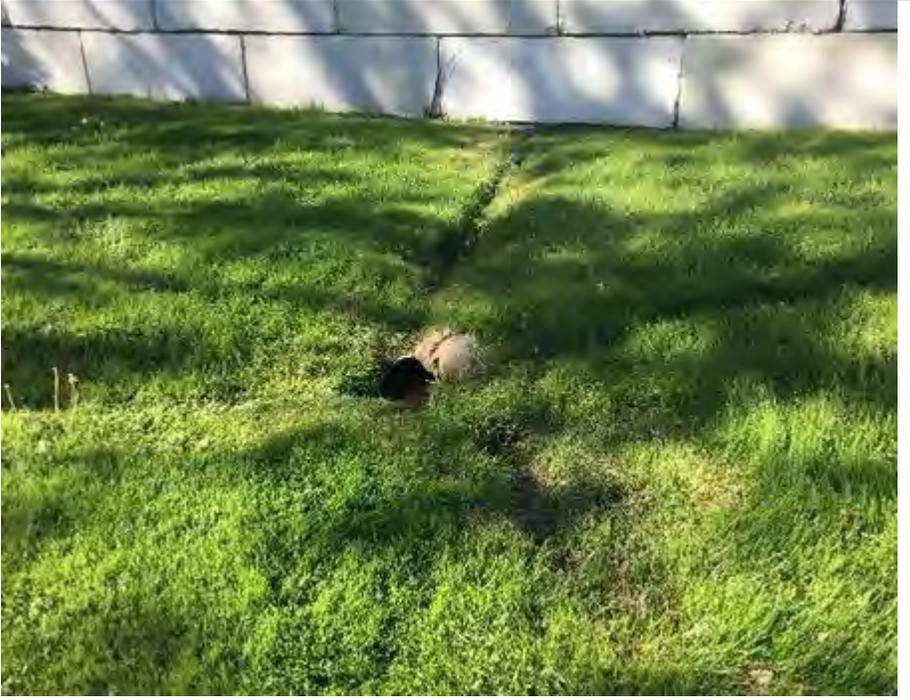
Description		
View of an inflow to the basin far left corner of the property.		
Violation Type(if applicable):

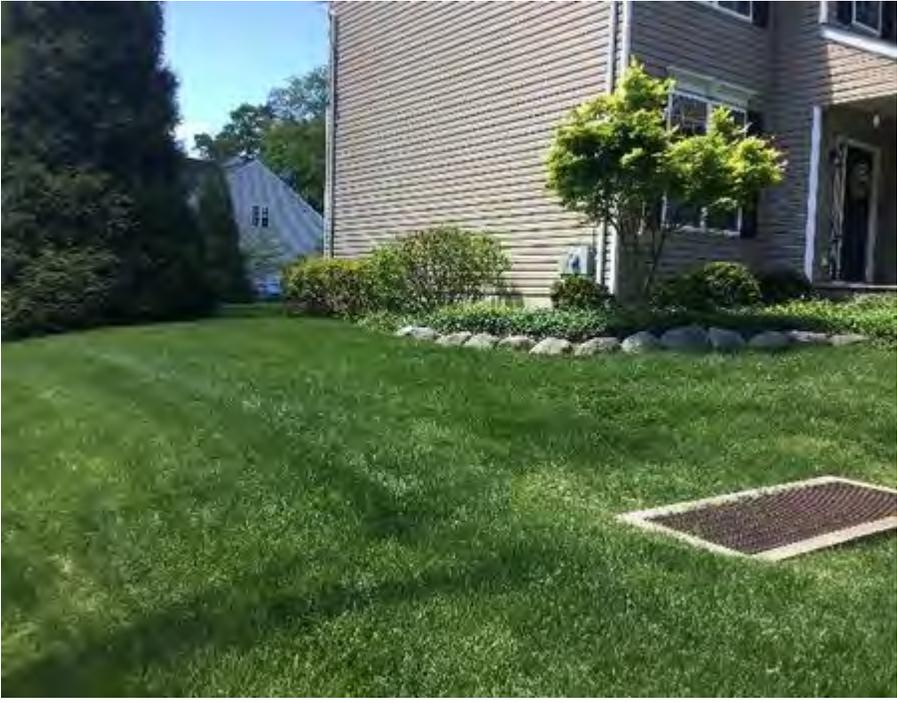
BMP #: 8		BMP Type: Underground Basin	BMP Address: 2171 Alexander Dr, Norristown, PA 19403
Photo No. 1	Date: 05/12/2021	Date:	
Description

Overall view of the BMP.			
Violation Type (if applicable):			
Photo No. 2	Date: 05/12/2021	Date:	
Description

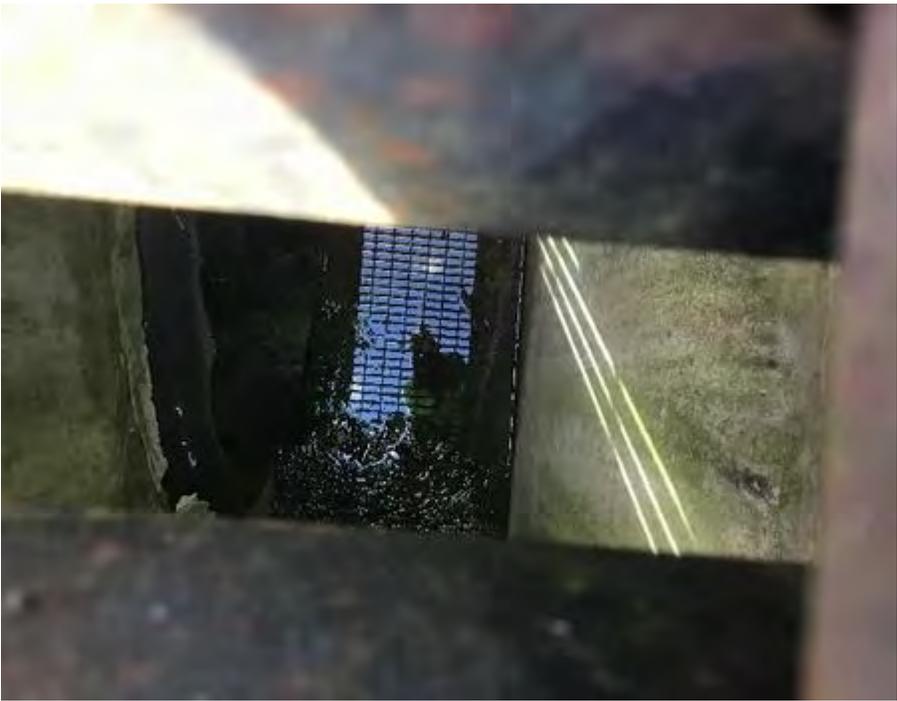
Inside the observation inlet.			
Violation Type (if applicable):

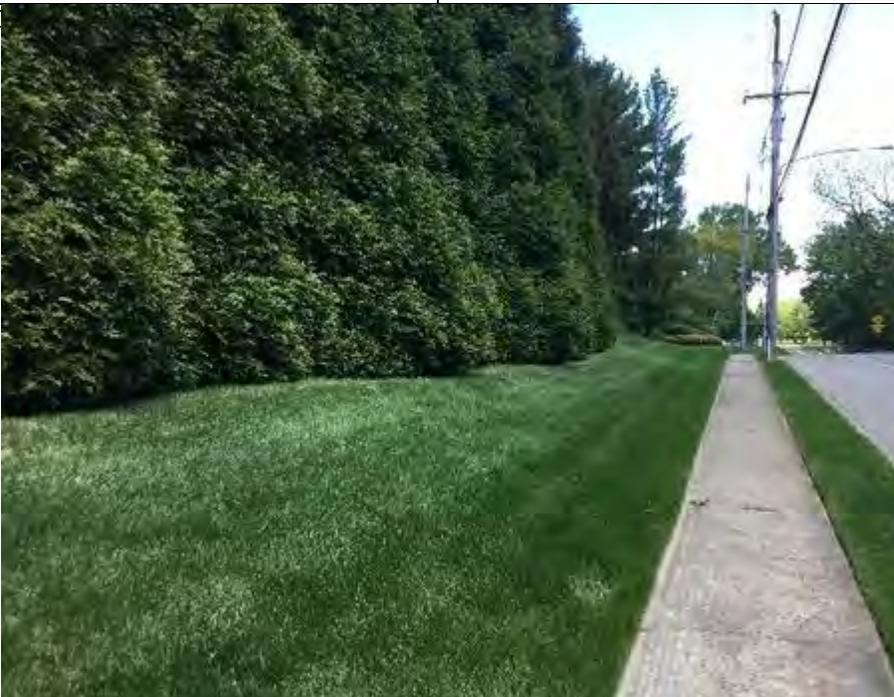
Description			
View of the location of the underground BMP.			
Violation Type (if applicable):			
Photo No. 4	Date: 05/12/2021

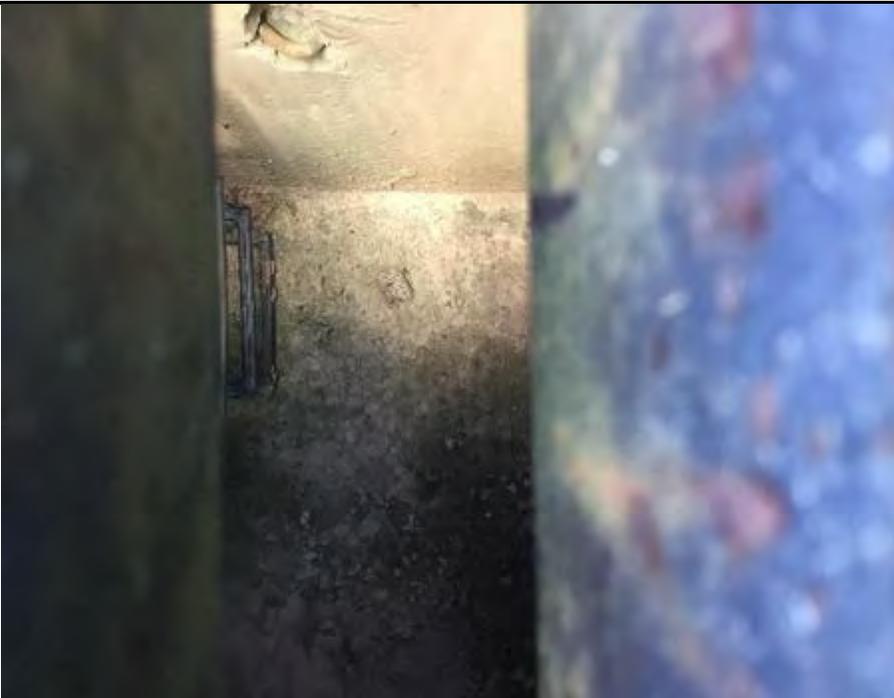
Description			
Are you inside the second observation well on the far side of the property.			
Violation Type (if applicable):

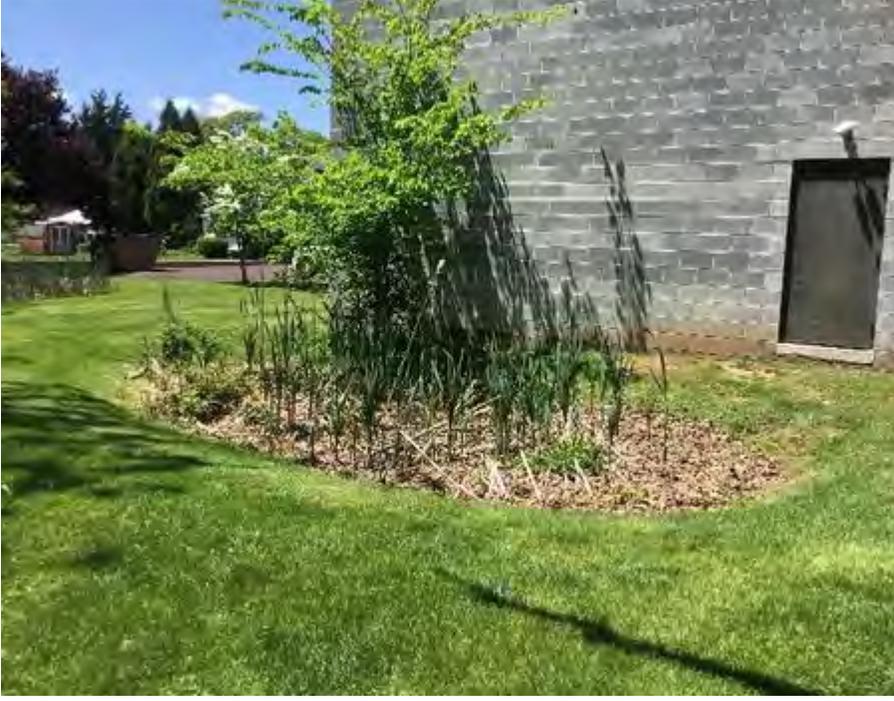
Overview of the BMP.			
Violation Type (if applicable):			
Photo No. 2	Date: 05/13/2021	Date:	
Description

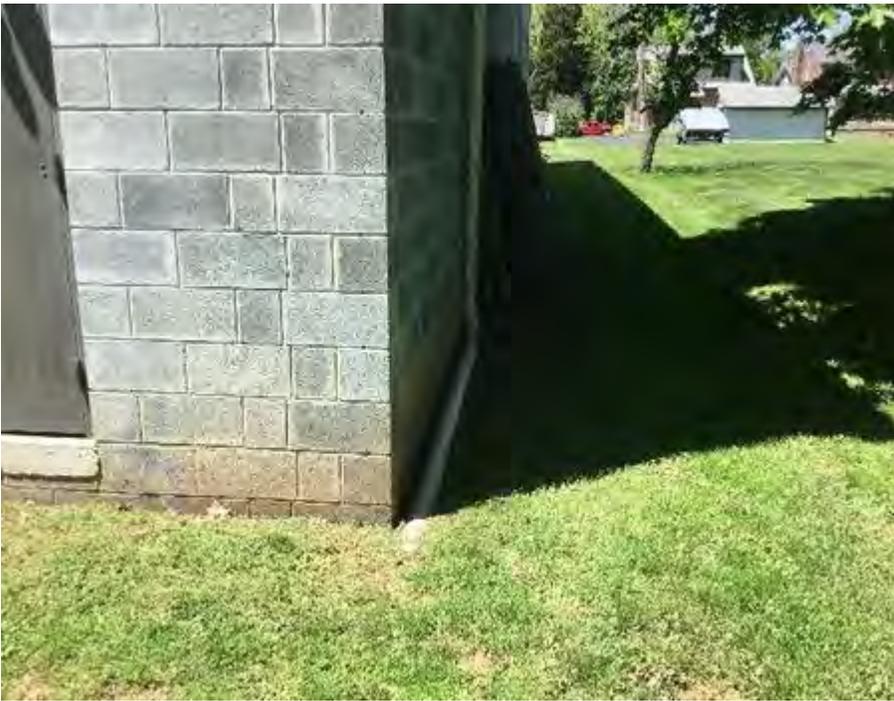
Connected downspouts.			
Violation Type (if applicable):

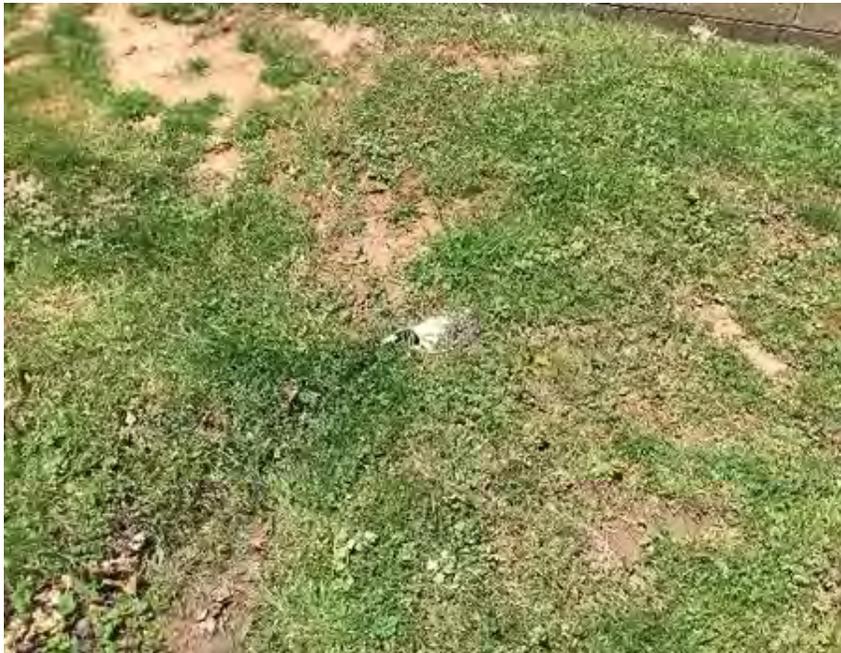
Inflow to the basin.			
Violation Type (if applicable):			
Photo No. 4	Date: 05/13/2021	Date:	
Description

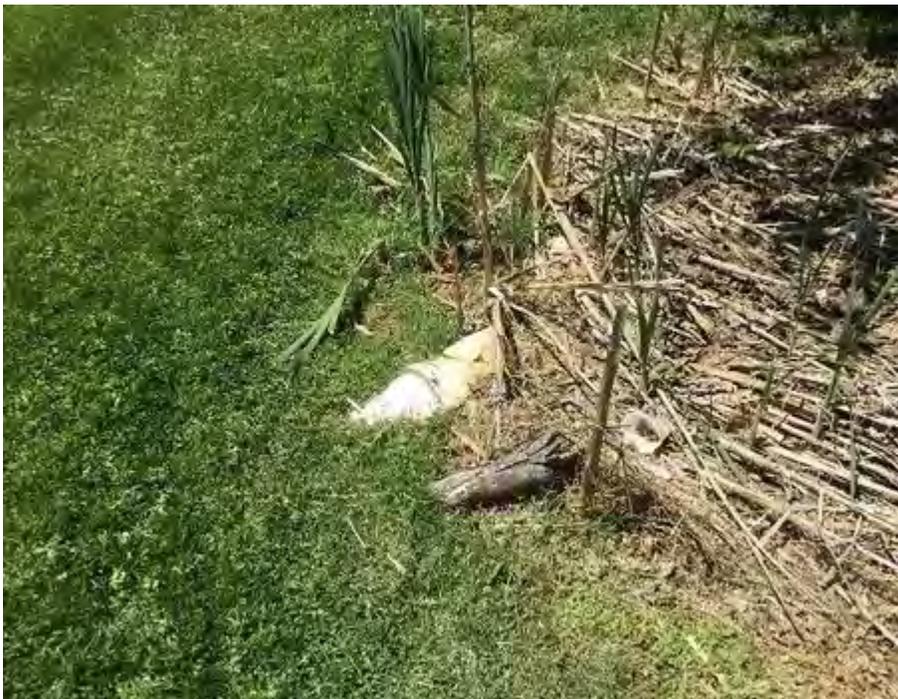
Outlet structure of the basin.			
Violation Type (if applicable):

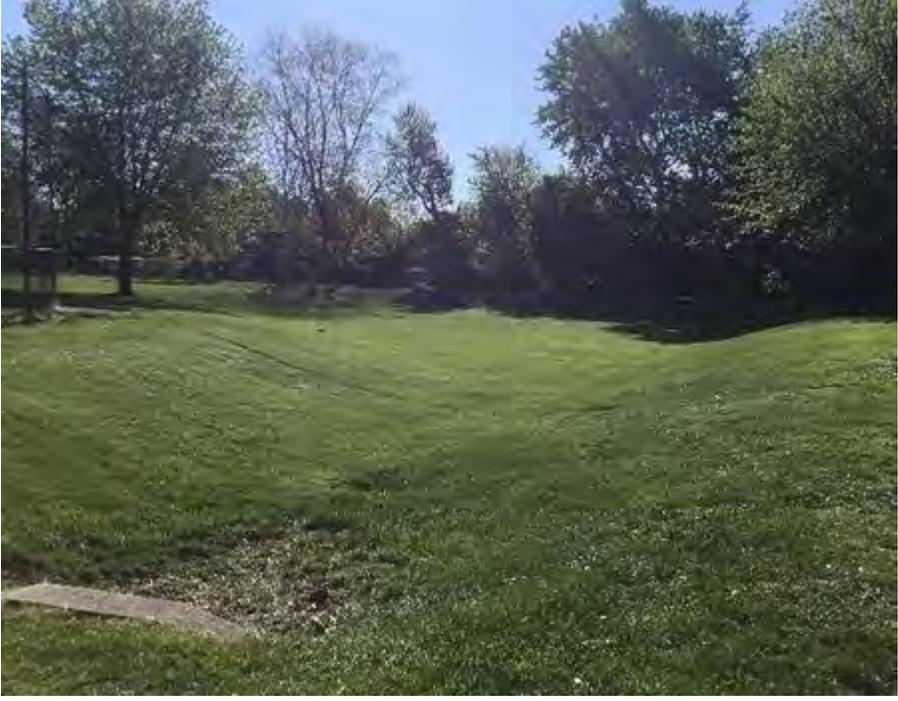
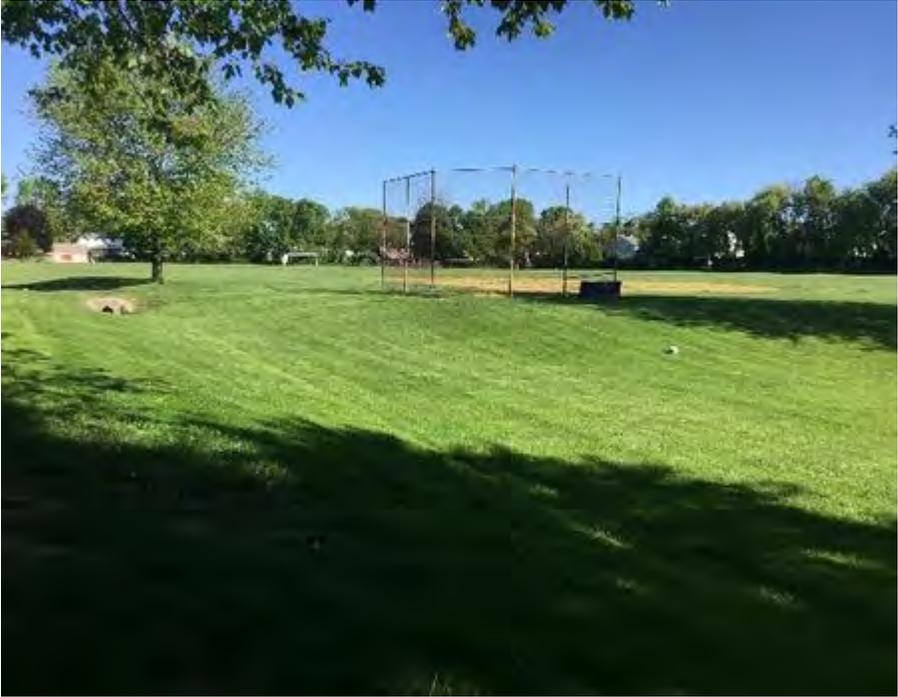
Overall view of the BMP.			
Violation Type (if applicable):			
Photo No. 2	Date: 05/13/2021	Date:	
Description

Overall view of the BMP.			
Violation Type (if applicable):

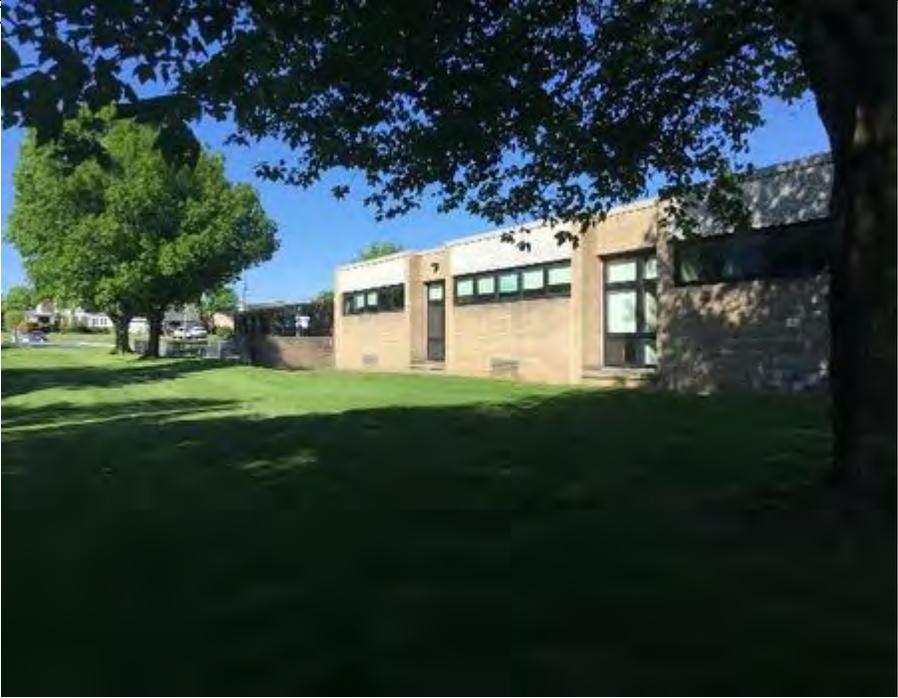
Description			
View of the contributing drainage area.			
Violation Type (if applicable):			
Photo No. 4	Date: 05/13/2021

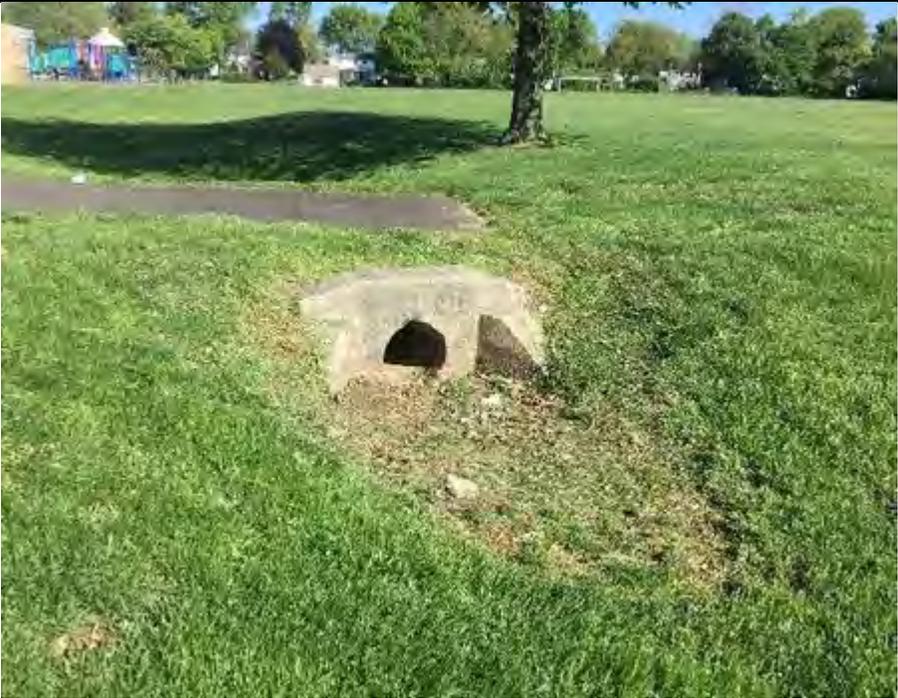
Description			
View of the structure leading to the BMP.			
Violation Type (if applicable):

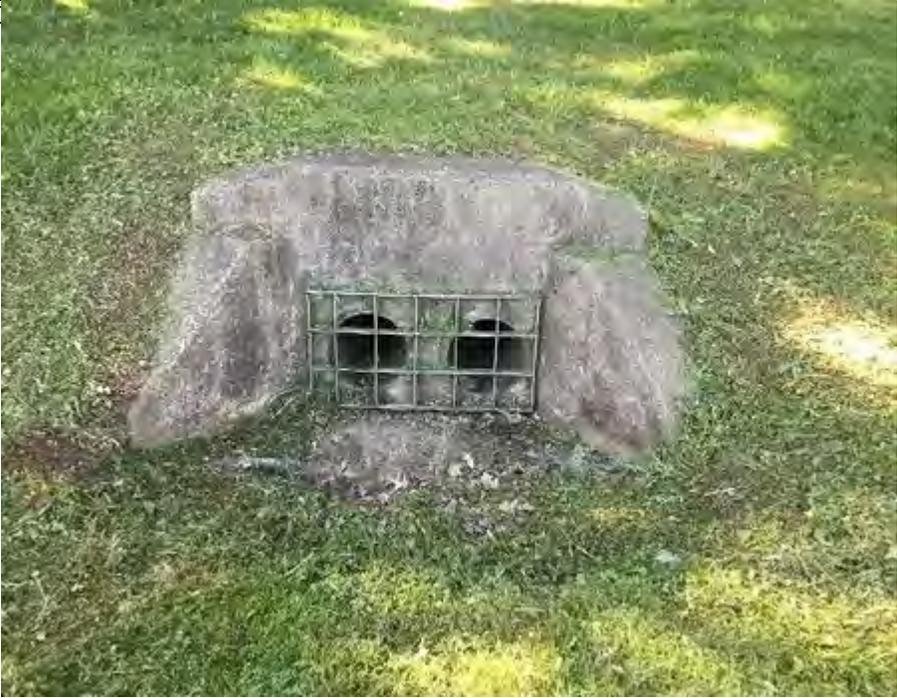
Description			
View of the outlet structure with the trash guard.			
Violation Type (if applicable):

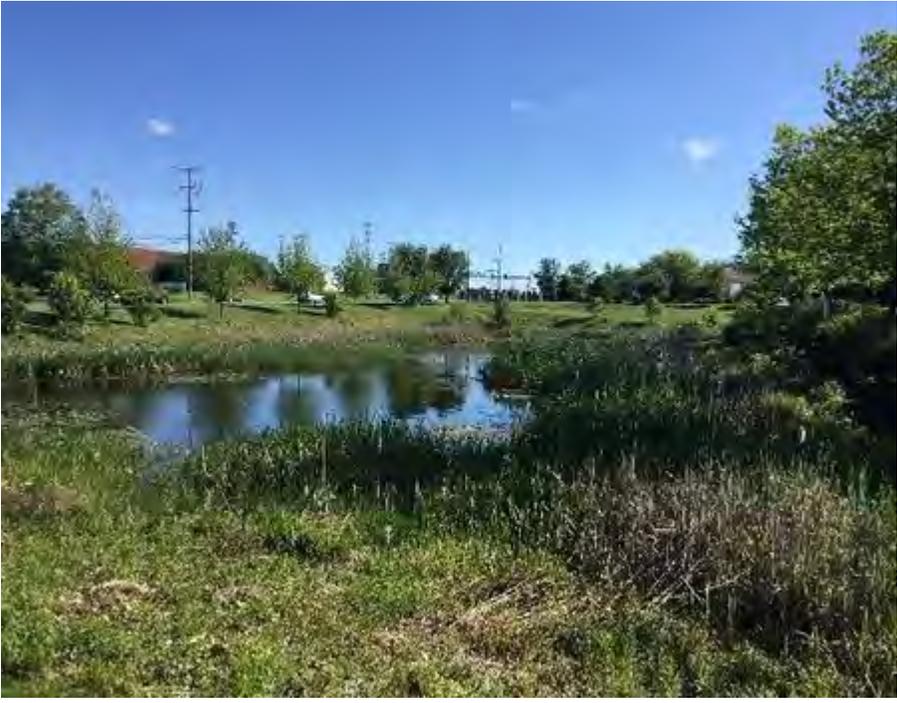
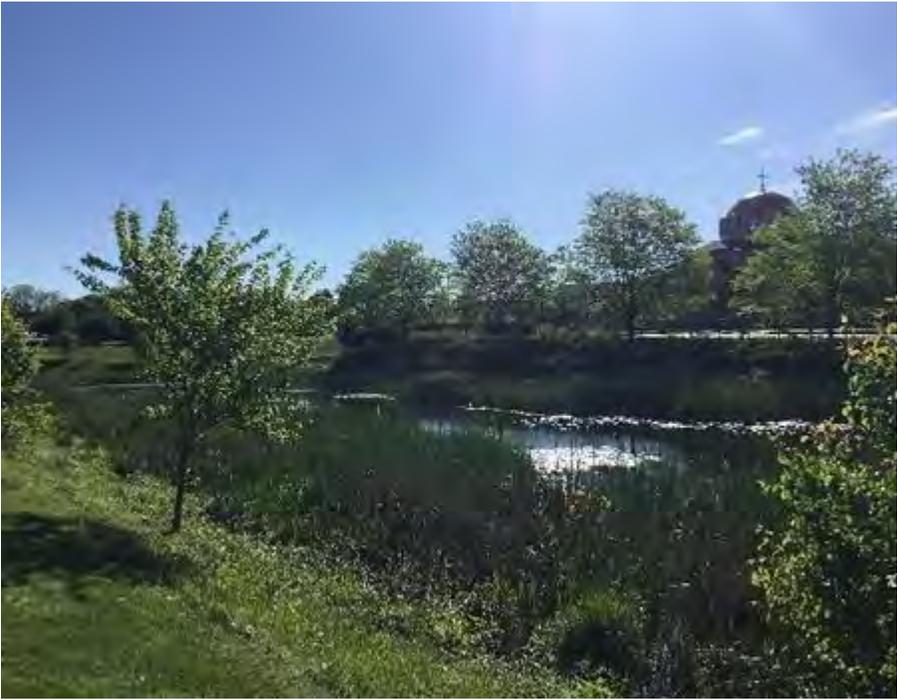
Overall view of the BMP.			
Violation Type (if applicable):			
Photo No. <b>2</b>	Date: 05/12/2021	Date:	
Description

Overall view of the BMP.			
Violation Type (if applicable):

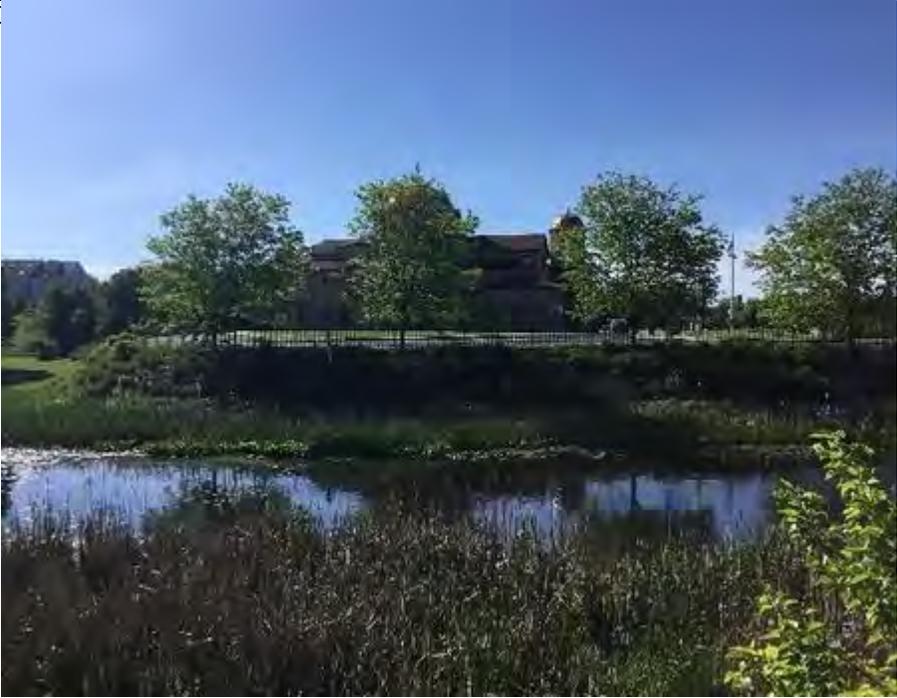
Description			
View of the contributing drainage area.			
Violation Type (if applicable):			
Photo No. 4	Date: 05/12/2021

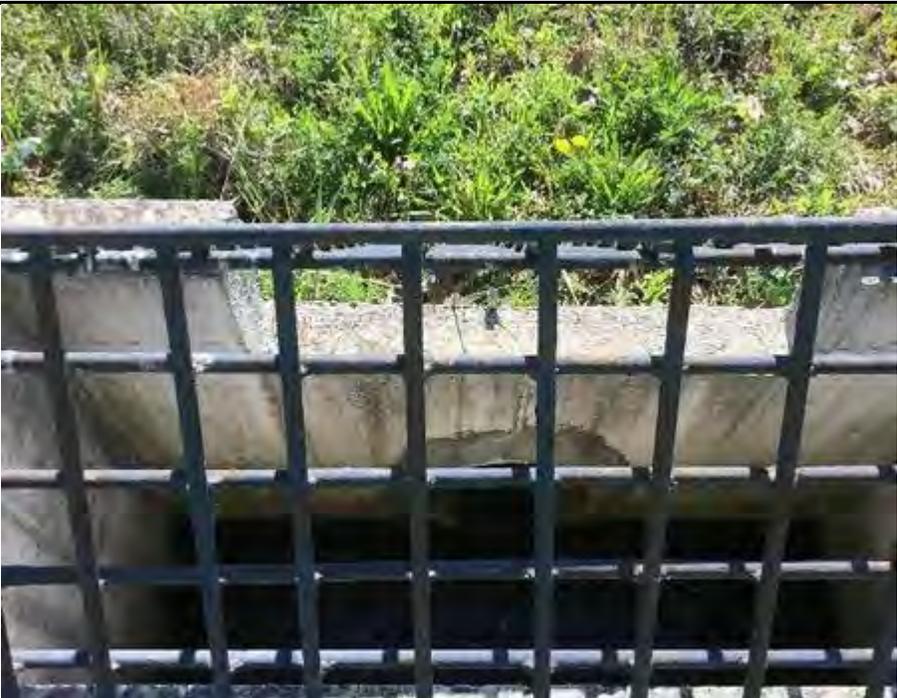
Description			
View of the riser.			
Violation Type (if applicable):

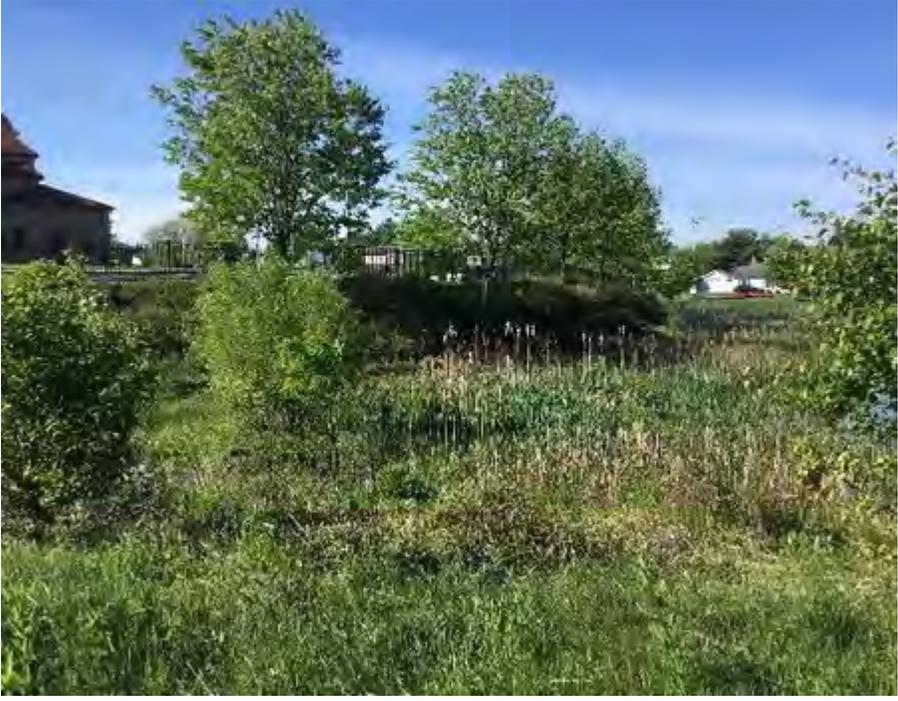
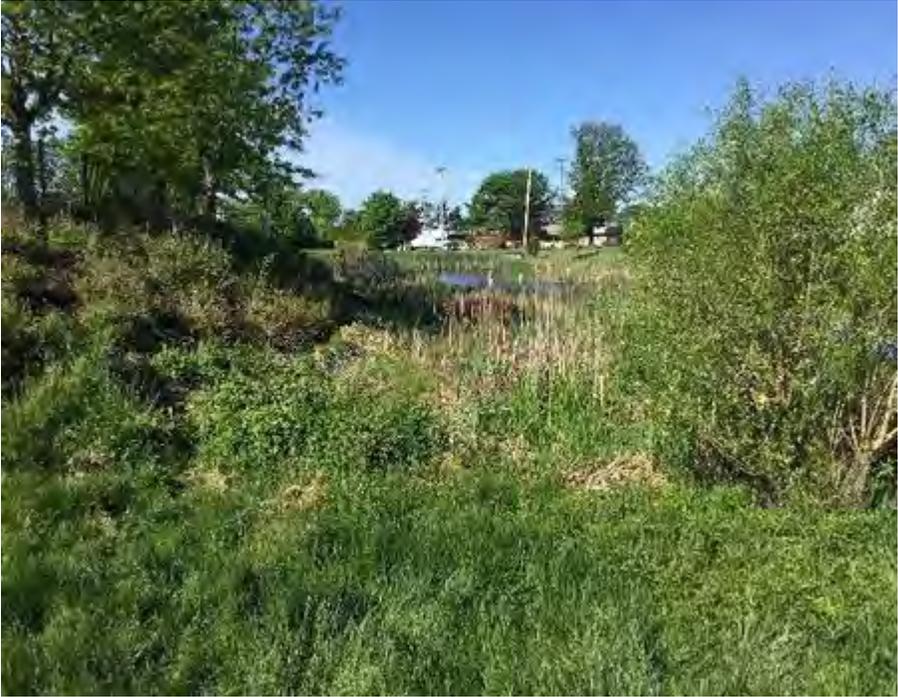
Overall view of the BMP.			
Violation Type (if applicable):			
Photo No. <b>2</b>	Date: 05/12/2021	Date:	
Description

Overall view of the BMP.			
Violation Type (if applicable):

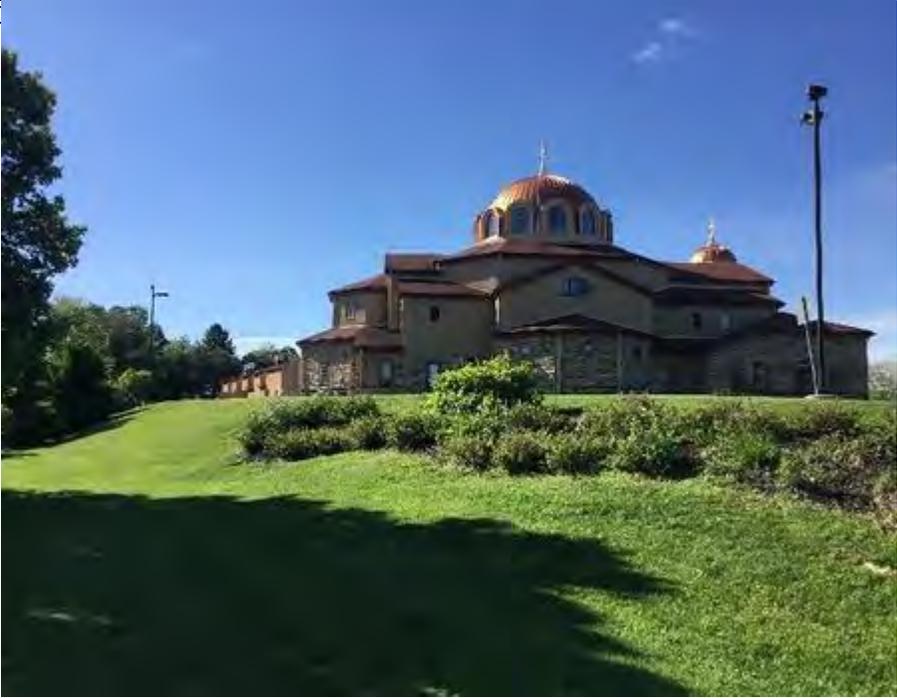
Description			
View of the contributing drainage area.			
Violation Type (if applicable):			
Photo No. 4	Date: 05/12/2021

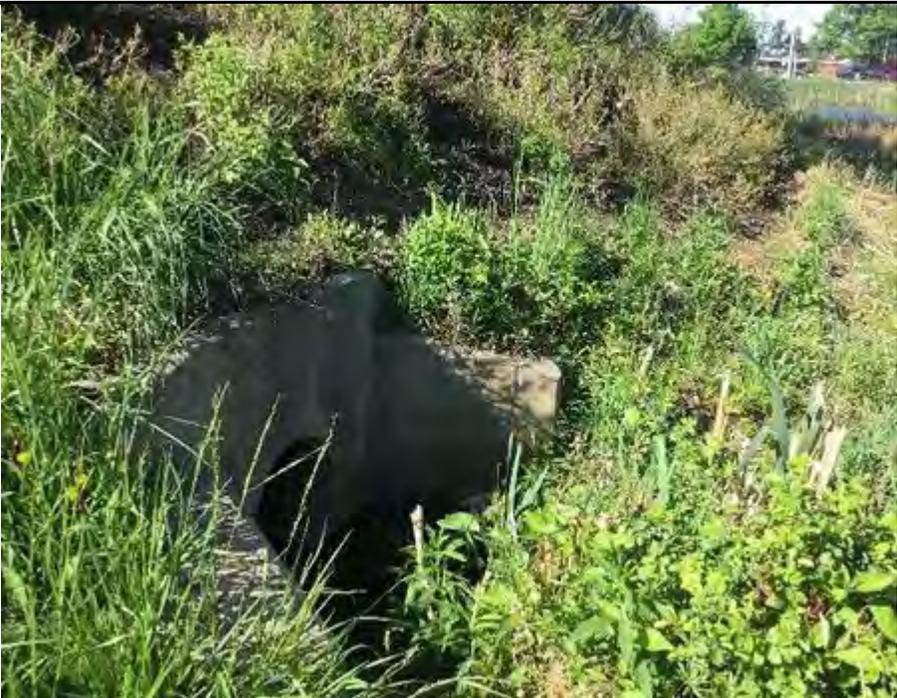
Description			
View of the structure leading to the BMP.			
Violation Type (if applicable):

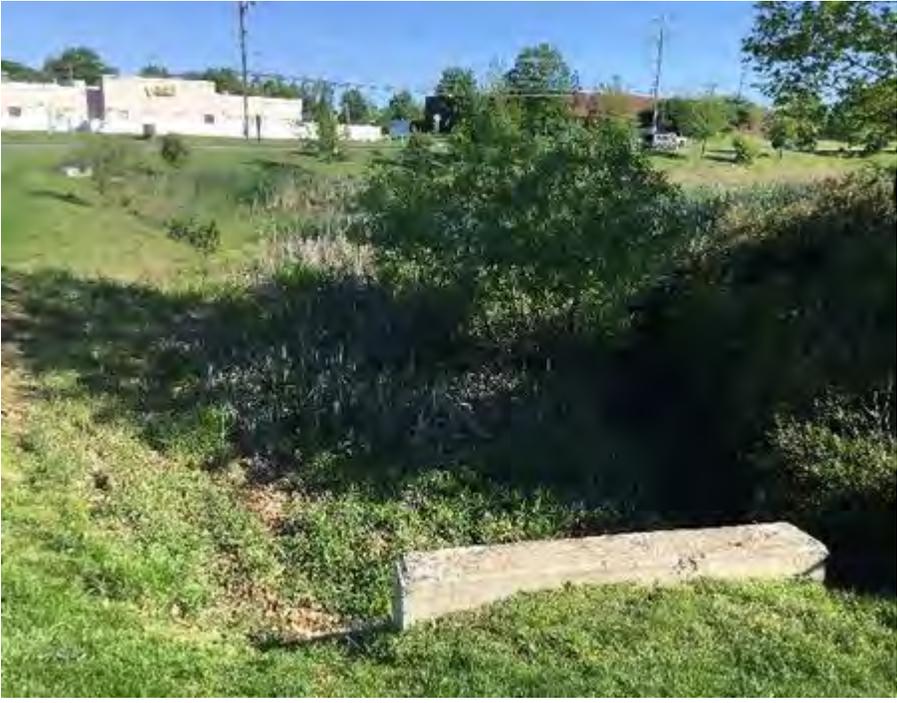
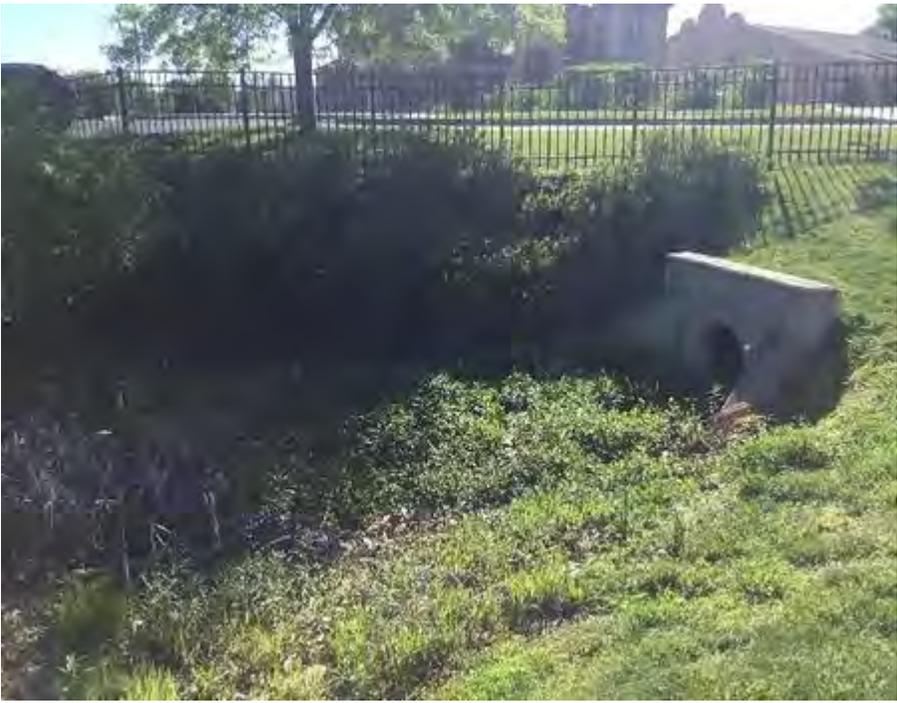
Overall view of the BMP.			
Violation Type (if applicable):			
Photo No. 2	Date: 05/12/2021	Date:	
Description

Overall view of the BMP.			
Violation Type (if applicable):

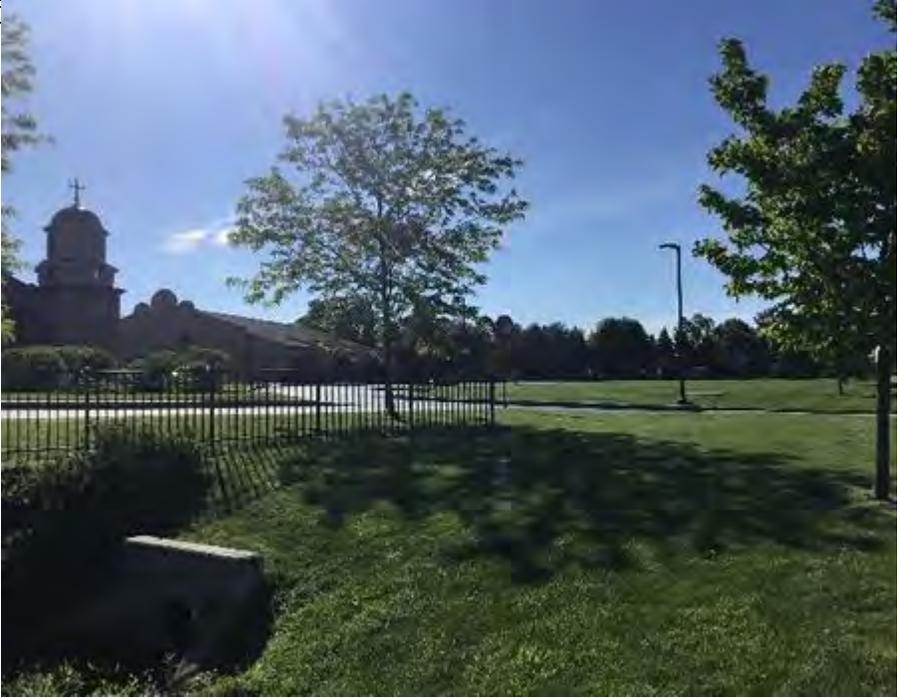
Description			
View of the contributing drainage area.			
Violation Type (if applicable):			
Photo No. 4	Date: 05/12/2021

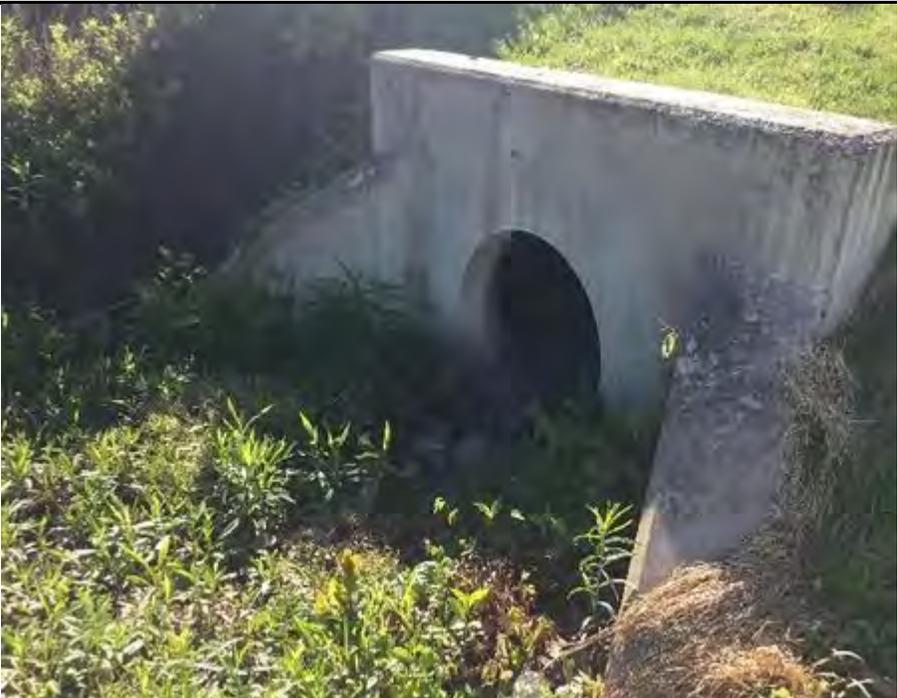
Description			
View of the structure leading to the BMP.			
Violation Type (if applicable):

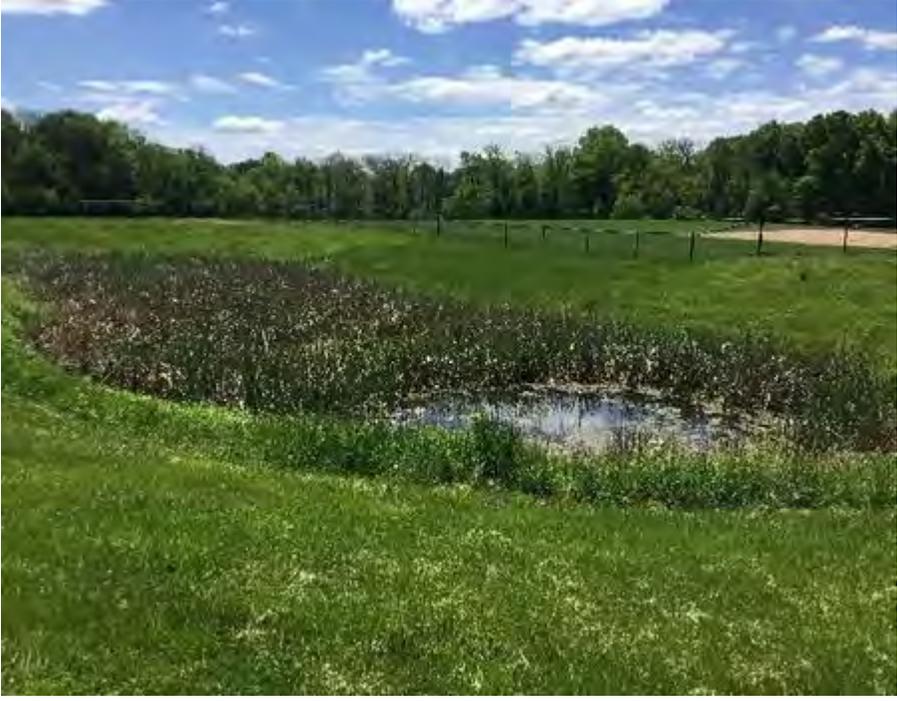
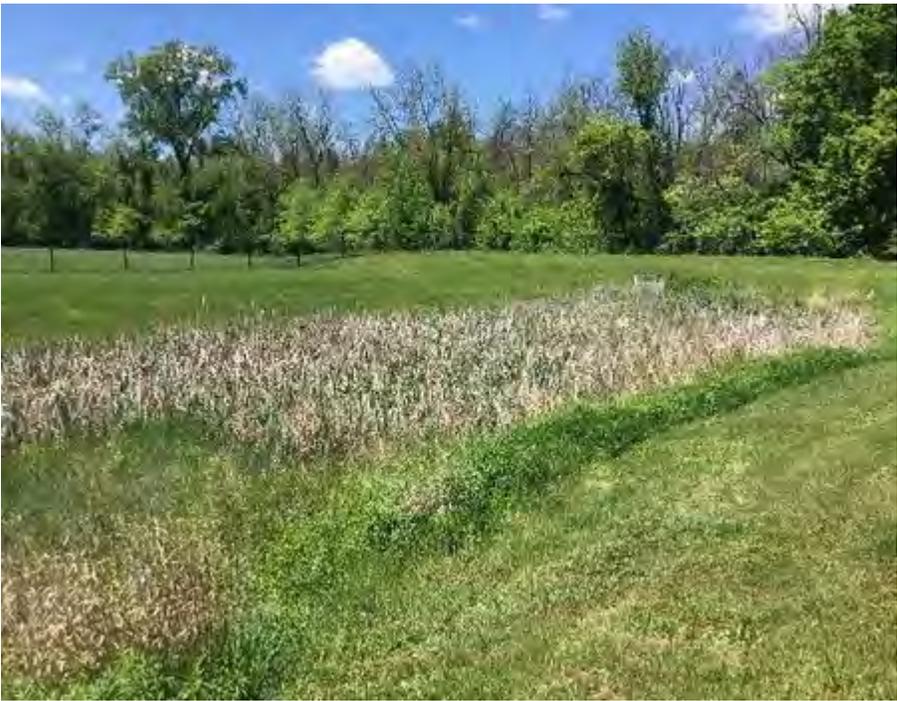
Overall view of the BMP.			
Violation Type (if applicable):			
Photo No. 2	Date: 05/12/2021	Date:	
Description

Overall view of the BMP.			
Violation Type (if applicable):

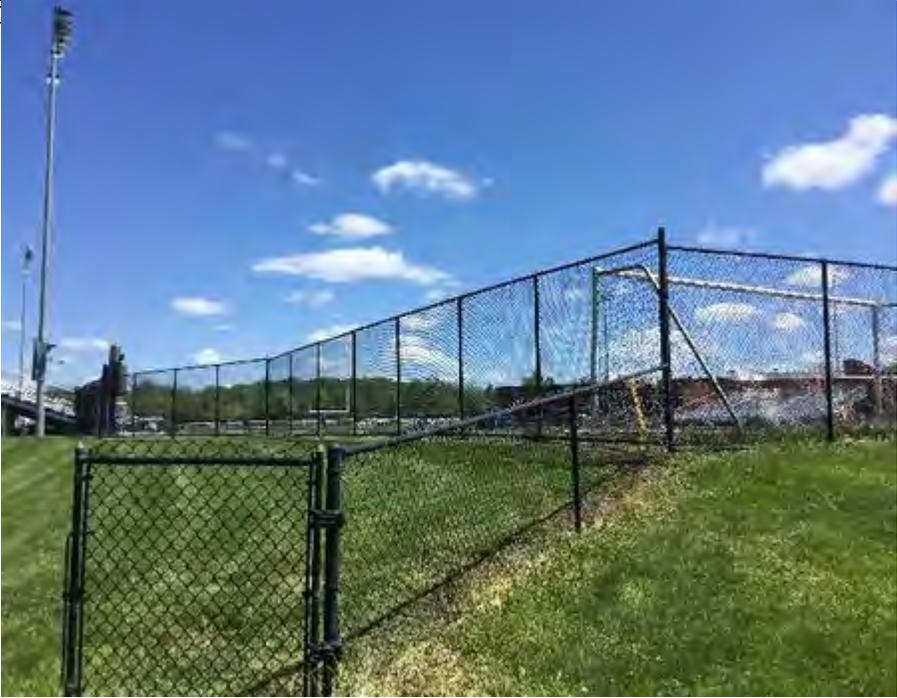
Description			
View of the contributing drainage area.			
Violation Type (if applicable):			
Photo No. 4	Date: 05/12/2021

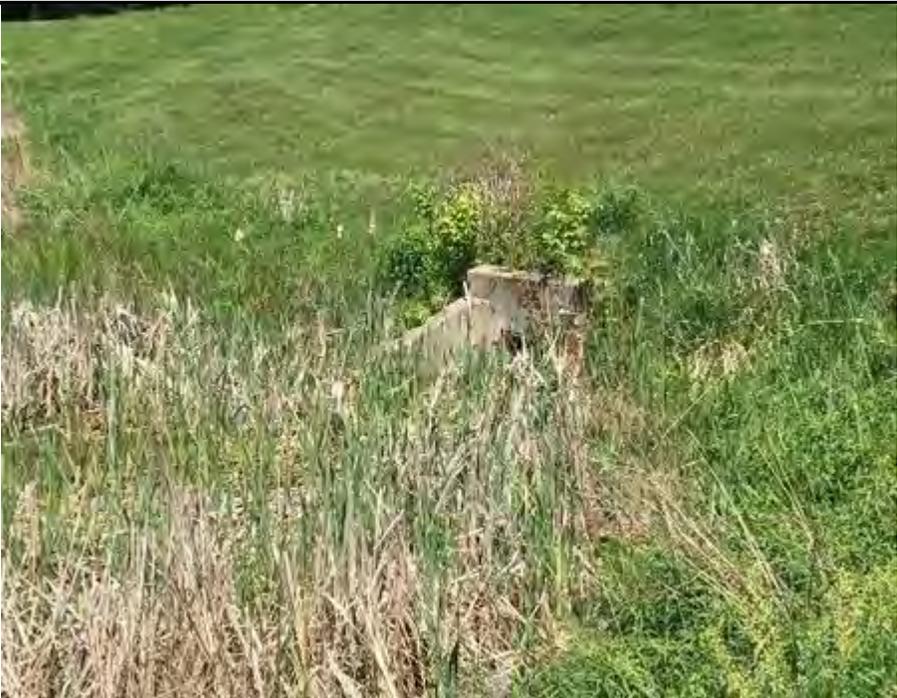
Description			
View of the structure leading to the BMP.			
Violation Type (if applicable):

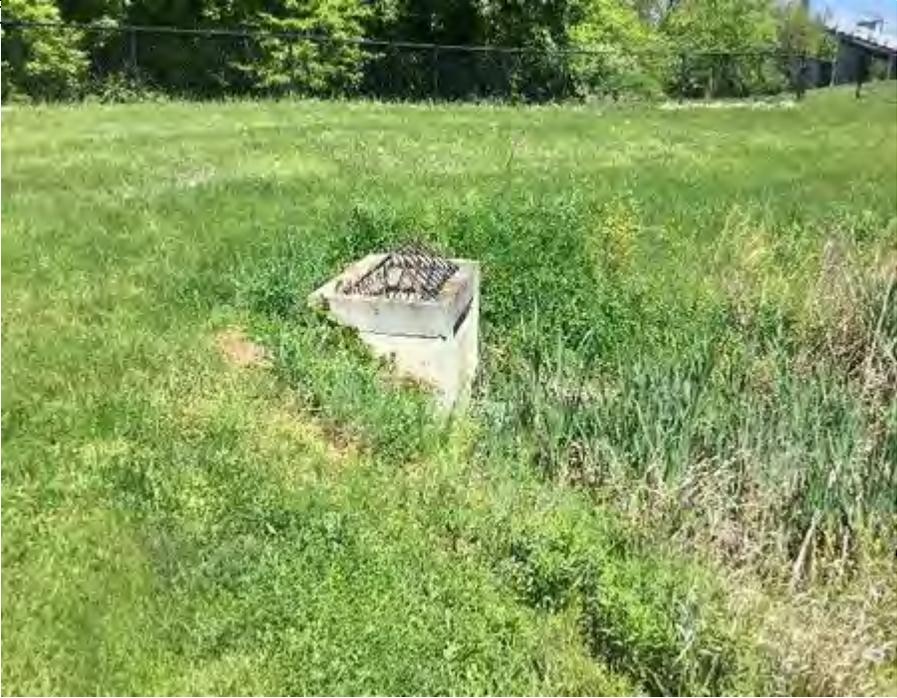
Description			
View of the riser.			
Violation Type (if applicable):			
Photo No. 6	Date: 05/12/2021

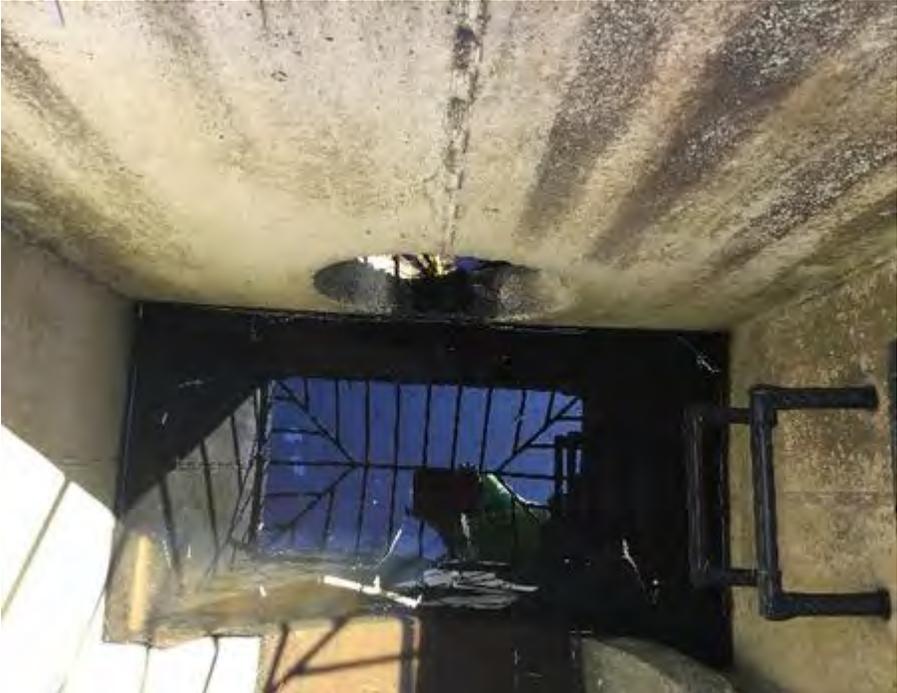
Description			
View inside of the riser.			
Violation Type(if applicable):
