RE: 2021 Annual MS4 Status Report  
NPDES Permit No. PAG130006  
West Norriton Township, Montgomery County  
WNR-21-006

# **ANNUAL MUNICIPAL SEPARATE STORM SEWER SYSTEM (MS4) STATUS REPORT**

West Norriton Township  
Montgomery County, PA  
1630 W. Marshall Street  
Jeffersonville, PA 19403

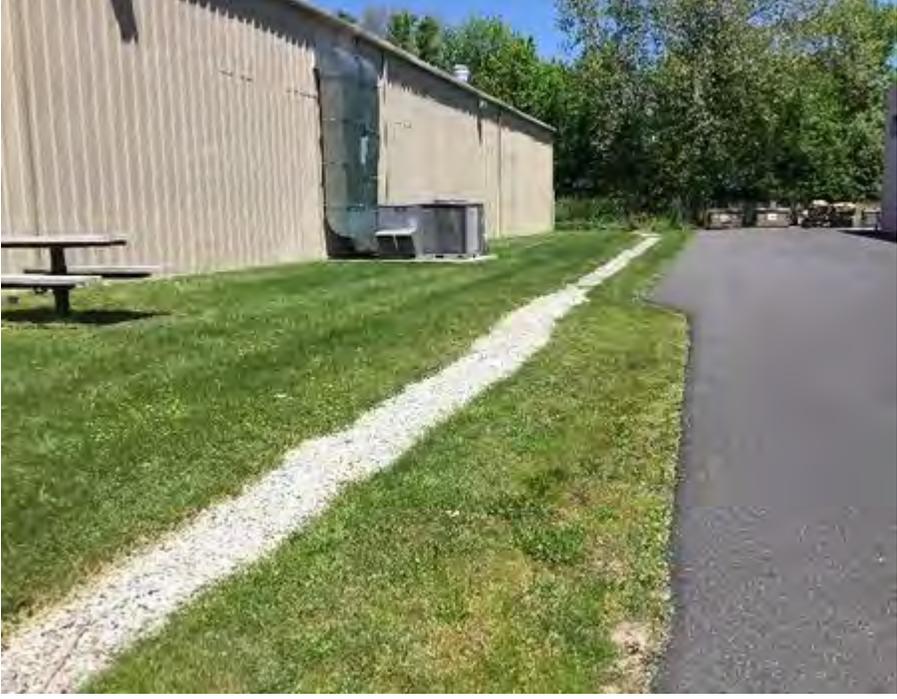
Overview of the BMP.			
Violation Type (if applicable):			
Photo No. 2	Date: 05/13/2021	Date:	
Description

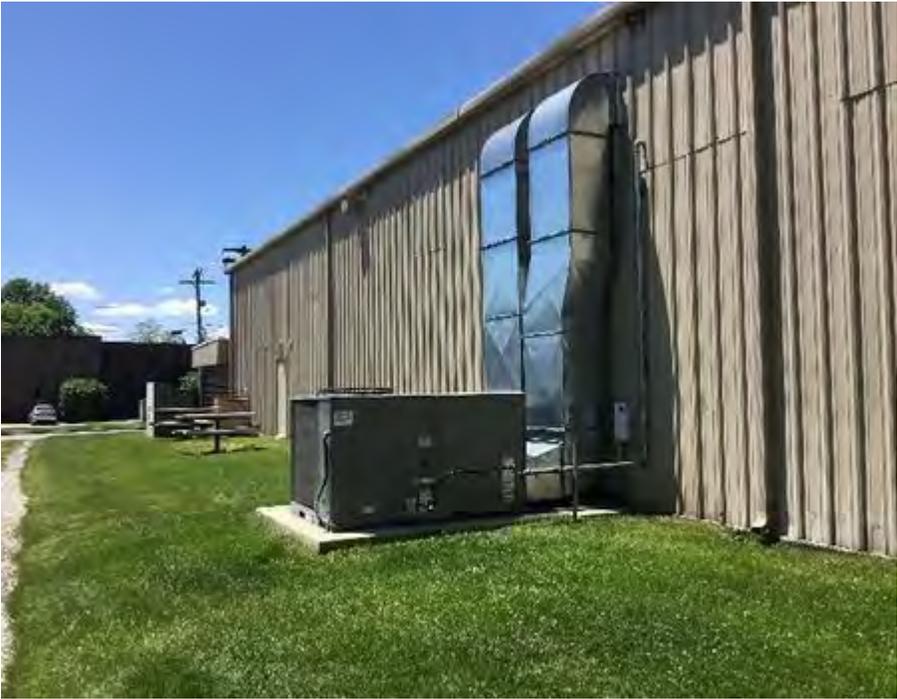
Contributing drainage area.			
Violation Type (if applicable):

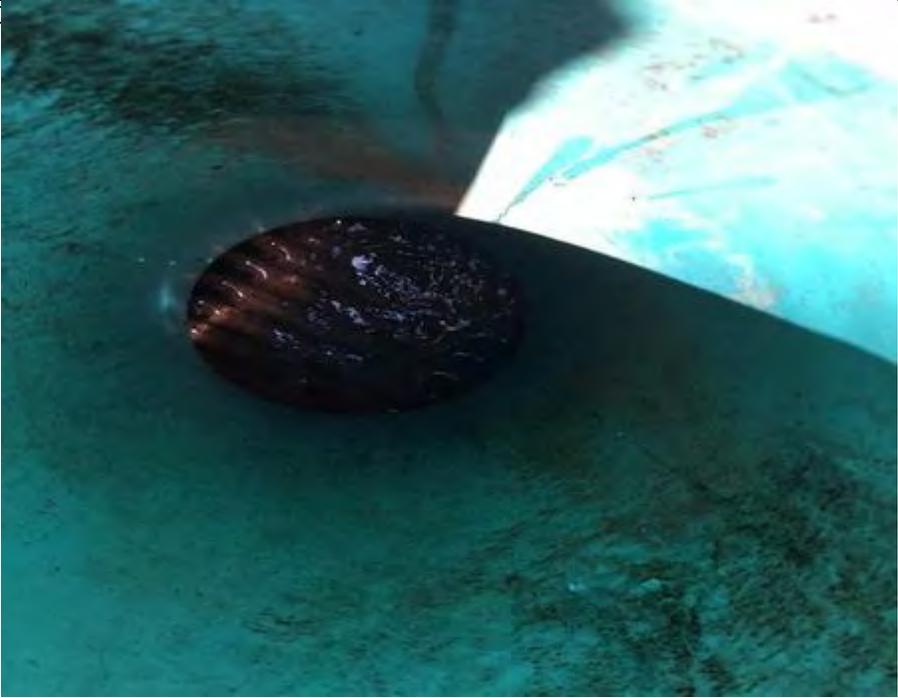
Description			
View of the cleanout. Running water appears to be coming from ground water source.			
Violation Type (if applicable):

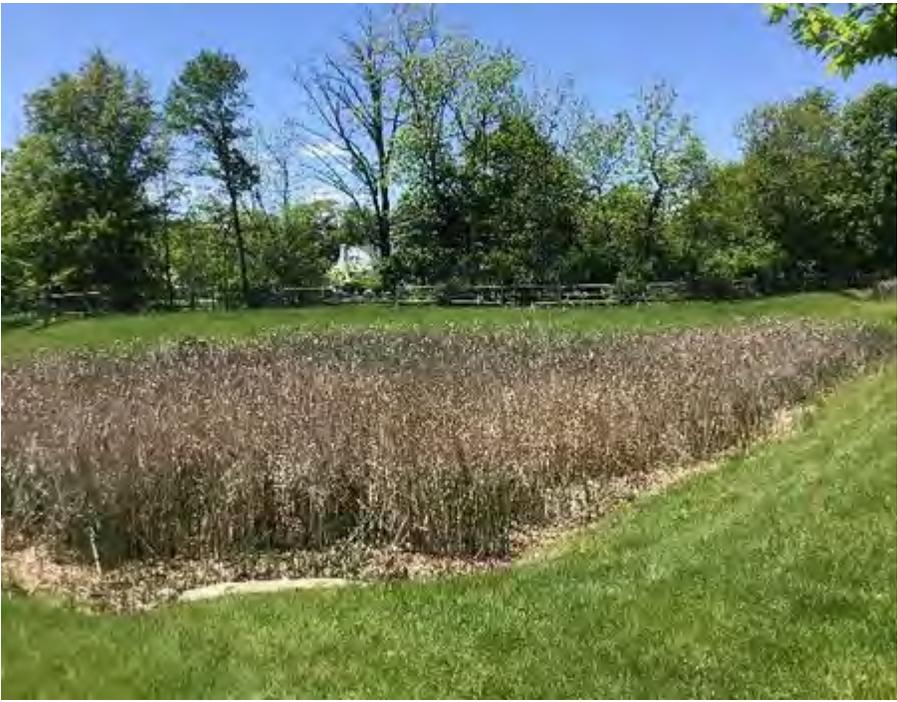
BMP #: 14		BMP Type: Detention Basin	BMP Address:
Photo No. <b>1</b>	Date: 05/13/2021	Date:	
Description Overview of the BMP.

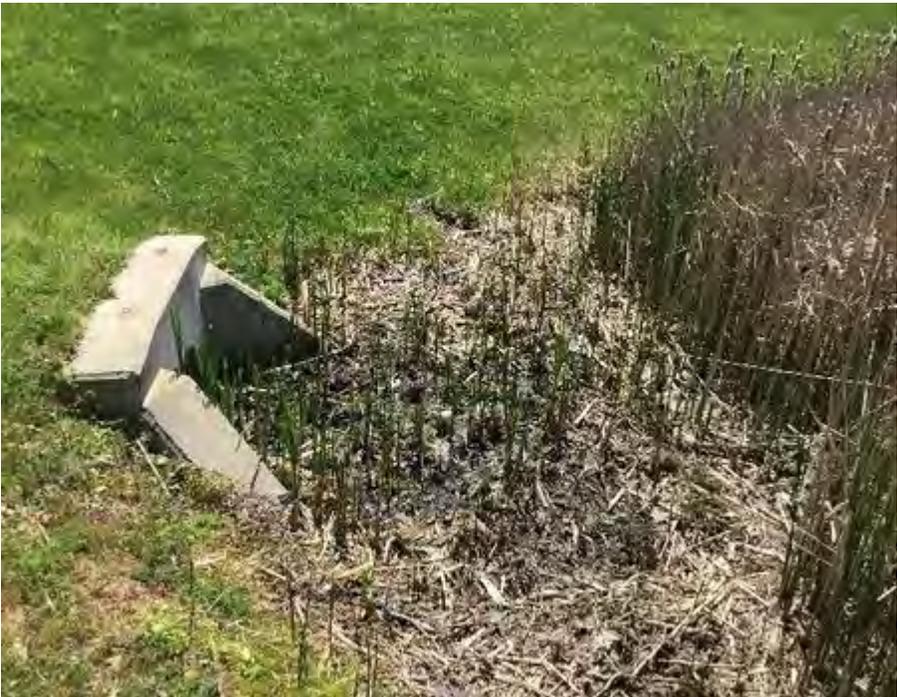
Violation Type (if applicable):			
Photo No. <b>2</b>	Date: 05/13/2021	Date:	
Description View of the inflow to the basin.

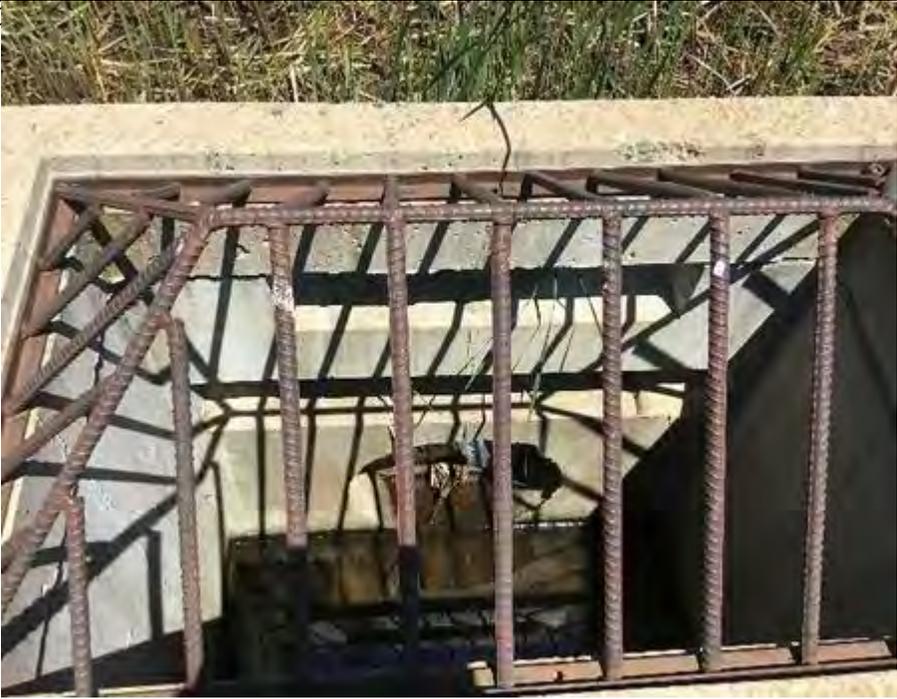
Description		
Riser of the basin.		
Violation Type (if applicable):		
Photo No. <b>6</b>	Date: 05/13/2021

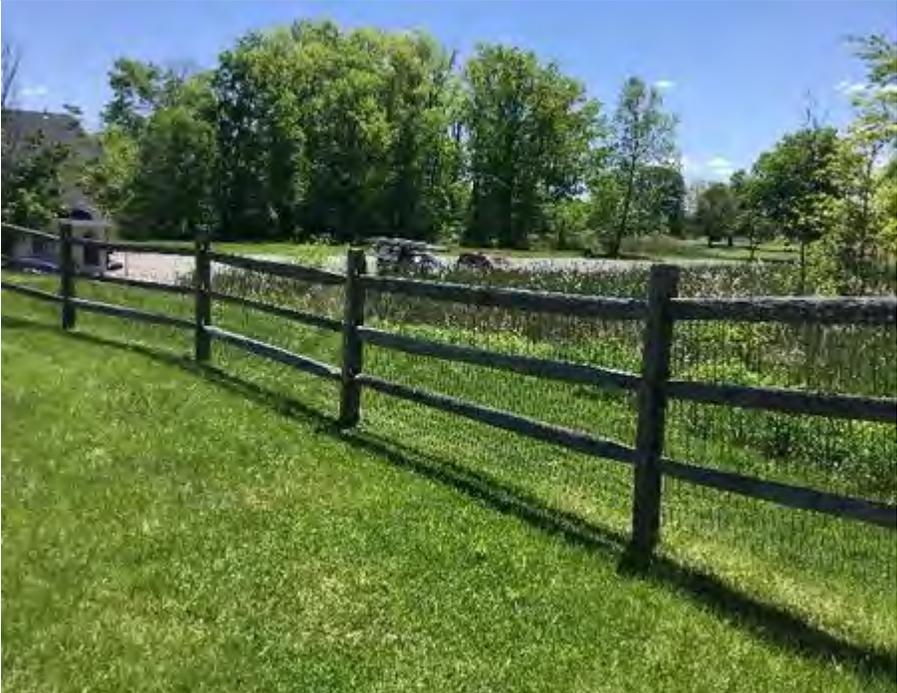
Description		
Spillway and other side of the basin.		
Violation Type(if applicable):

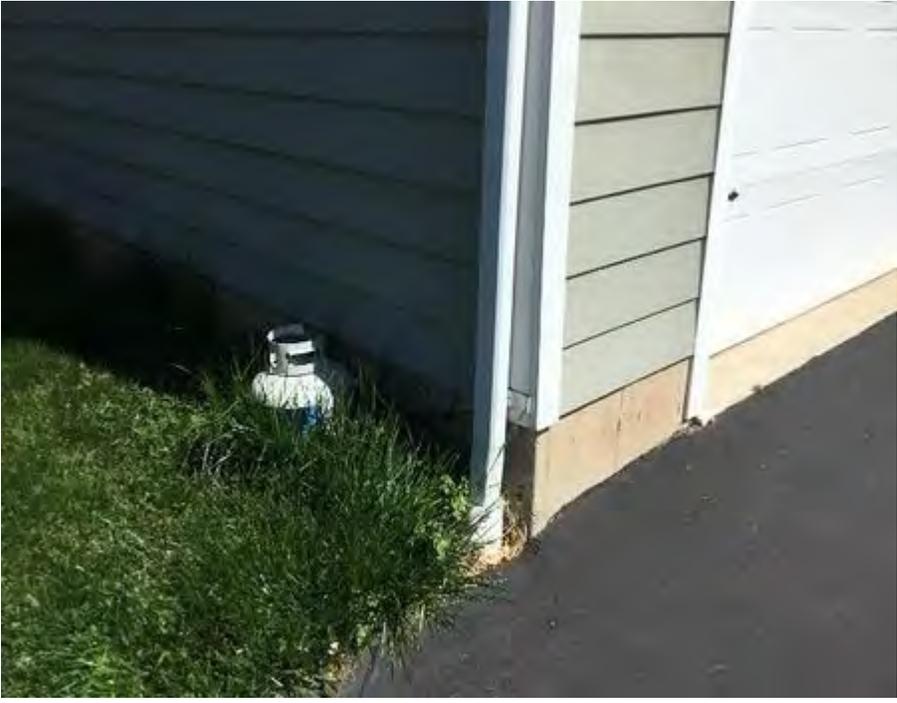
Connected downspout to the system.			
Violation Type (if applicable):			
Photo No. 2	Date: 05/12/2021	Date:	
Description

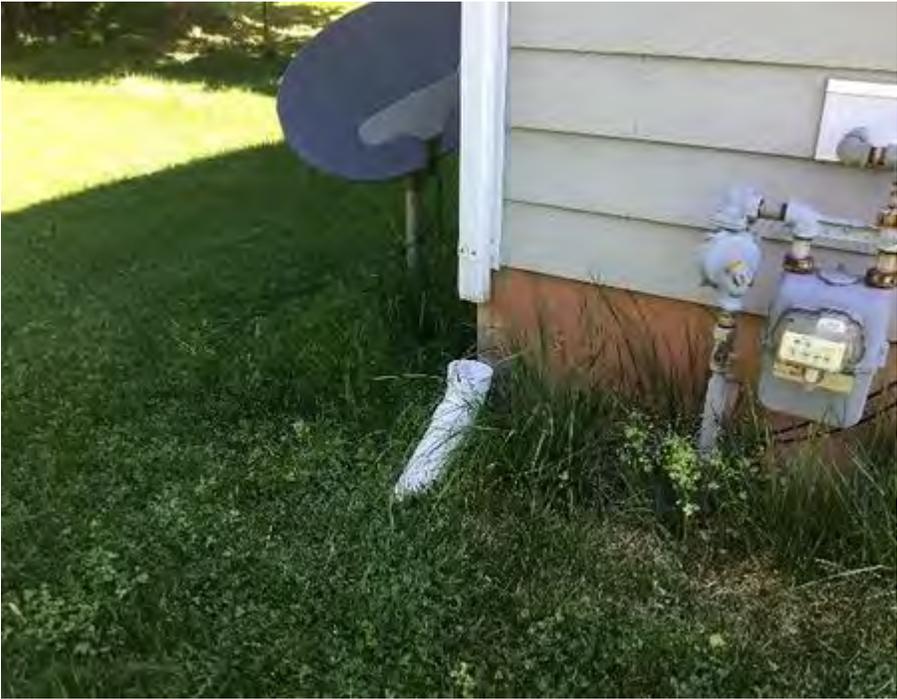
Disconnected downspout.			
Violation Type (if applicable): Disconnected downspout to the underground system.

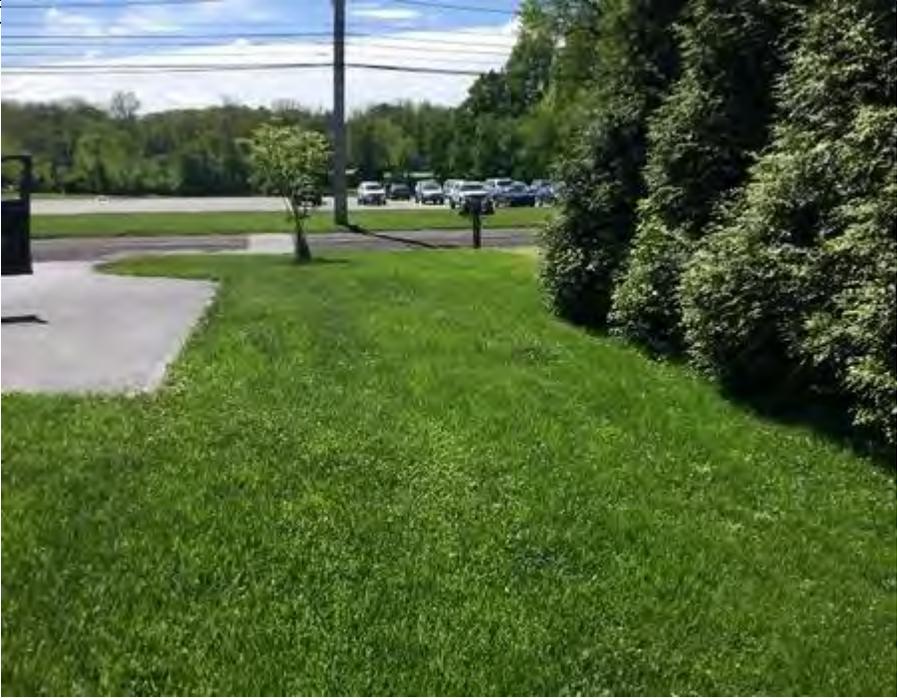
Description			
View of the underground BMP.			
Violation Type (if applicable):			
Photo No. 4	Date: 05/12/2021

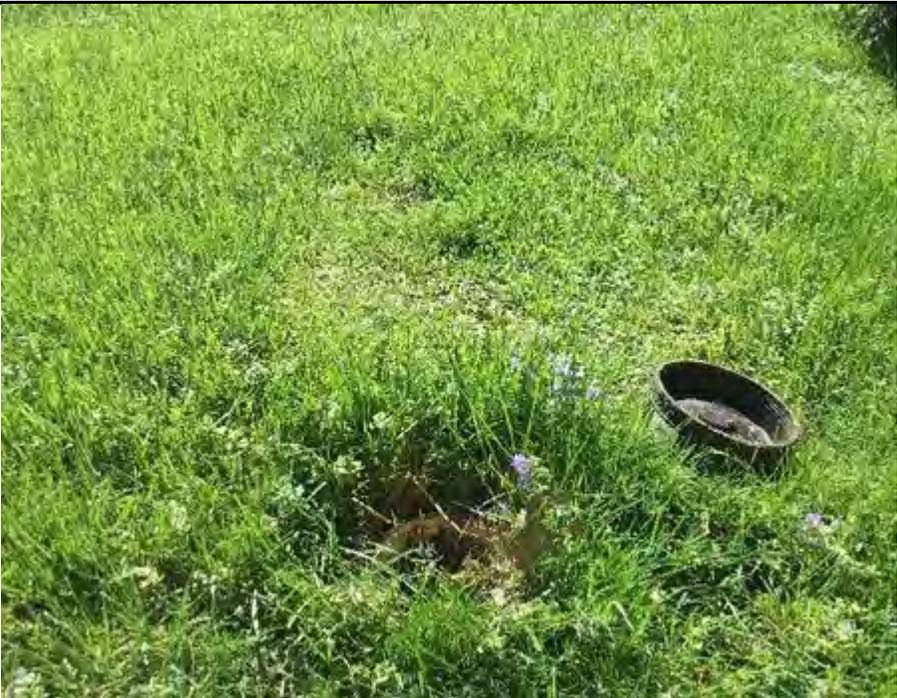
Description			
View of the observation well closest to the house.			
Violation Type (if applicable): Standing water present.

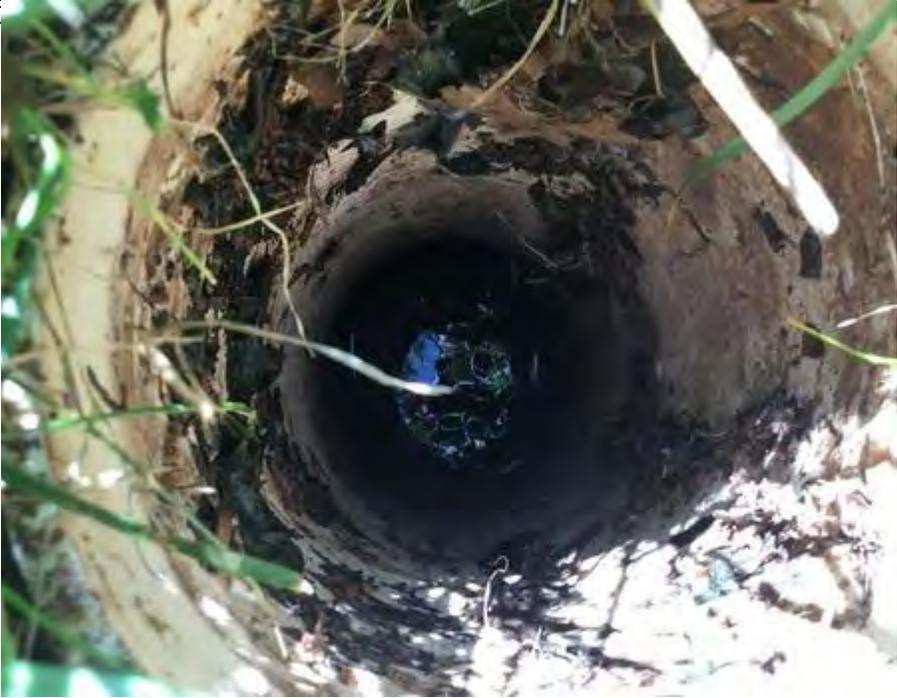
BMP #: 15		BMP Type: Seepage Bed	BMP Address: 519 Port Indian Rd, Norristown, PA 19403
Photo No. 5	Date: 05/12/2021

Description			
View inside the observation while closest to the house.			
Violation Type (if applicable): Standing water present.			
Photo No. 6	Date: 05/12/2021

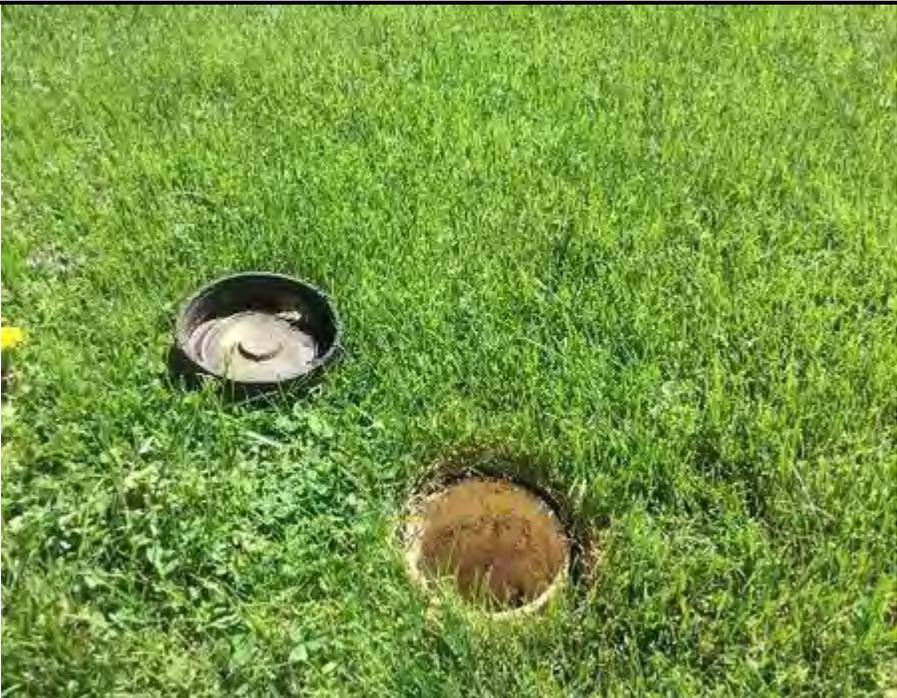
Description			
View of the observation while closest to the road.			
Violation Type(if applicable): Standing water present.

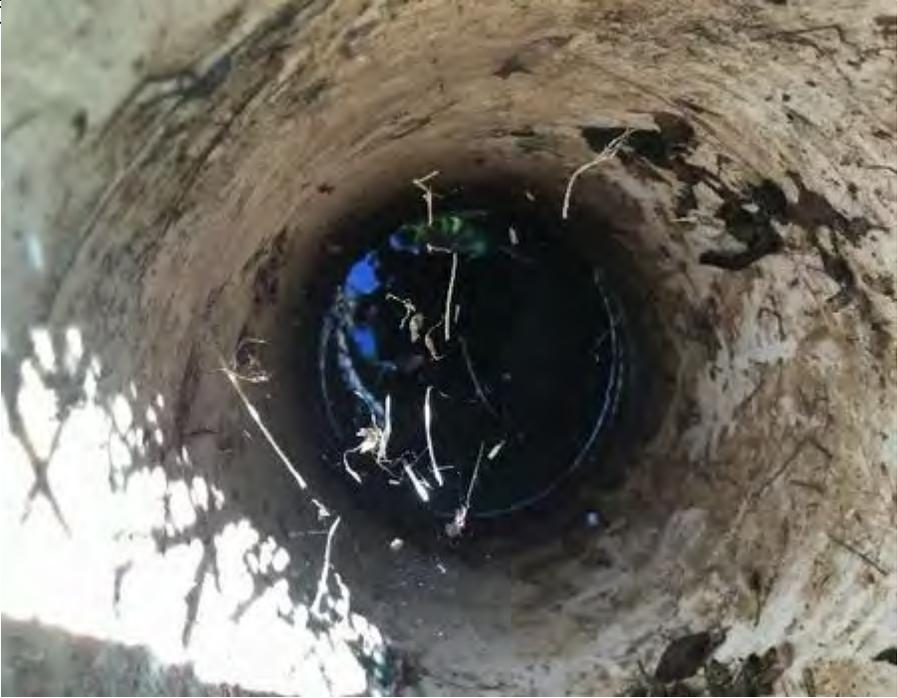
BMP #: 15		BMP Type: Seepage Bed	BMP Address: 519 Port Indian Rd, Norristown, PA 19403
Photo No. 7	Date: 05/12/2021

Description			
View of the observation well closest to the road.			
Violation Type (if applicable): Standing water present.

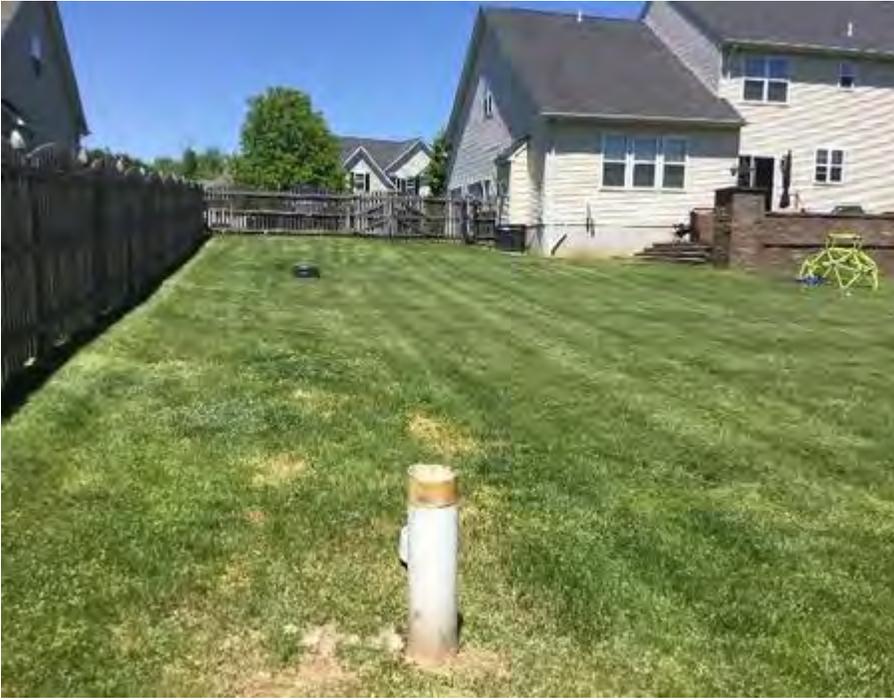
BMP #: 16		BMP Type: Underground Stone Infiltration Pit	BMP Address: 139 Clemens Cir, Jeffersonville, PA 19403
Photo No. 1	Date: 05/13/2021	Date:	
Description Overview of the BMP.

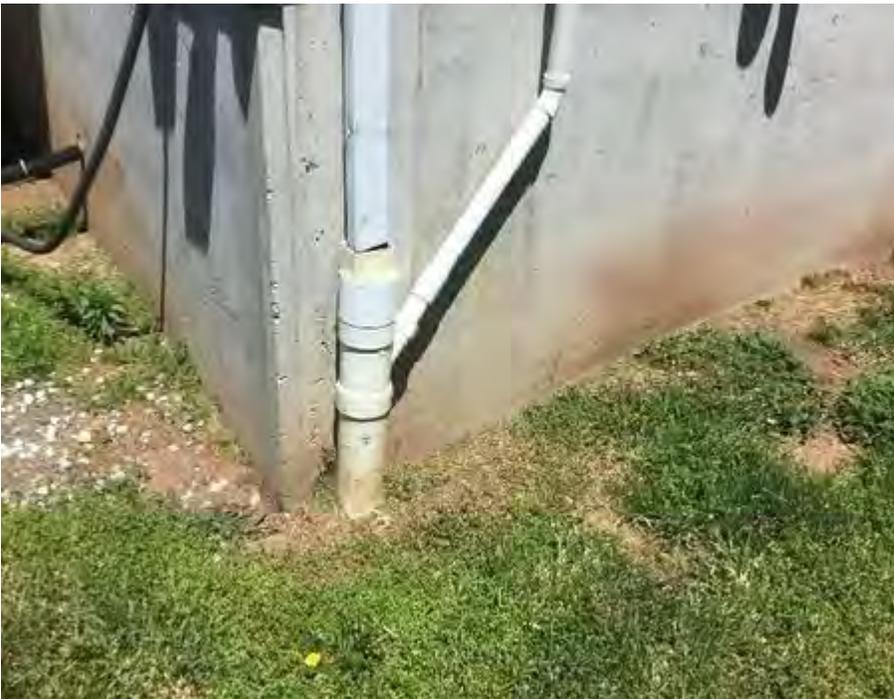
Violation Type (if applicable):			
Photo No. 2	Date: 05/13/2021	Date:	
Description Connected downspouts.

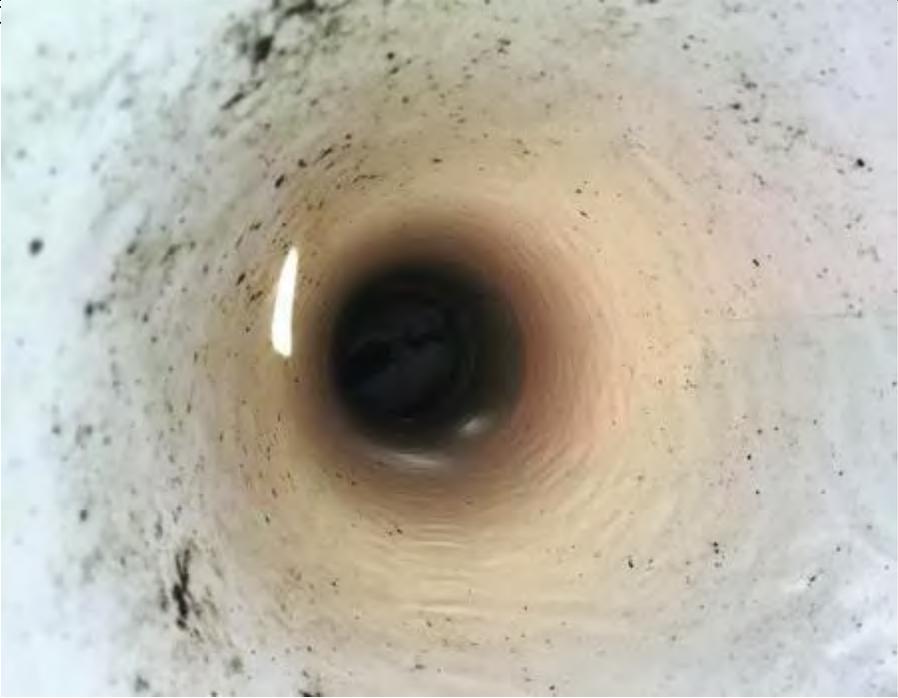
BMP #: 16		BMP Type: Underground Stone Infiltration Pit	BMP Address: 139 Clemens Cir, Jeffersonville, PA 19403
Photo No. 3	Date: 05/13/2021

Description			
View of the cleanout.			
Violation Type (if applicable):

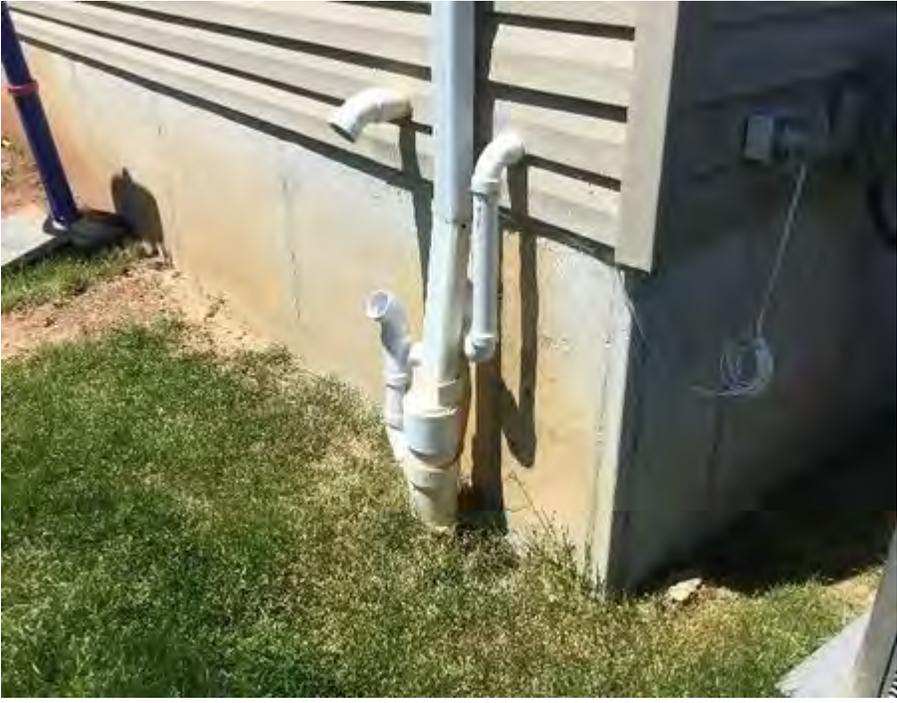
BMP #: 17		BMP Type: Underground Stone Infiltration Pit	BMP Address: 137 Clemens Cir, Norristown, PA 19403
Photo No. 1	Date: 05/13/2021	Date:	
Description

Connected downspout.			
Violation Type (if applicable):			
Photo No. 2	Date: 05/13/2021	Date:	
Description

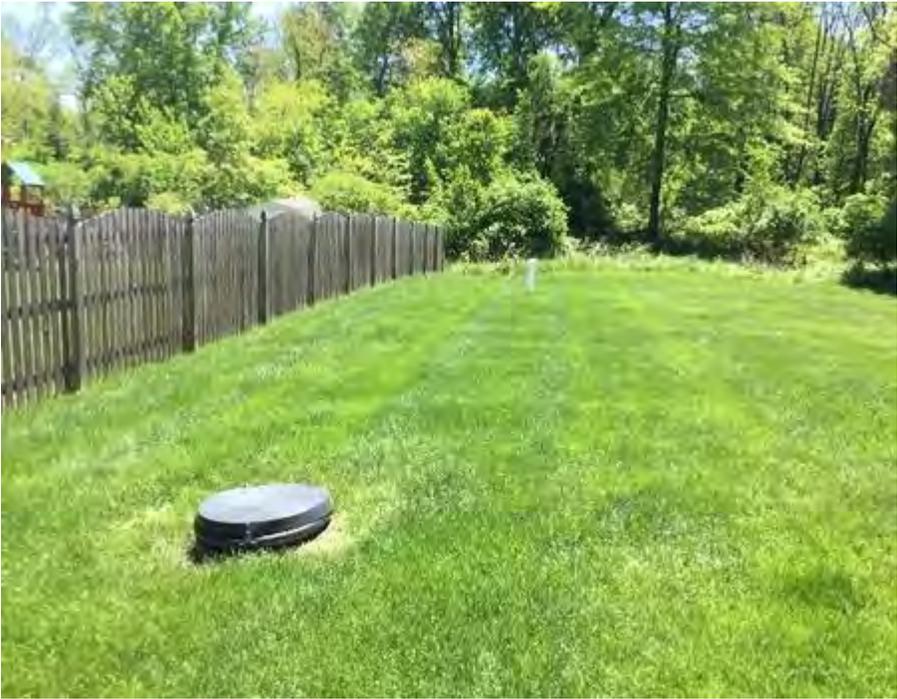
Overview of BMP.			
Violation Type (if applicable):

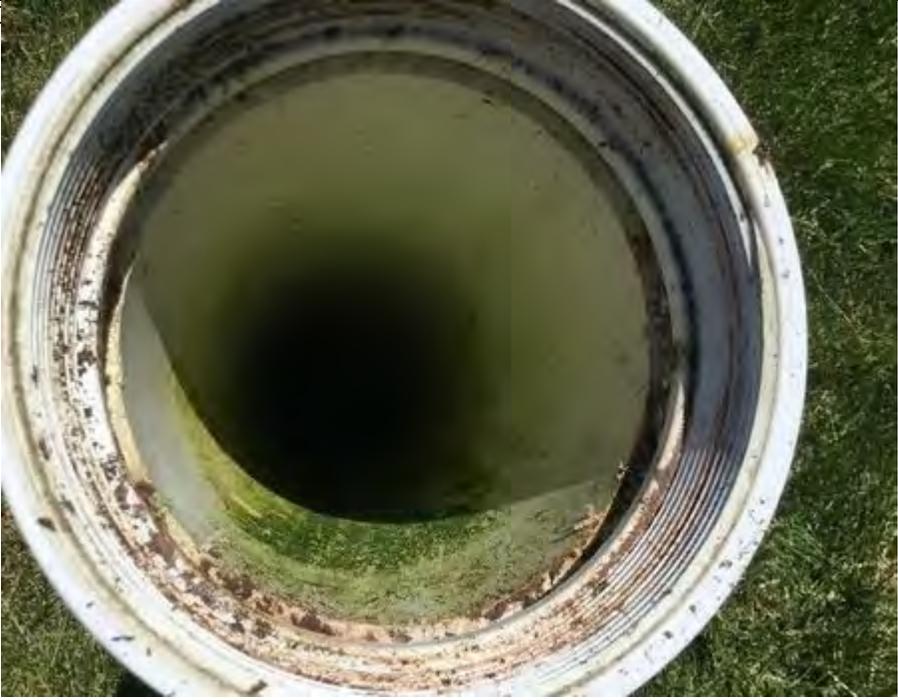
BMP #: 17		BMP Type: Underground Stone Infiltration Pit	BMP Address: 137 Clemens Cir, Norristown, PA 19403
Photo No. 3	Date: 05/13/2021

Description			
View of the cleanout.			
Violation Type (if applicable):

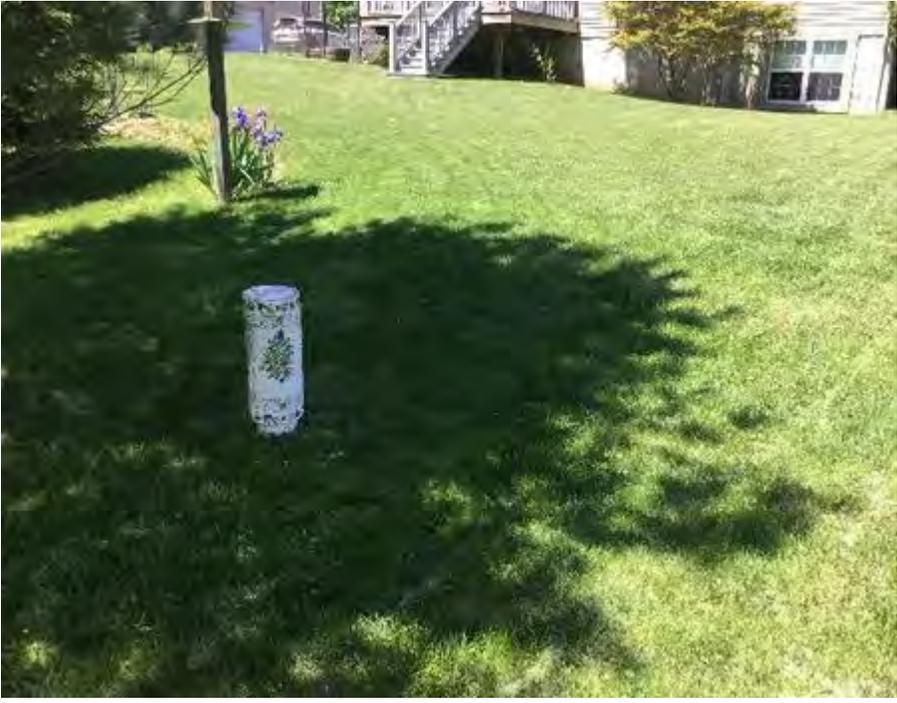
BMP #: 18		BMP Type: Underground Stone Infiltration Pit	BMP Address: 135 Clemens Cir, Norristown, PA 19403
Photo No. 1	Date: 05/13/2021	Date:	
Description

Overview of the BMP.			
Violation Type (if applicable):			
Photo No. 2	Date: 05/13/2021	Date:	
Description

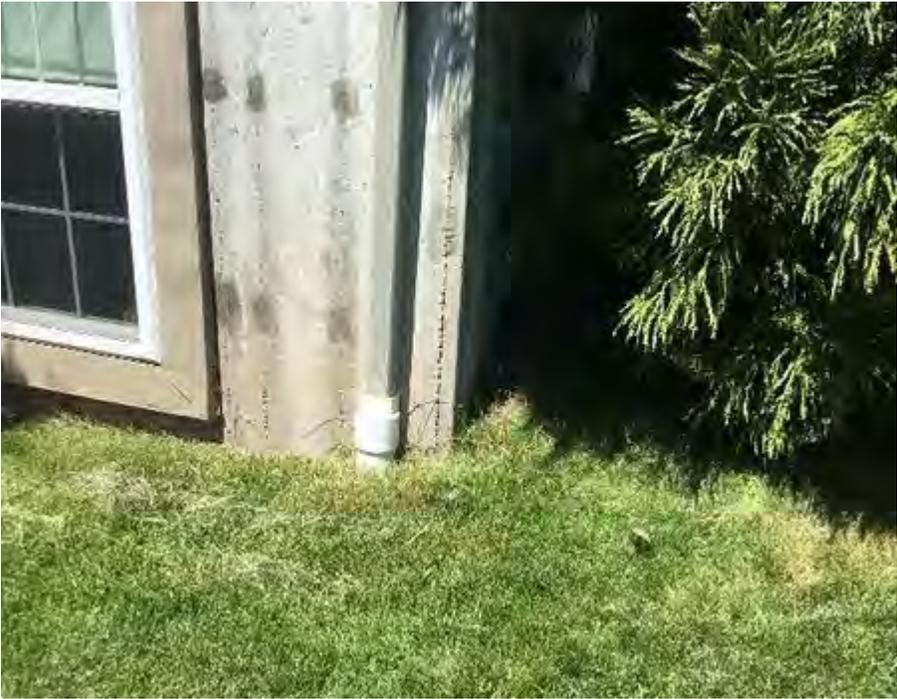
Connected downspouts.			
Violation Type (if applicable):

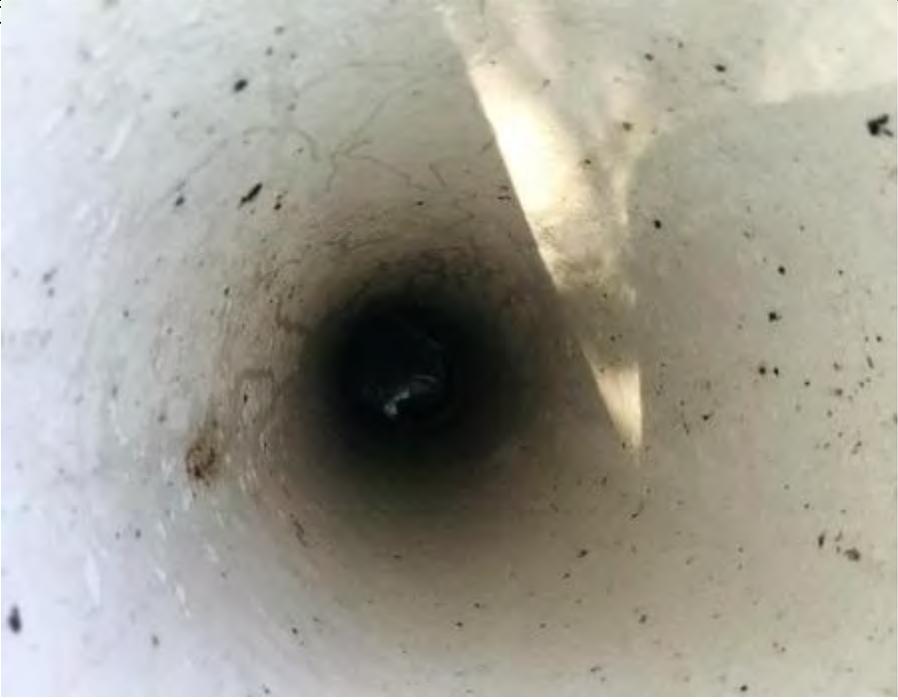
BMP #: 18		BMP Type: Underground Stone Infiltration Pit	BMP Address: 135 Clemens Cir, Norristown, PA 19403
Photo No. 3	Date: 05/13/2021

Description			
View of the cleanout.			
Violation Type (if applicable):

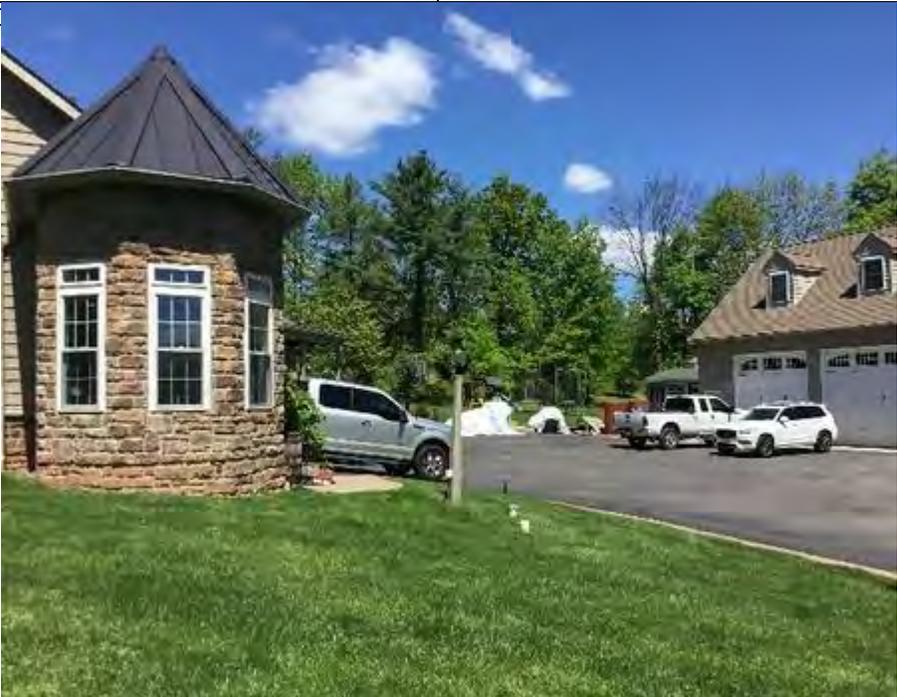
BMP #: 19		BMP Type: Seepage Bed	BMP Address:
Photo No. 3	Date: 05/12/2021

Description			
View of the contributing drainage area.			
Violation Type (if applicable):			
Photo No. 4	Date: 05/12/2021

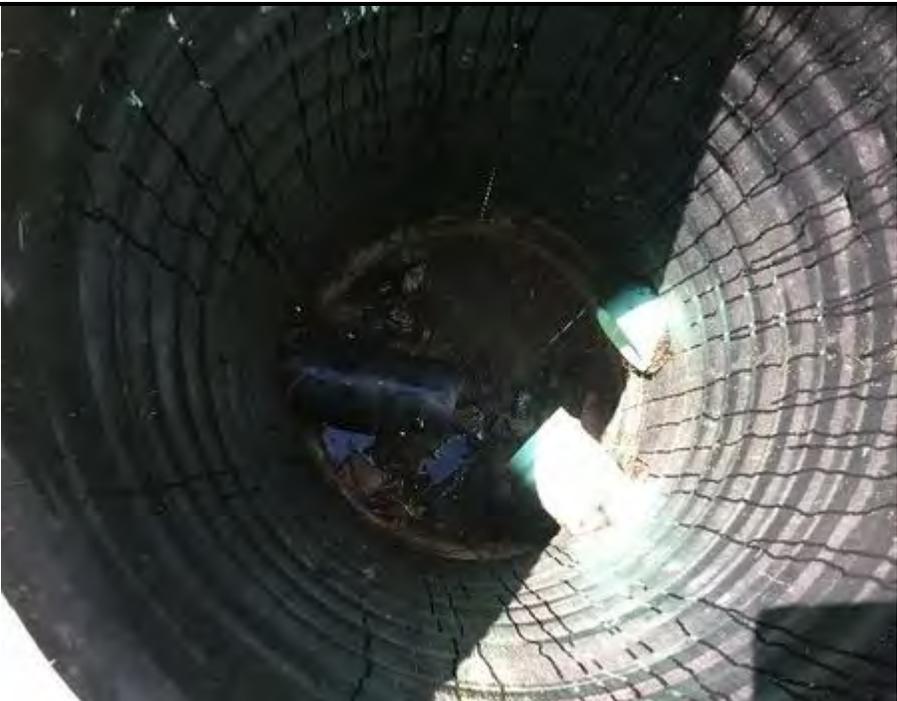
Description			
View inside the observation well.			
Violation Type (if applicable):

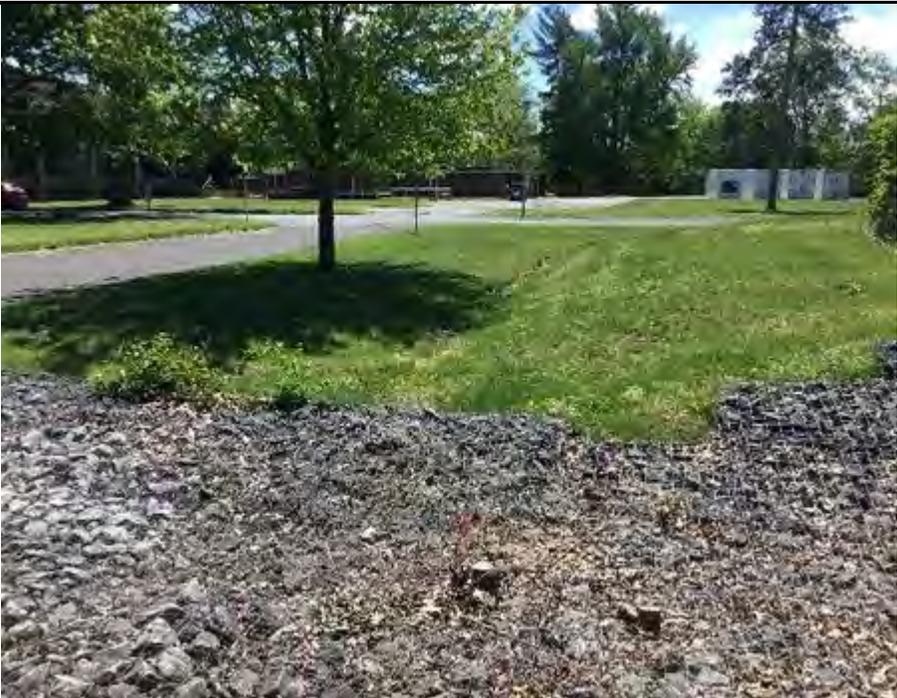
Description			
View of the rock overflow structure.			
Violation Type (if applicable):

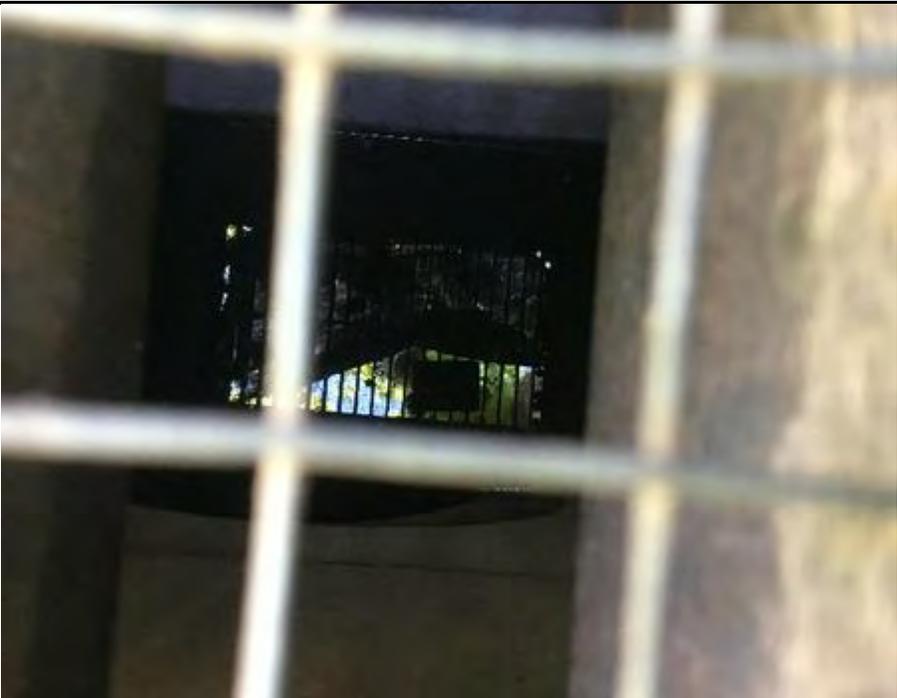
Description			
View of the observation inlet.			
Violation Type (if applicable):

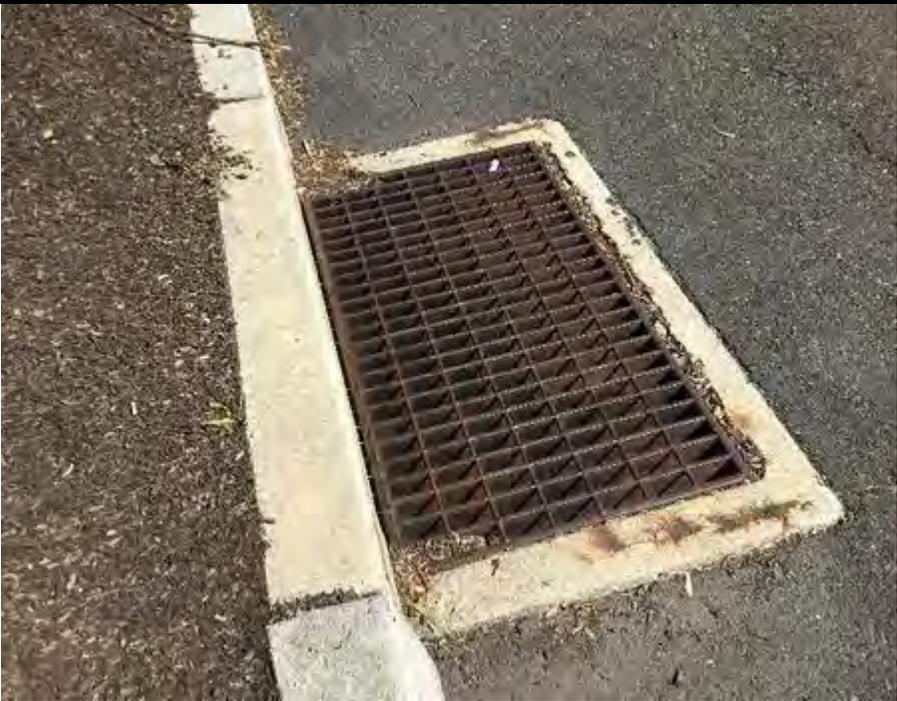
Description			
View of the structure leading to the BMP.			
Violation Type (if applicable):

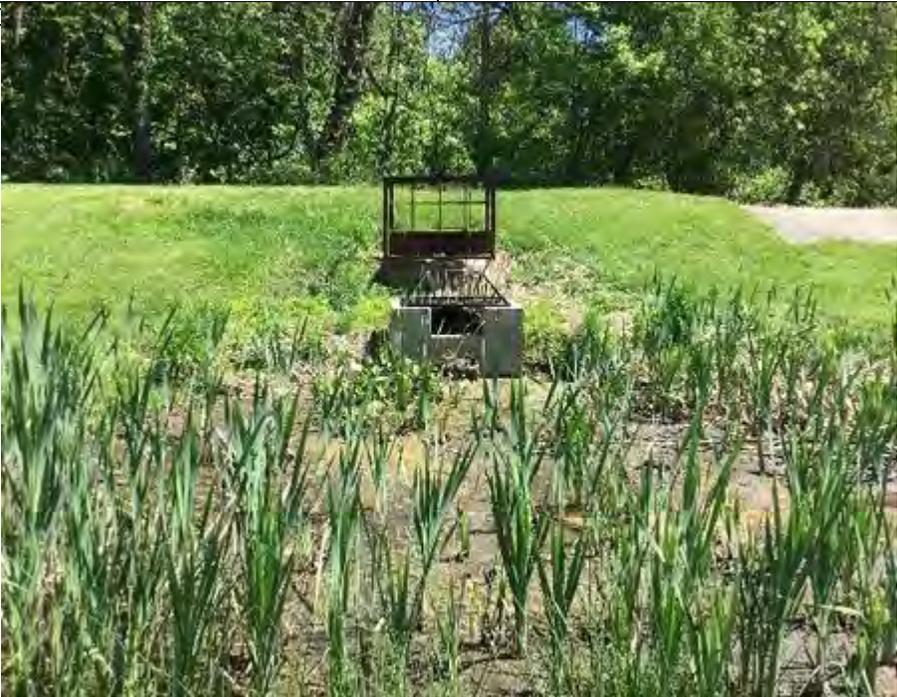
BMP #: 24		BMP Type: Detention Basin	BMP Address: 1630 W Marshall St.
Photo No. 5	Date: 05/12/2021

Description			
View of the riser.			
Violation Type (if applicable):			
Photo No. 6	Date: 05/12/2021

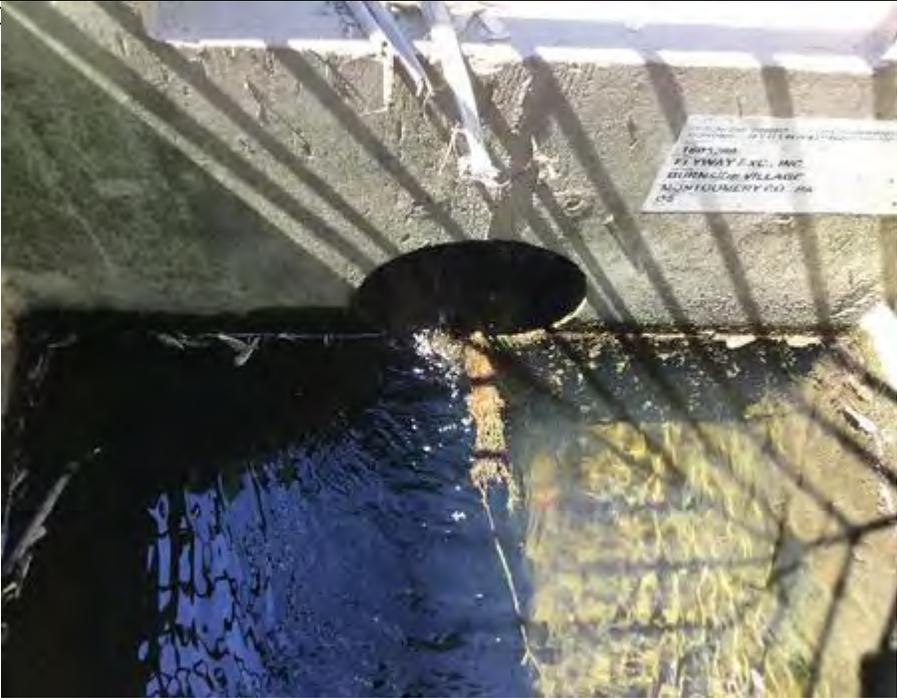
BMP #: 24		BMP Type: Detention Basin	BMP Address: 1630 W Marshall St.
Photo No. <b>7</b>	Date: 05/12/2021

Description			
View inside the riser.			
Violation Type (if applicable):			
Photo No. <b>8</b>	Date: 05/12/2021

BMP Component	Violations Observed					
<b>Contributing Drainage Area</b>	<input type="checkbox"/> Excessive trash/debris	<input type="checkbox"/> Exposed/bare soil	<input type="checkbox"/> Evidence of accelerated erosion	<input type="checkbox"/> Other		
<input checked="" type="checkbox"/> No violations present at the time of inspection						
Photo No.	Comments:					
<b>Pretreatment: Inlets, Forebays &amp; Inflow</b>	<input checked="" type="checkbox"/> Excessive trash/debris/sediment accumulation	<input type="checkbox"/> Evidence of clogging	<input checked="" type="checkbox"/> Evidence of accelerated erosion	<input type="checkbox"/> Evidence of ponding, odors, water stains, floating aquatic	<input type="checkbox"/> Structural deterioration of the structure(s)	<input type="checkbox"/> Illicit inflow devices
<input type="checkbox"/> No violations present at the time of inspection						
Photo No. 7	Comments: Evidence of erosion and sediment deposits up-hill of the Verizon inflow to the basin.

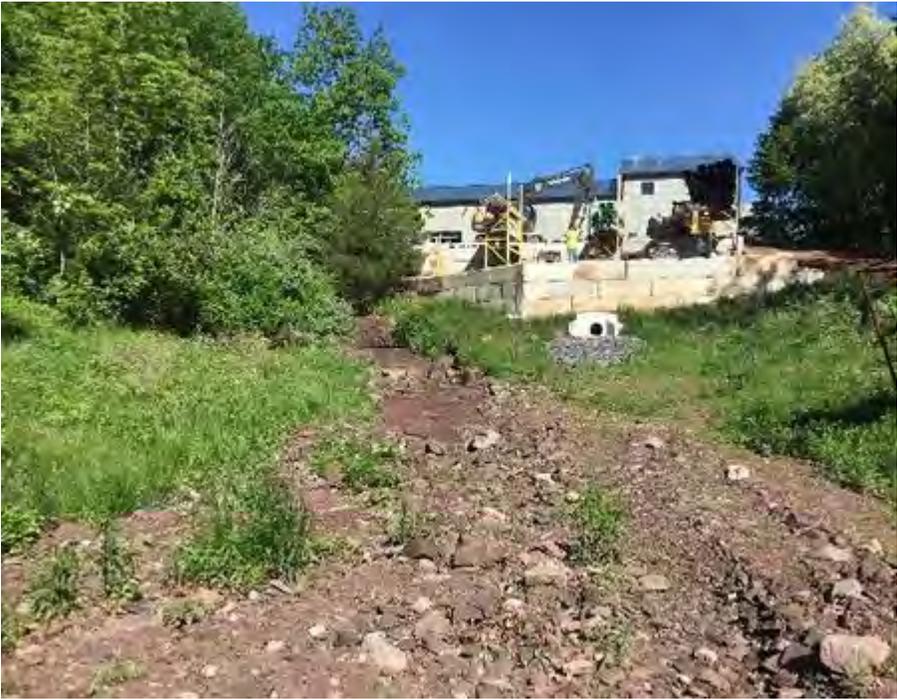
View facing the inflow swale to the basin.			
Violation Type (if applicable): Eroded swale and sediment deposits.

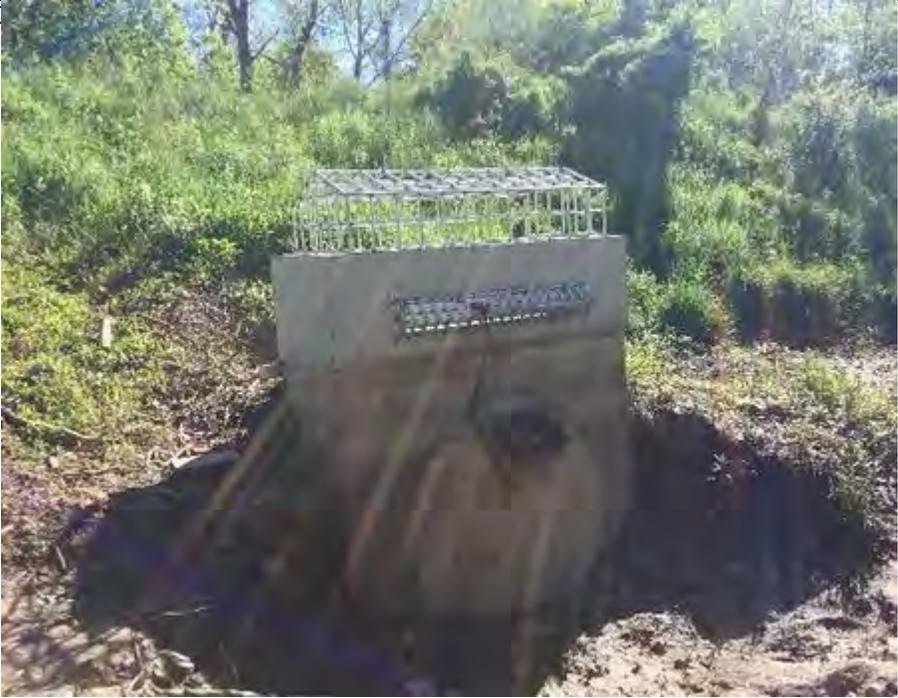
Description			
View of the riser.			
Violation Type (if applicable):			
Photo No. 4	Date: 05/12/2021

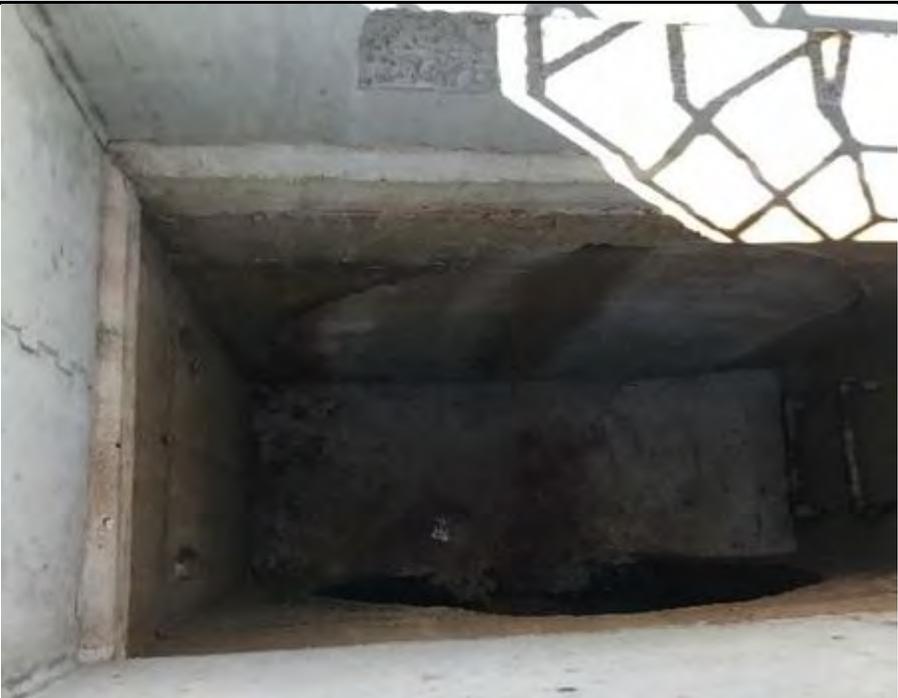
Description			
View inside the riser structure.			
Violation Type (if applicable):

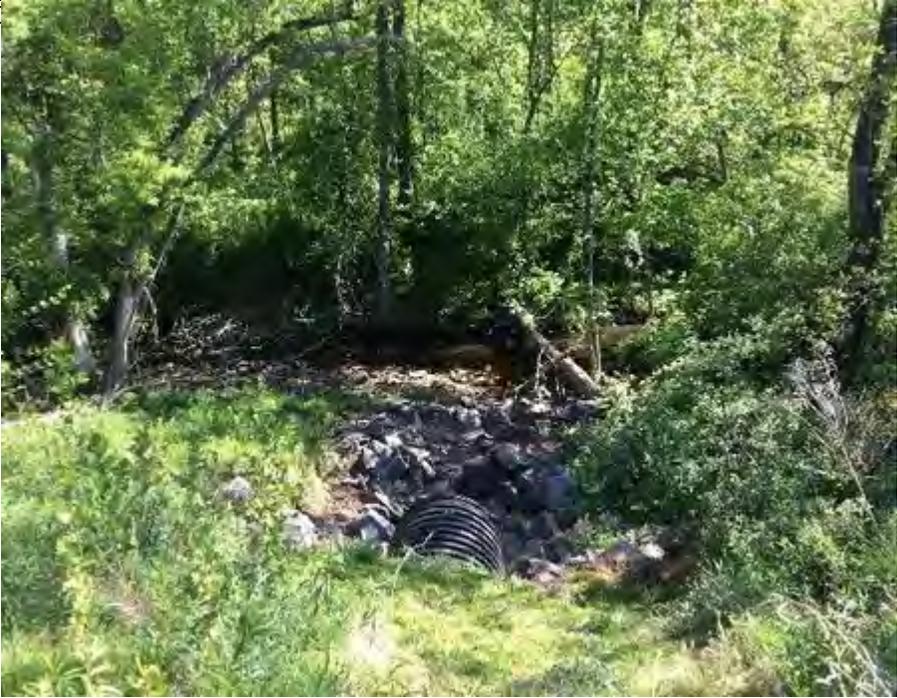
Description			
View facing downstream of the outlet pipe towards the creek.			
Violation Type (if applicable):			
Photo No. 6	Date: 05/12/2021
