RE: 2021 Annual MS4 Status Report  
NPDES Permit No. PAG130006  
West Norriton Township, Montgomery County  
WNR-21-006

# **ANNUAL MUNICIPAL SEPARATE STORM SEWER SYSTEM (MS4) STATUS REPORT**

West Norriton Township  
Montgomery County, PA  
1630 W. Marshall Street  
Jeffersonville, PA 19403

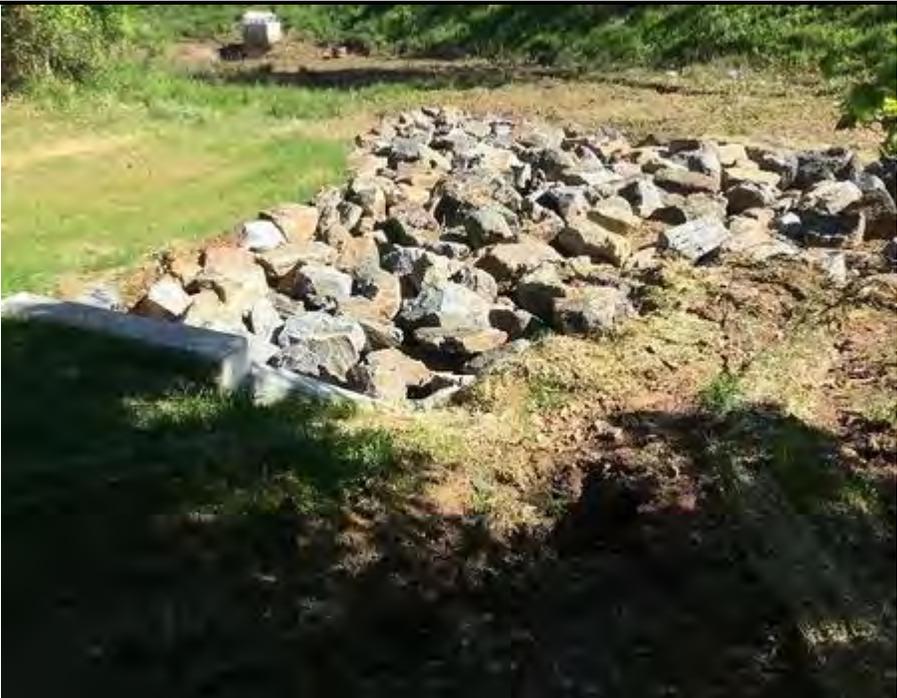
Description			
View of the Verizon inflow to the basin.			
Violation Type(if applicable):

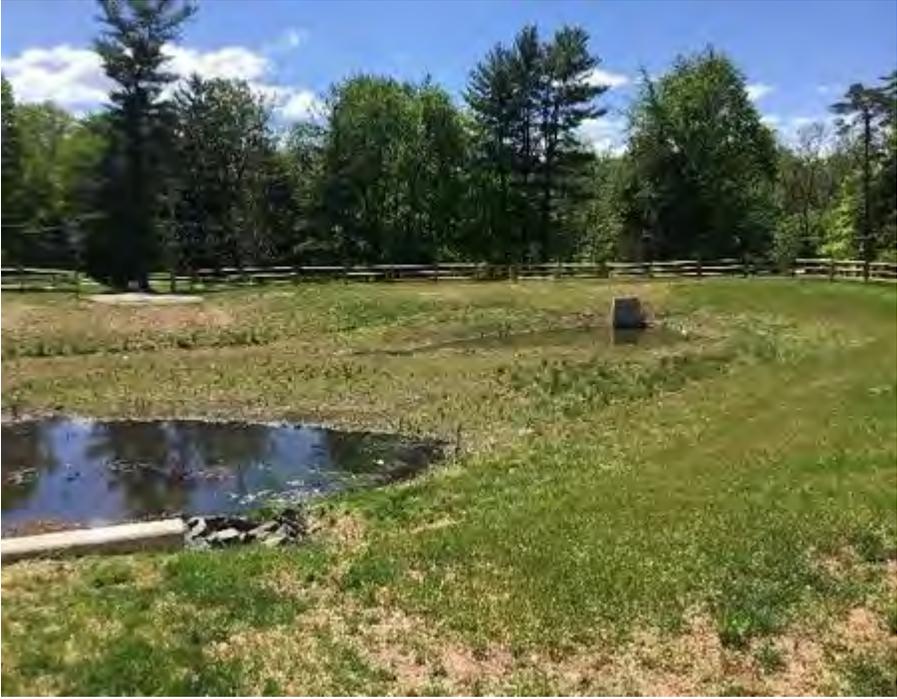
BMP #: X		BMP Type: Detention Basin	BMP Address: Alexander Dr. & Burnside Blvd
Photo No. 1	Date: 05/12/2021	Date:	
Description

Overall view of the BMP.			
Violation Type (if applicable):			
Photo No. 2	Date: 05/12/2021	Date:	
Description

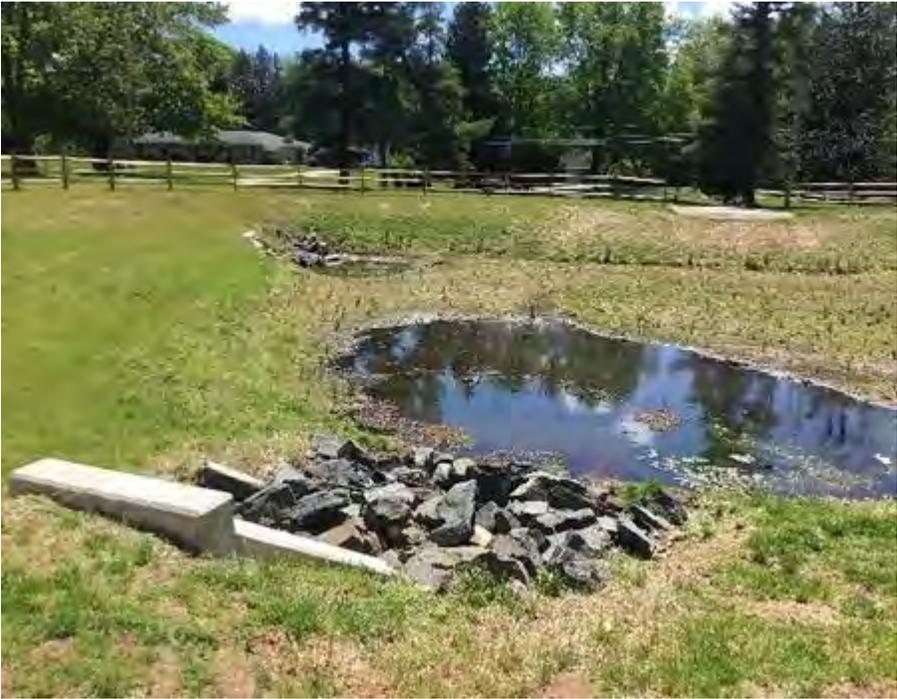
Overall view of the BMP.			
Violation Type (if applicable):

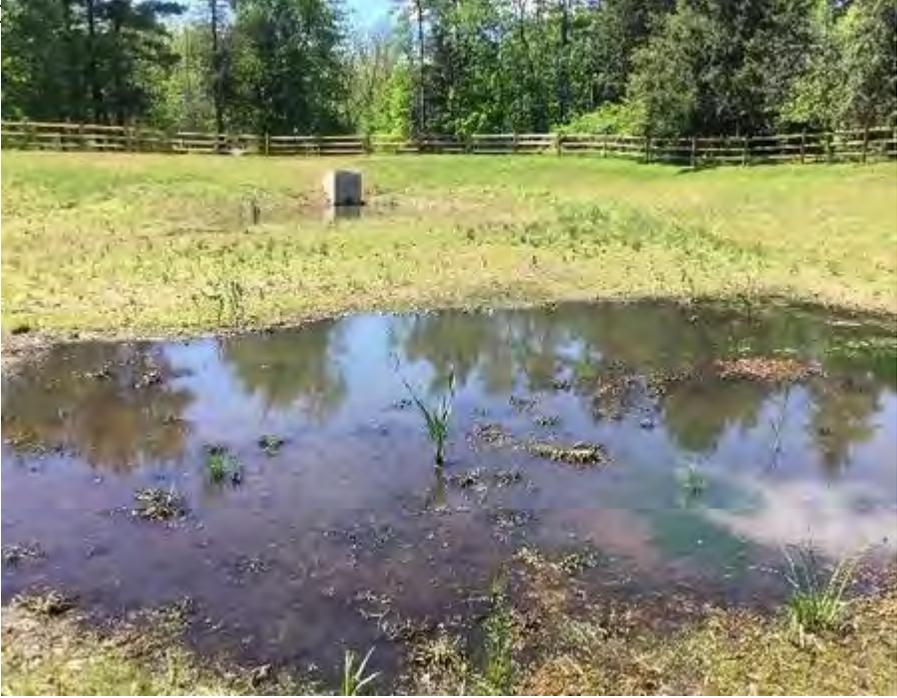
BMP #: X		BMP Type: Detention Basin	BMP Address: Alexander Dr. & Burnside Blvd
Photo No. 3	Date: 05/12/2021

The plant plugs in the micropools appear to have not completely survived. There are few plants located in the micropools. The plugs in the other locations appear to be thriving. The seed mix is not readily establishing. It is recommended that it be reseeded. Suggest clearing off debris from the riser inlet and orifice. There are erosion gullies leading into the outlet structure micropool that need to be stabilized. It is recommended that the Township waits until the end of the maintenance bond performance period to remediate in case there are any other items that need to be addressed. The silt sock closest to Burnside Ave still remains and should be removed.

Description			
View of the micro pools.			
Violation Type (if applicable):			
Photo No. 4	Date: 05/12/2021

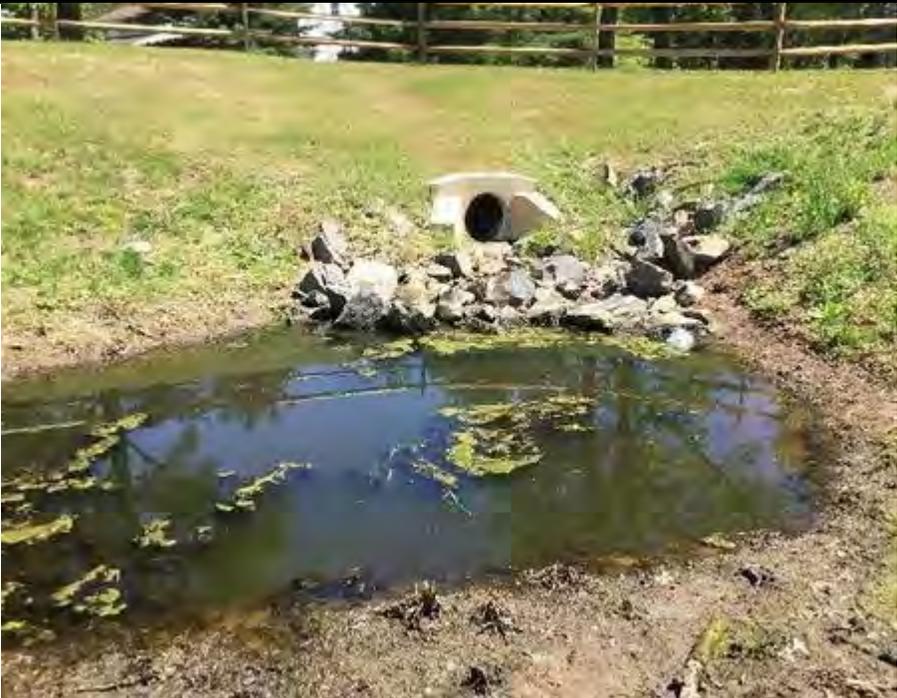
Description			
View of the inflow to the basin. Lack of plugs in the micropool.			
Violation Type (if applicable):

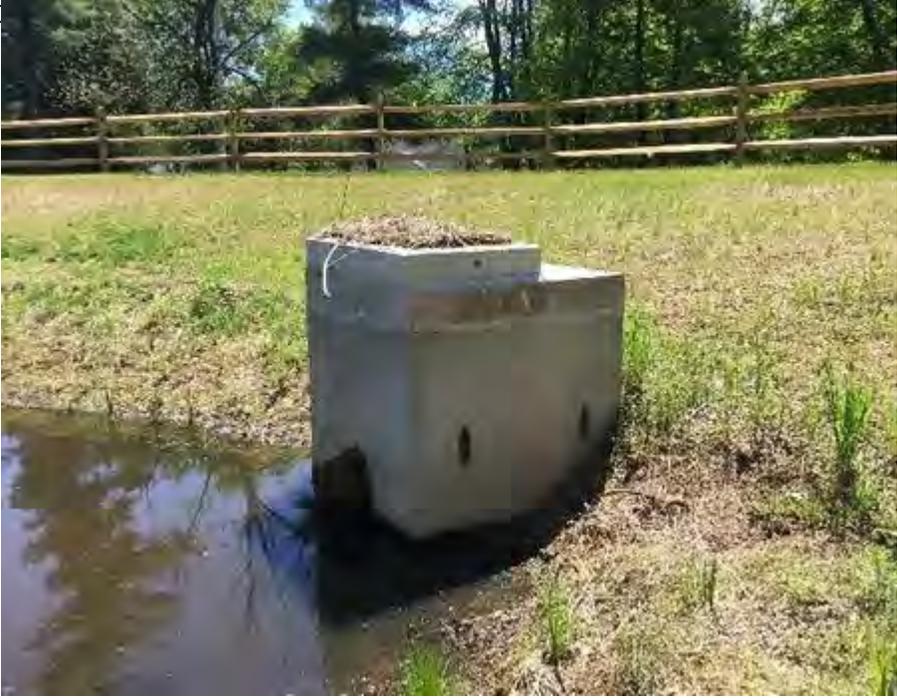
BMP #: X		BMP Type: Detention Basin	BMP Address: Alexander Dr. & Burnside Blvd
Photo No. 5	Date: 05/12/2021

Description			
View of the riser structure with debris covering the orifice and the top inlet grate.			
Violation Type (if applicable):			
Photo No. 6	Date: 05/12/2021

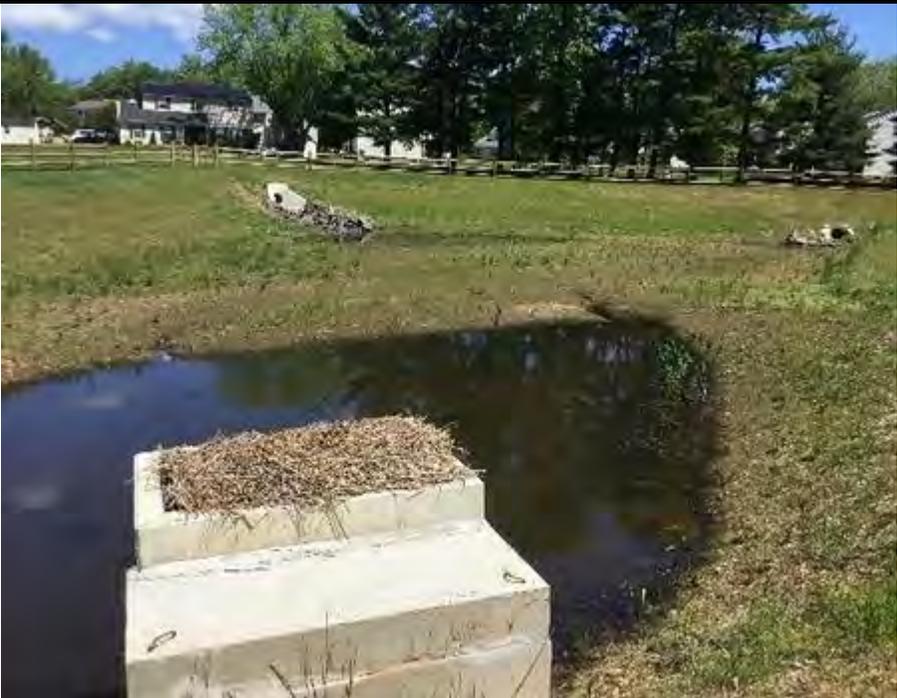
Description			
Overview of the basin and the erosion gullies leading into the outlet micropool.			
Violation Type(if applicable):

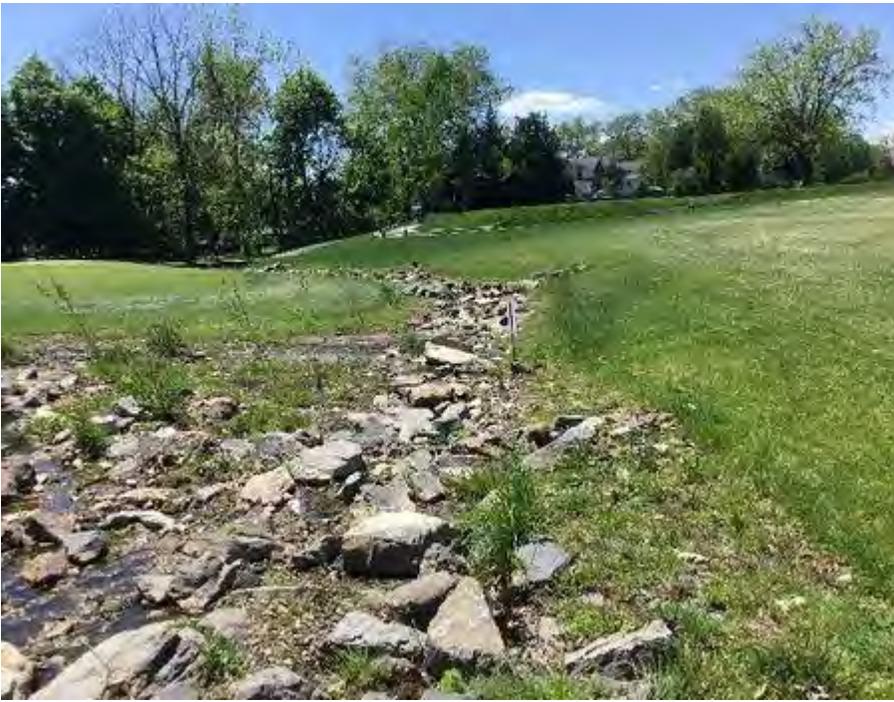
BMP #: Hole 2		BMP Type: Stream Restoration	BMP Address: 2400 W Main Street
Photo No. <b>1</b>	Date: 05/13/2021	Date:	
Description

Overview of the stream restoration.			
Violation Type (if applicable):			
Photo No. <b>2</b>	Date: 05/13/2021	Date:	
Description

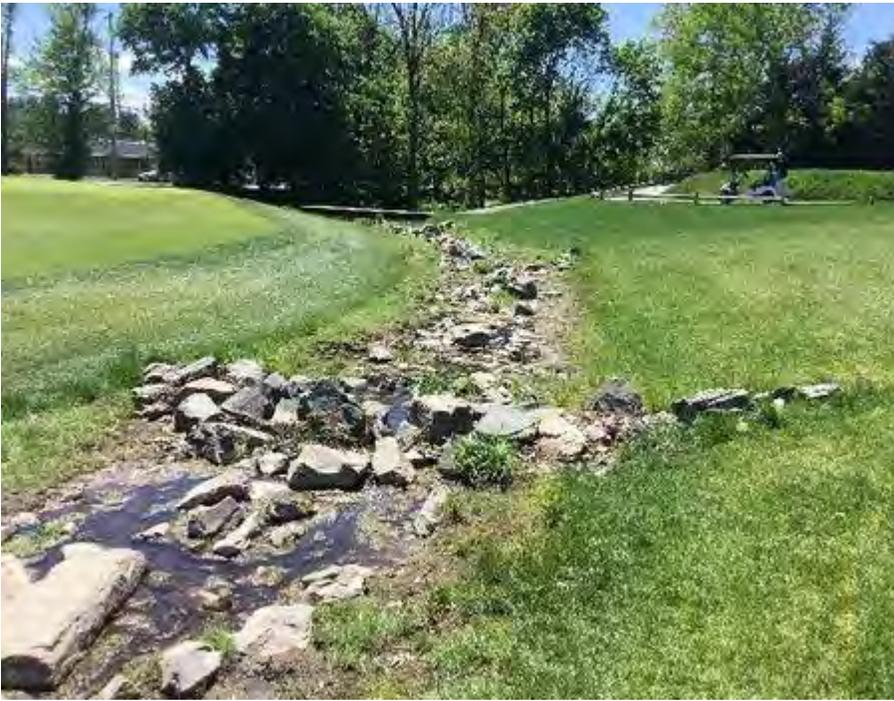
Overview of the stream restoration.			
Violation Type (if applicable):

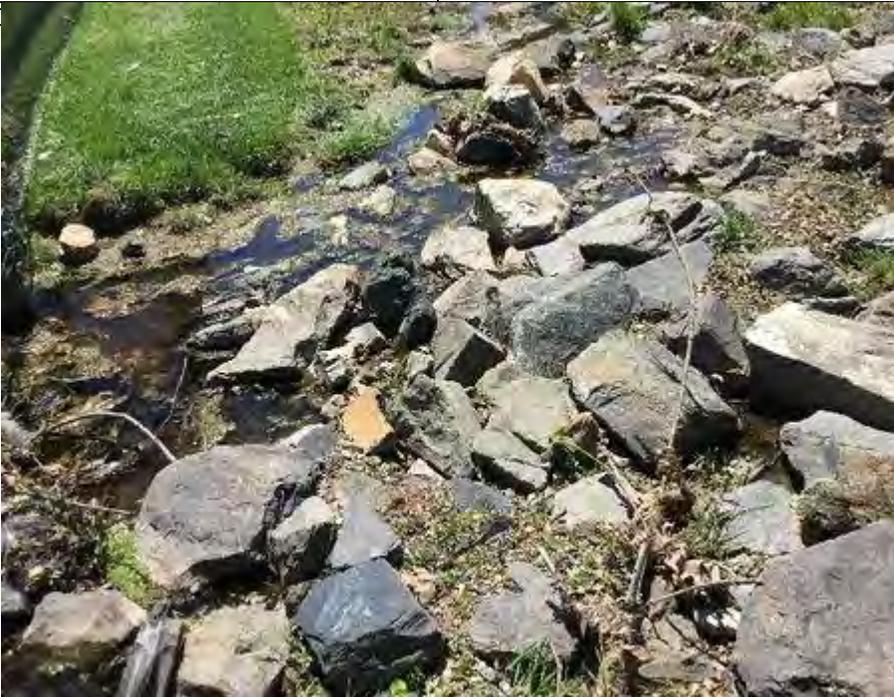
BMP #: Hole 2		BMP Type: Stream Restoration	BMP Address: 2400 W Main Street
Photo No. 3	Date: 05/13/2021

The woodland and raingarden seed mixes do not appear to have been established and/or maintained per plan. The streambed appears to consist entirely of R-4 rip-rap and not any reused existing streambed material. Some algal growth was observed in the stream channel and buffer area as well.

Description			
View of the stream bed material.			
Violation Type (if applicable):			
Photo No. 4	Date: 05/13/2021

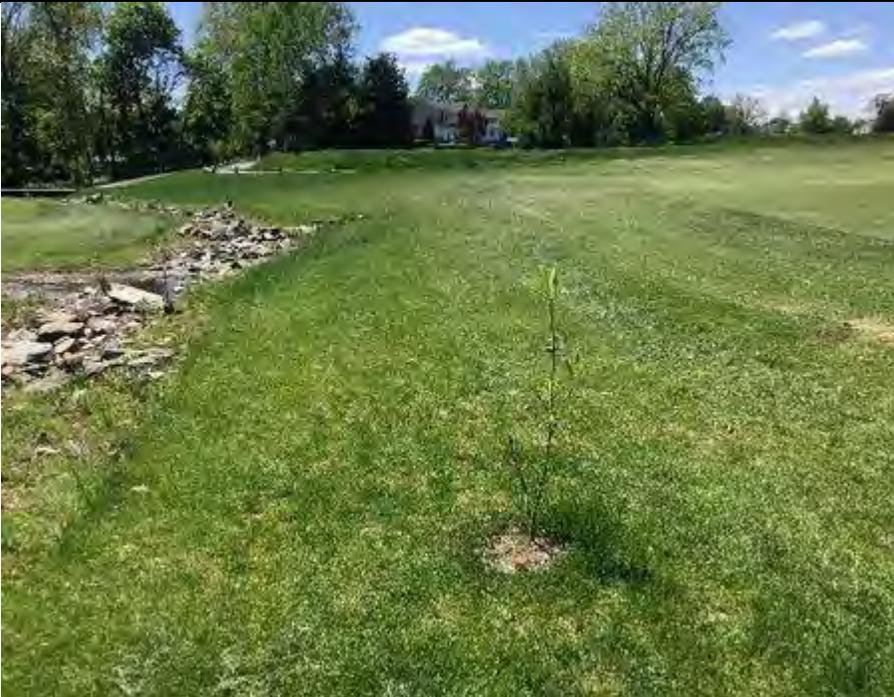
Description			
View of the vegetation on the berm of the stream restoration.			
Violation Type (if applicable):
