RE: West Norriton Township Annual MS4 Status Report
NPDES Permit No. PAG130006
West Norriton Township, Montgomery County
233-22-0007

ANNUAL MUNICIPAL SEPARATE STORM SEWER SYSTEM (MS4) STATUS REPORT

West Norriton Township

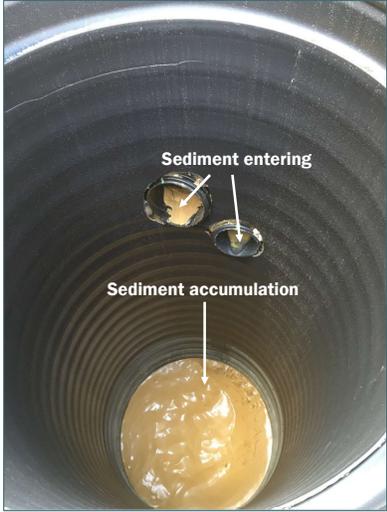
Sediment entering

Sediment accumulation

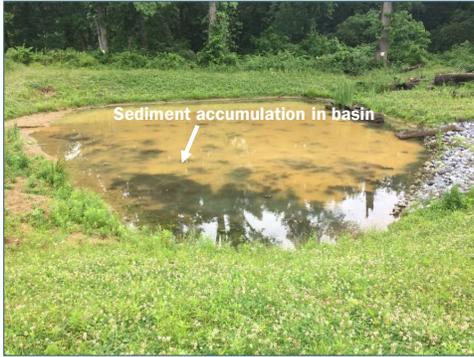
Sediment accumulation in basin

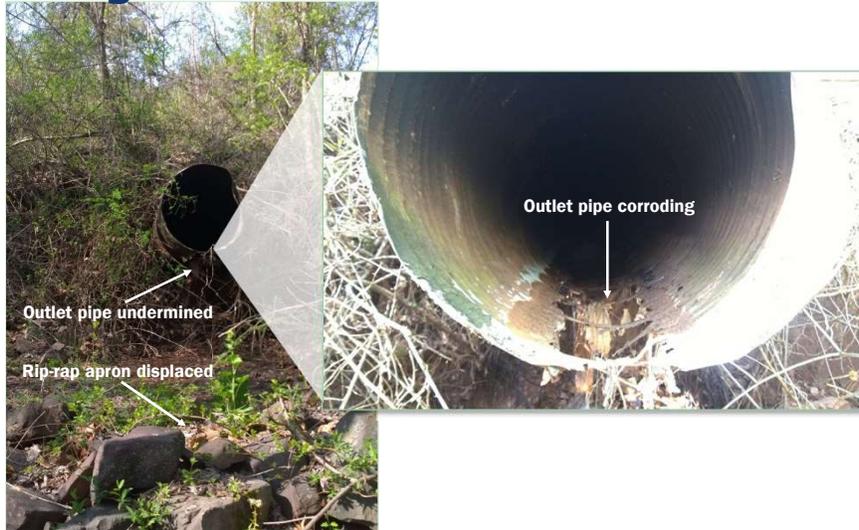
Deteriorating Structures

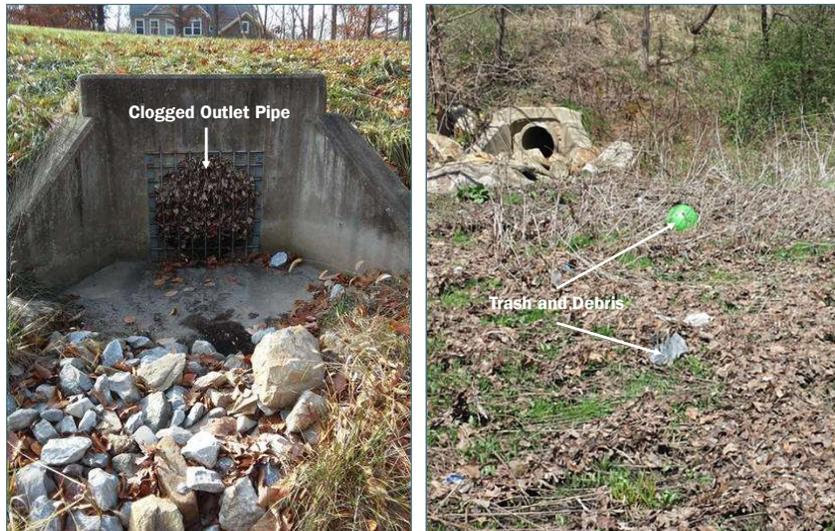
Debris and Trash Accumulation

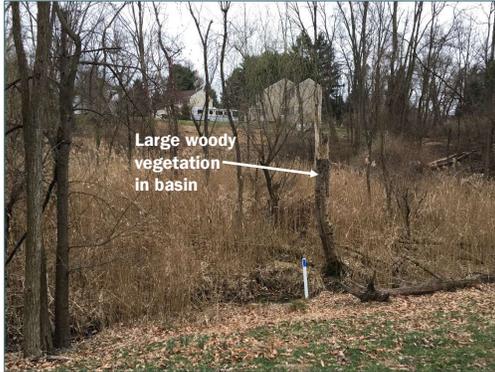
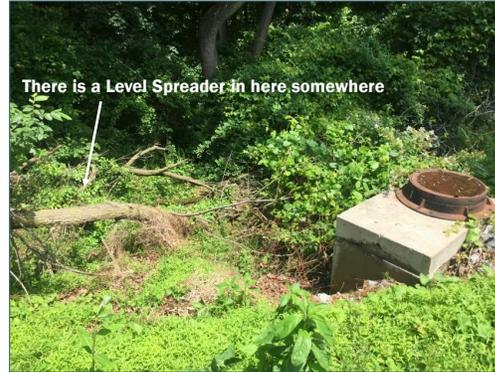
Excessive Vegetation

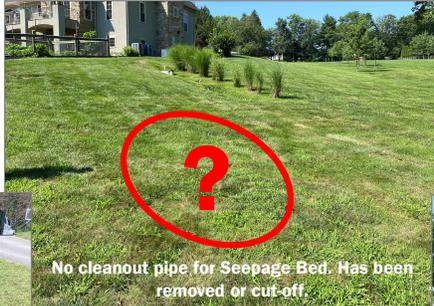
No cleanout pipe for Seepage Bed. Has been removed or cut-off.

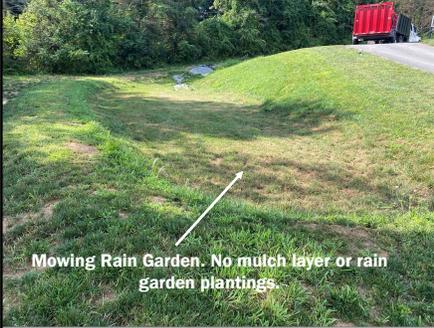
Mowing Rain Garden. No mulch layer or rain garden plantings.

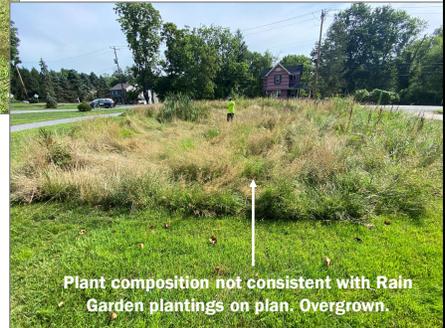
Plant composition not consistent with Rain Garden plantings on plan. Overgrown.

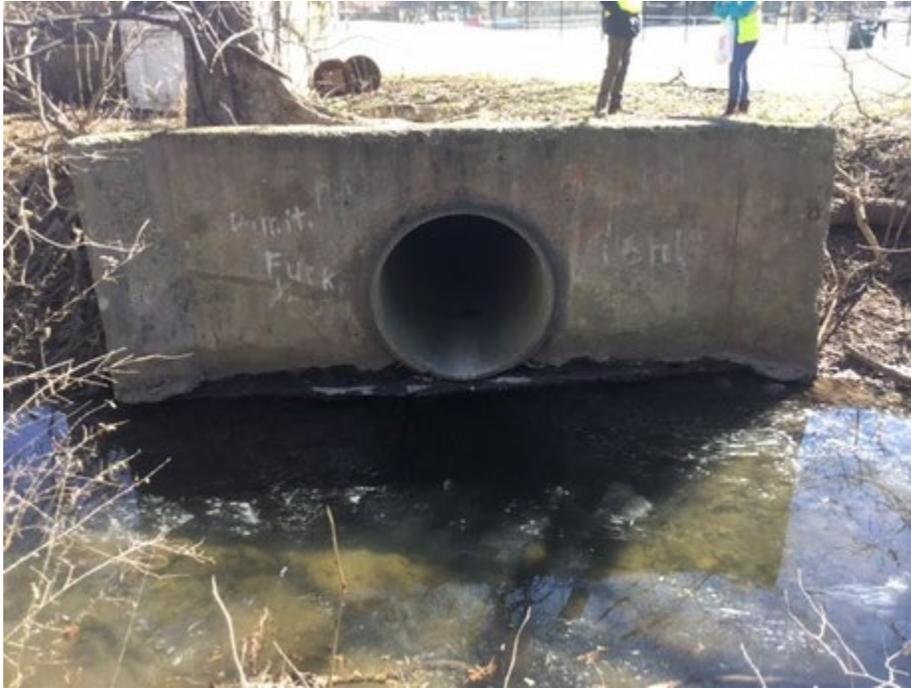
Photograph 2

Notes: Outfall 18 Appears to be compliant with the township's MS4 permit.

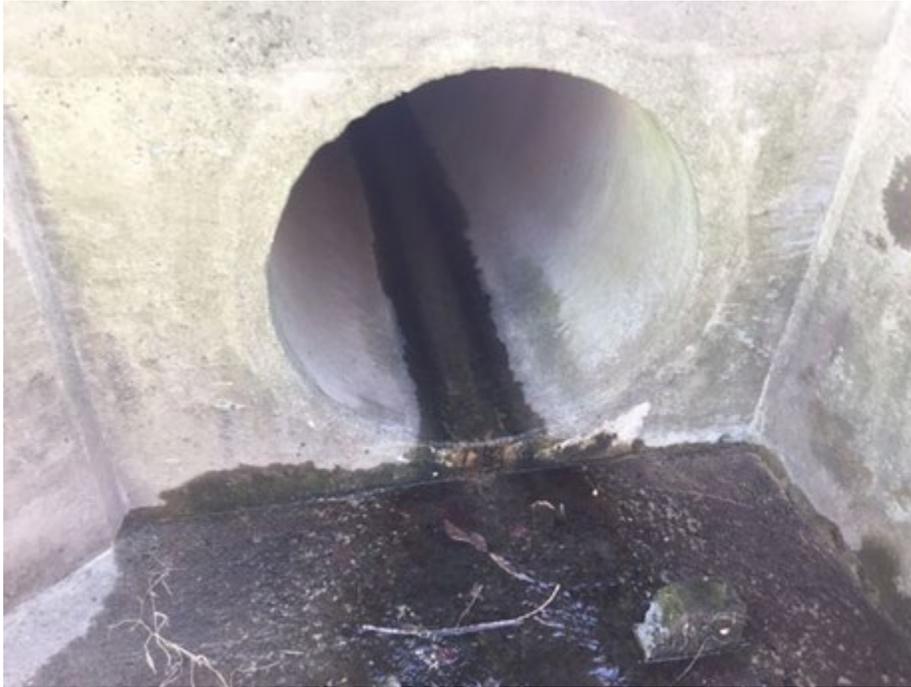
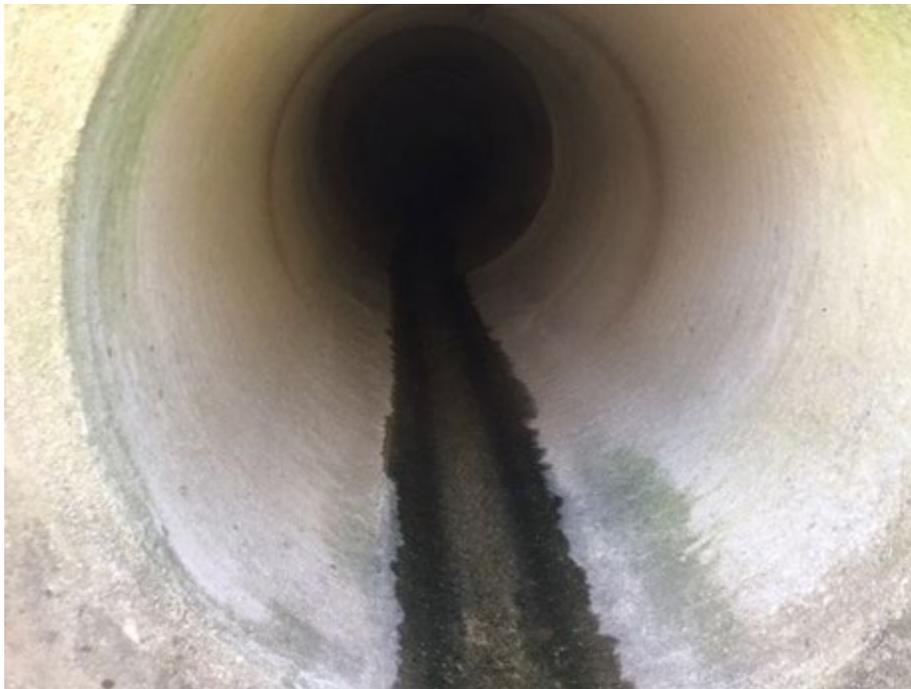
Indicator	Present?	Description	Comments
Outfall Damage		Energy dissipaters are damaged.	
Deposits/Stains			
Abnormal Vegetation			
Poor pool quality			
Pipe benthic growth

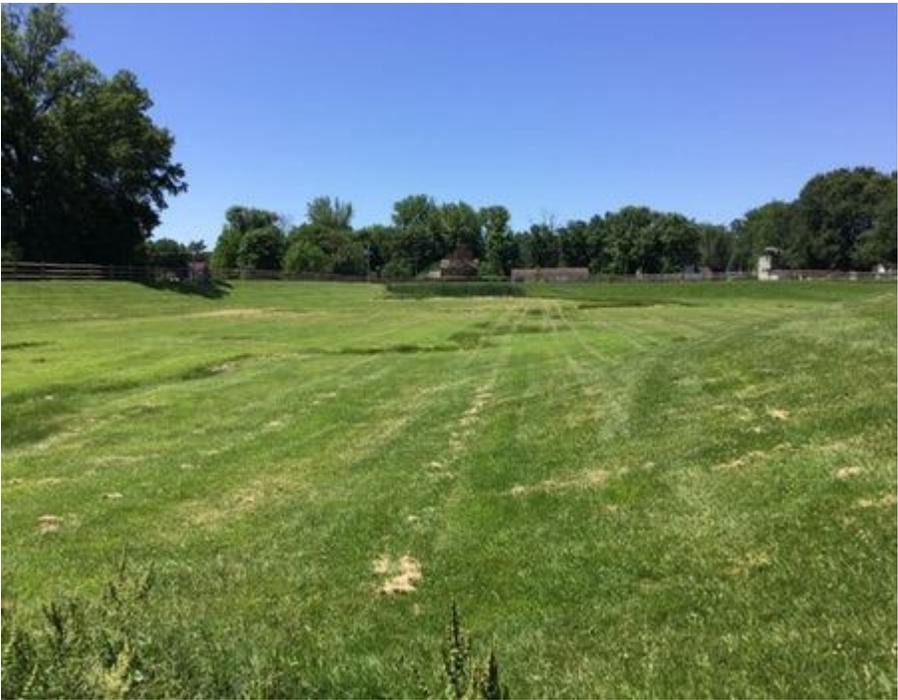
Overall view of the basin.			
Violation Type (if applicable):			
Photo No. 2	Date: 06/06/2022	Date:	
Description

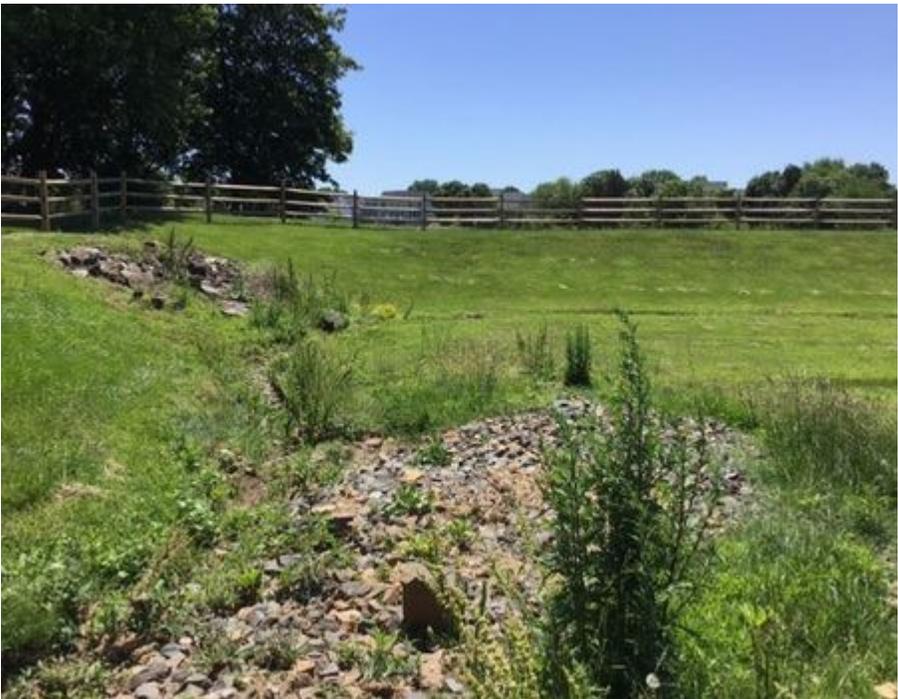
Overview of the basin.			
Violation Type (if applicable):

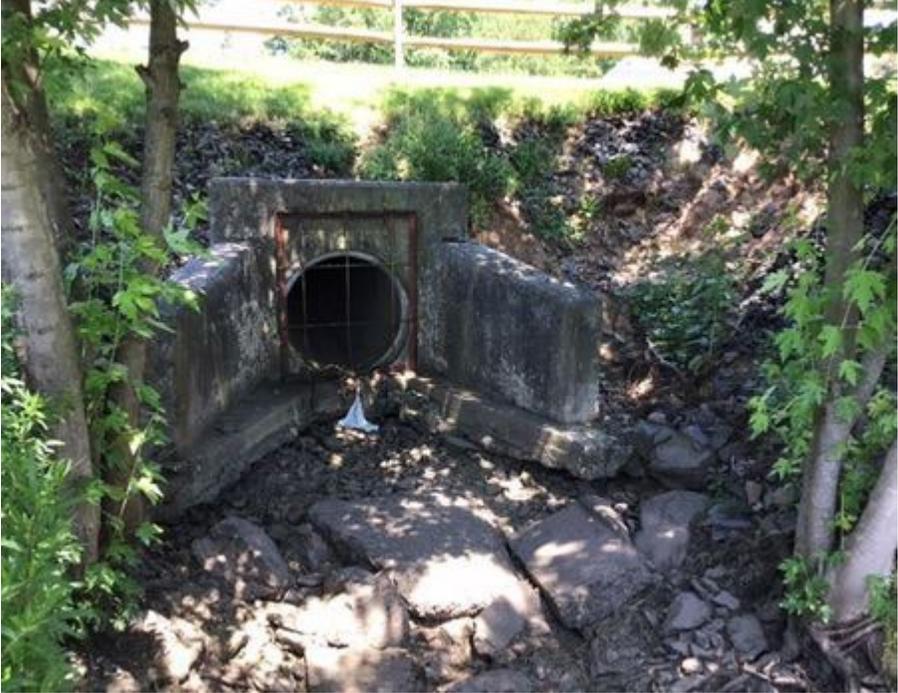
Inflow to the basin.			
Violation Type (if applicable): Large woody plants blocking the info to the basin.			
Photo No. 4	Date: 06/06/2022	Date:	
Description

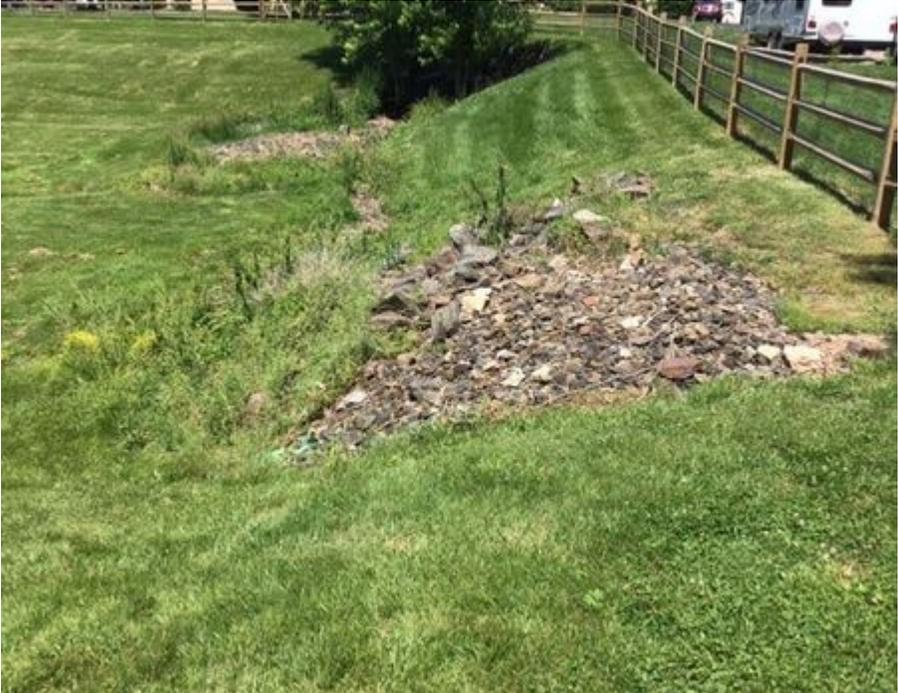
Overland flow inflow.			
Violation Type (if applicable):

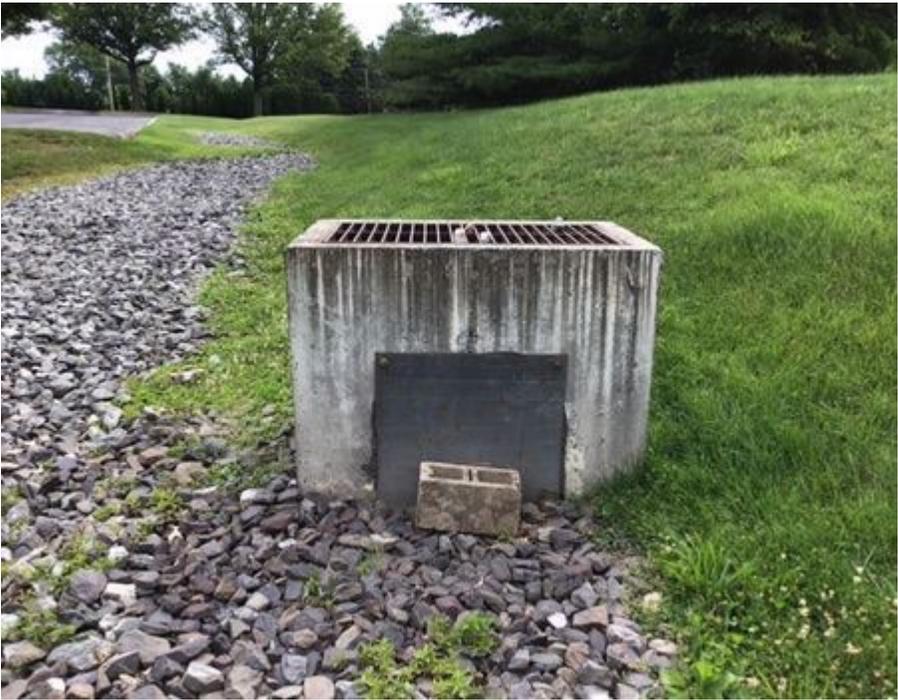
Description			
View of the riser structure.			
Violation Type (if applicable):

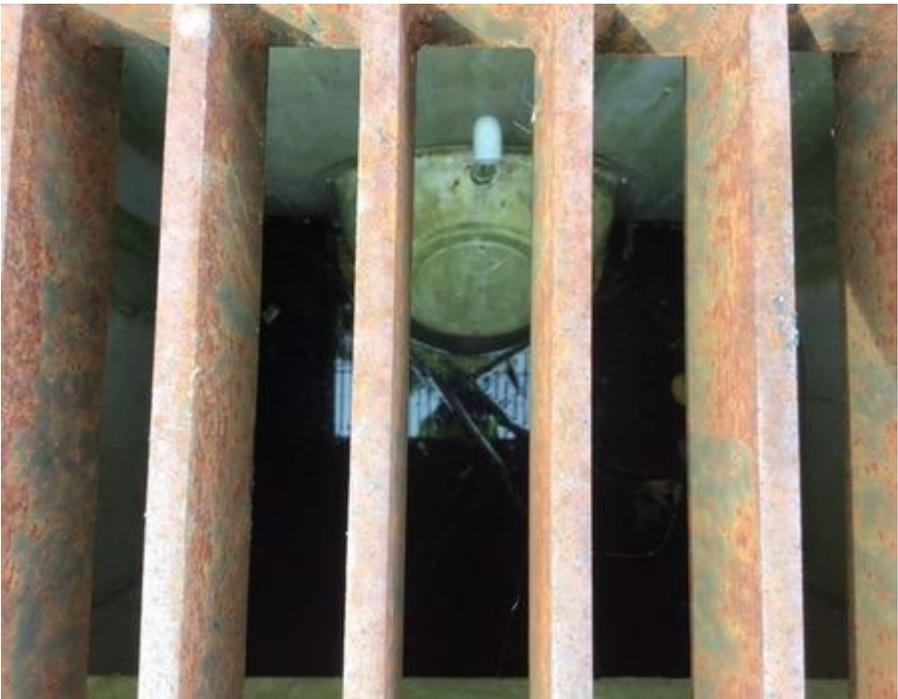
Description			
View of snout.			
Violation Type (if applicable):

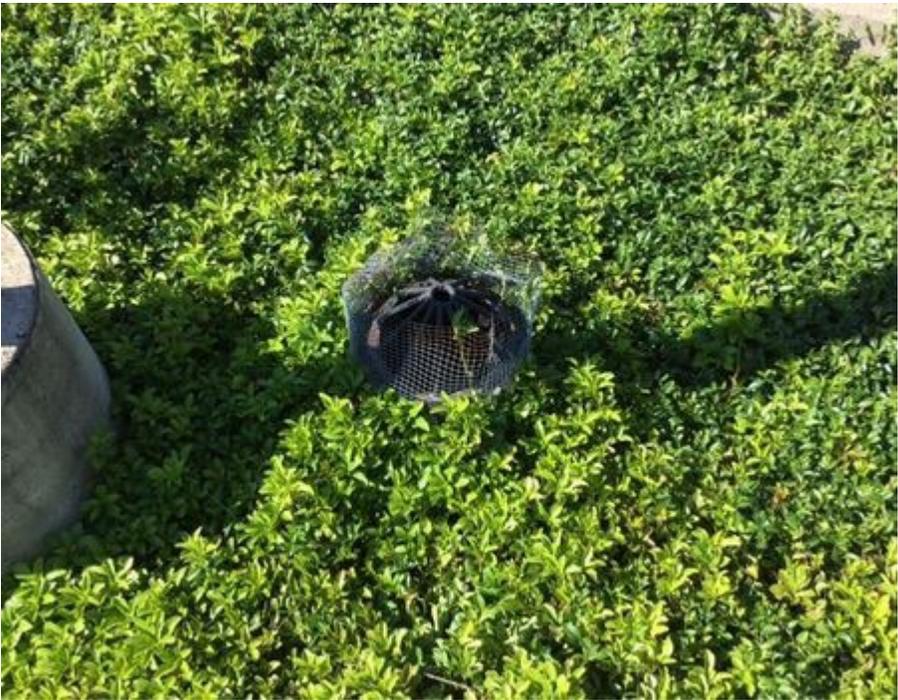
Description			
View of outlet riser.			
Violation Type (if applicable):			
Photo No. 2	Date: 06/06/2022

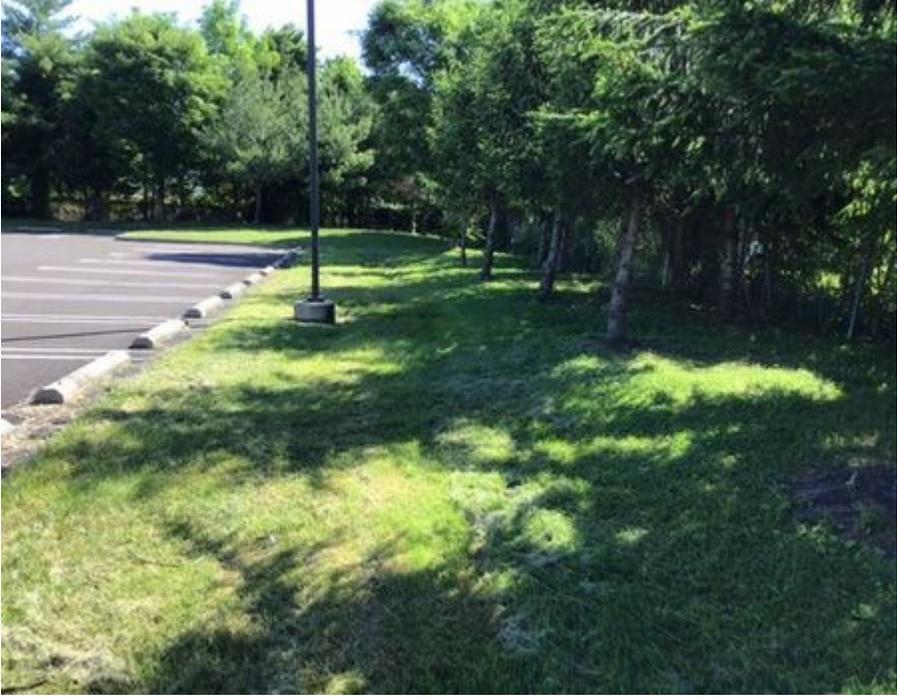
BMP #: 4A3		BMP Type: Rain Garden	BMP Address: 1911 W. Marshall St, Norristown, PA 19403
Photo No. 3	Date: 06/06/2022

Description			
View of the contributing drainage area.			
Violation Type (if applicable):			
Photo No. 4	Date: 06/06/2022

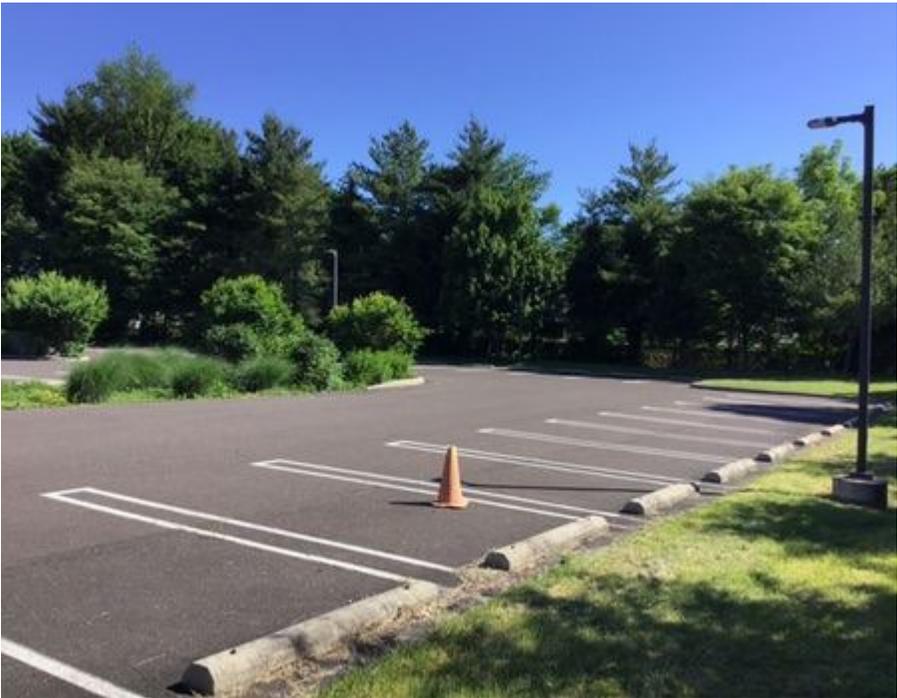
Description			
View of contributing drainage area.			
Violation Type (if applicable):

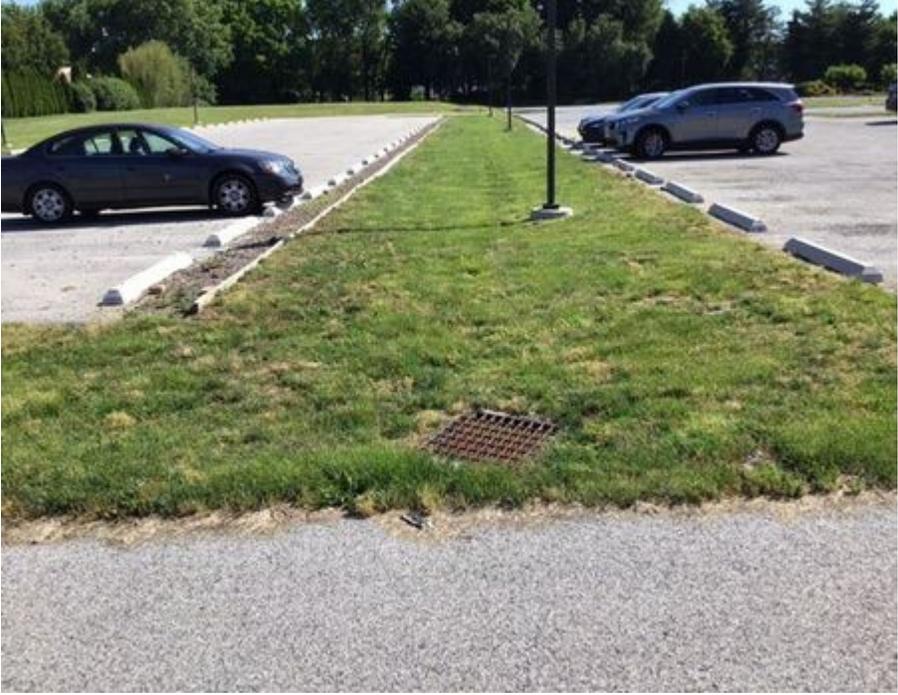
BMP #: 4B1		BMP Type: Infiltration Trench	BMP Address: 1911 W. Marshall St, Norristown, PA 19403
Photo No. 1	Date: 06/06/2022

Description			
Overall view of the BMP.			
Violation Type (if applicable):			
Photo No. 2	Date: 06/06/2022

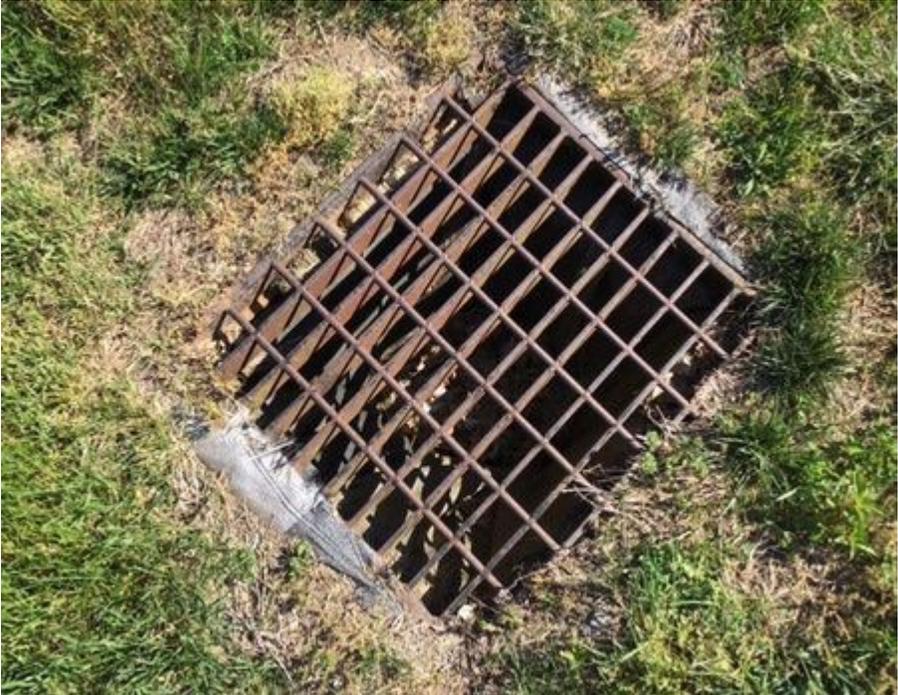
Description			
View BMP inlet.			
Violation Type (if applicable):

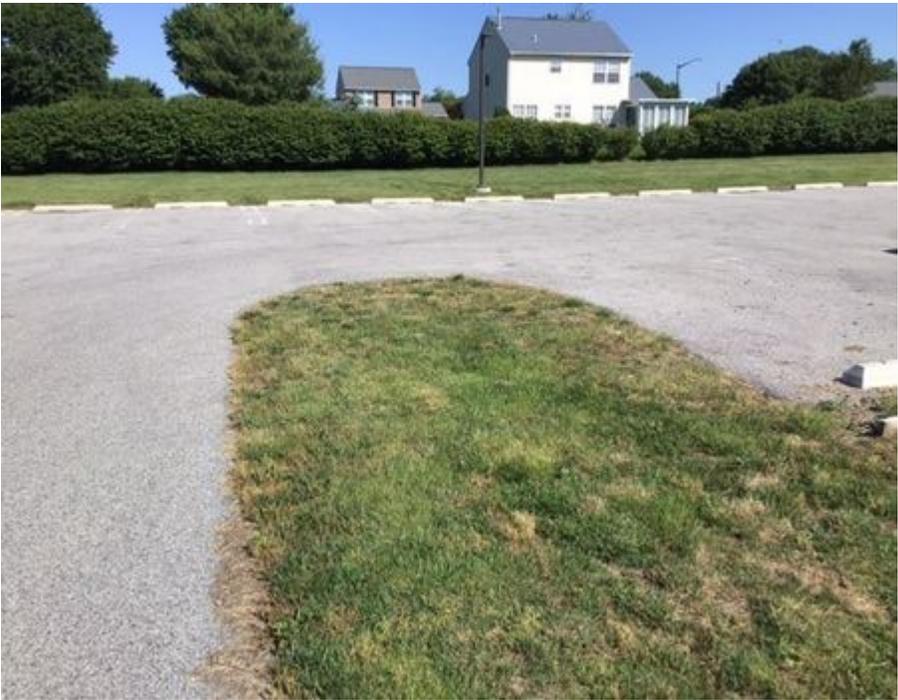
BMP #: 4B1		BMP Type: Infiltration Trench	BMP Address: 1911 W. Marshall St, Norristown, PA 19403
Photo No. 3	Date: 06/06/2022

Description			
View of contributing drainage area.			
Violation Type (if applicable):			
Photo No. 4	Date: 06/06/2022

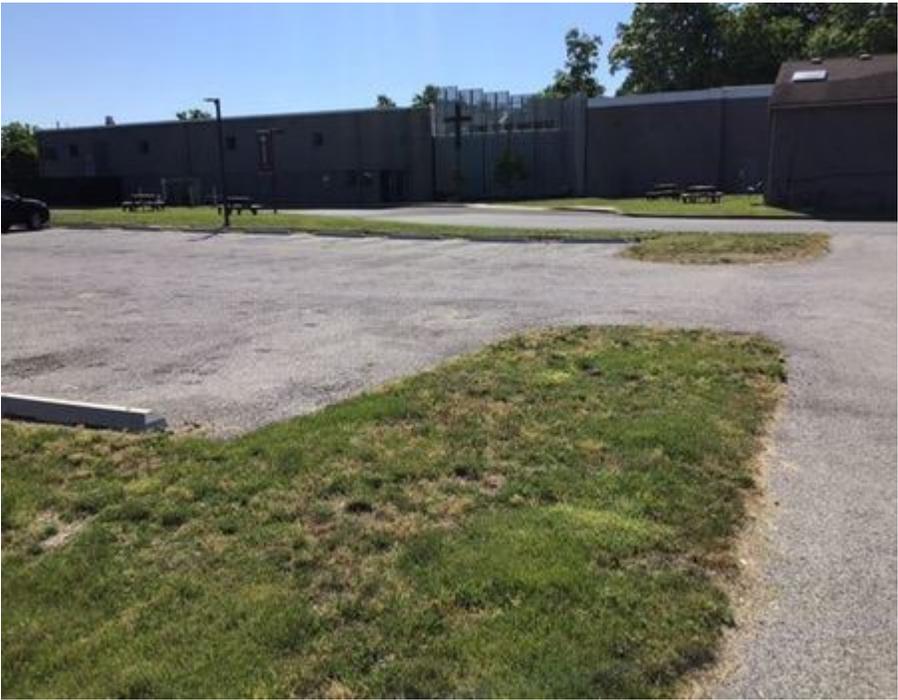
Description			
View of contributing drainage area.			
Violation Type (if applicable):

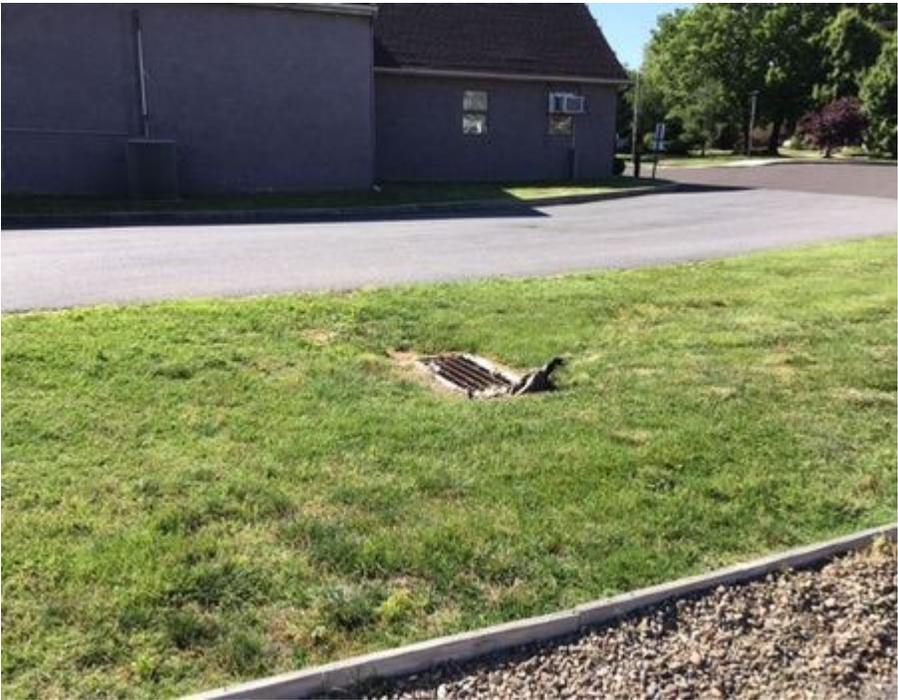
BMP #: 4B2		BMP Type: Infiltration Trench	BMP Address: 1911 W. Marshall St, Norristown, PA 19403
Photo No. 1	Date: 06/06/2022

Description			
Overall view of the BMP.			
Violation Type (if applicable):			
Photo No. 2	Date: 06/06/2022

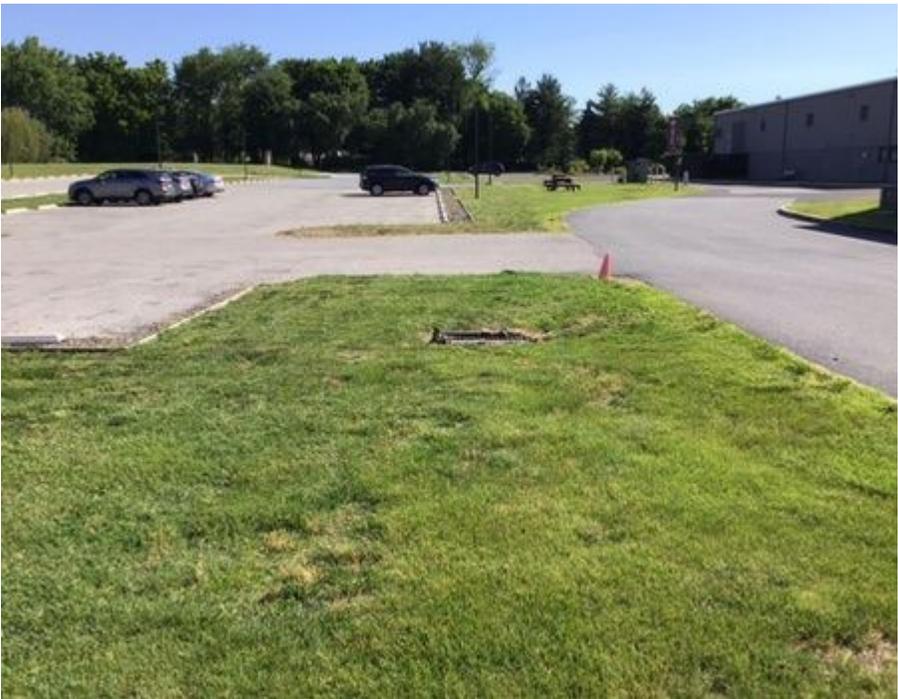
Description			
Overall view of the BMP.			
Violation Type (if applicable):

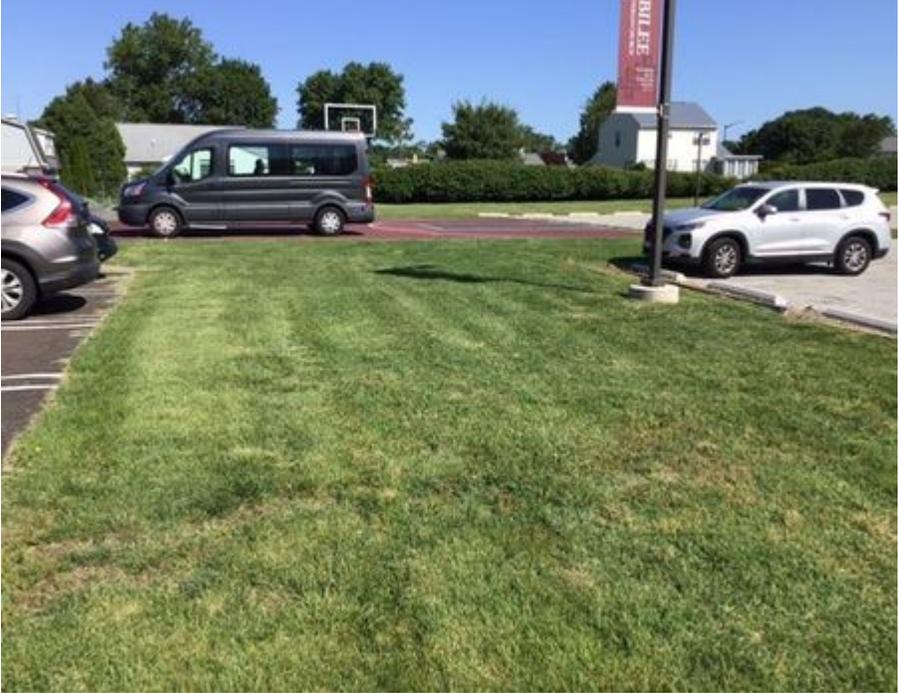
BMP #: 4B2		BMP Type: Infiltration Trench	BMP Address: 1911 W. Marshall St, Norristown, PA 19403
Photo No. 3	Date: 06/06/2022

Description			
View of the contributing drainage area.			
Violation Type (if applicable):			
Photo No. 4	Date: 06/06/2022

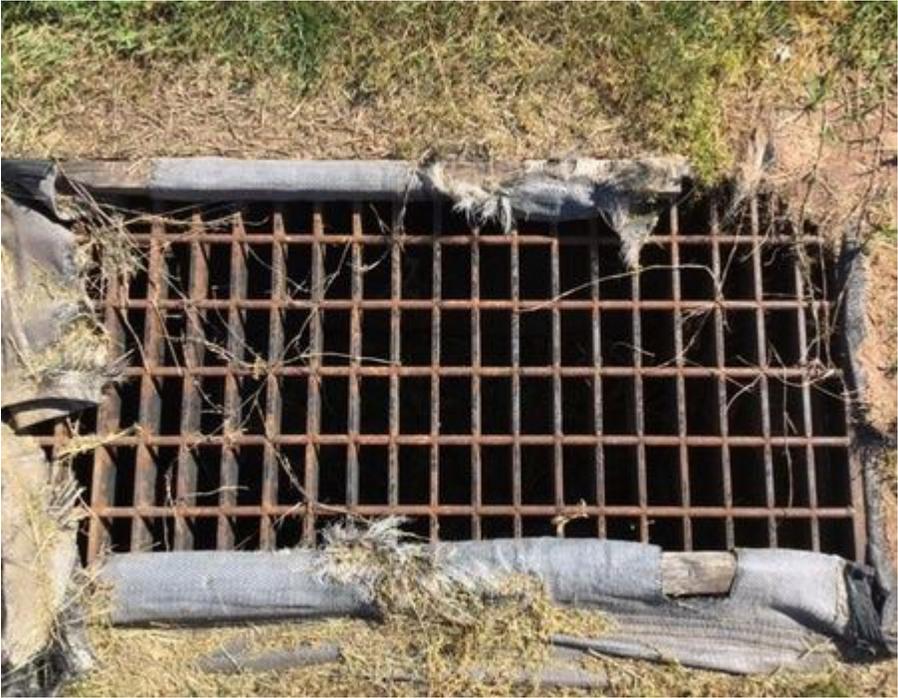
Description			
View of the inlet from the infiltration trench.			
Violation Type (if applicable):

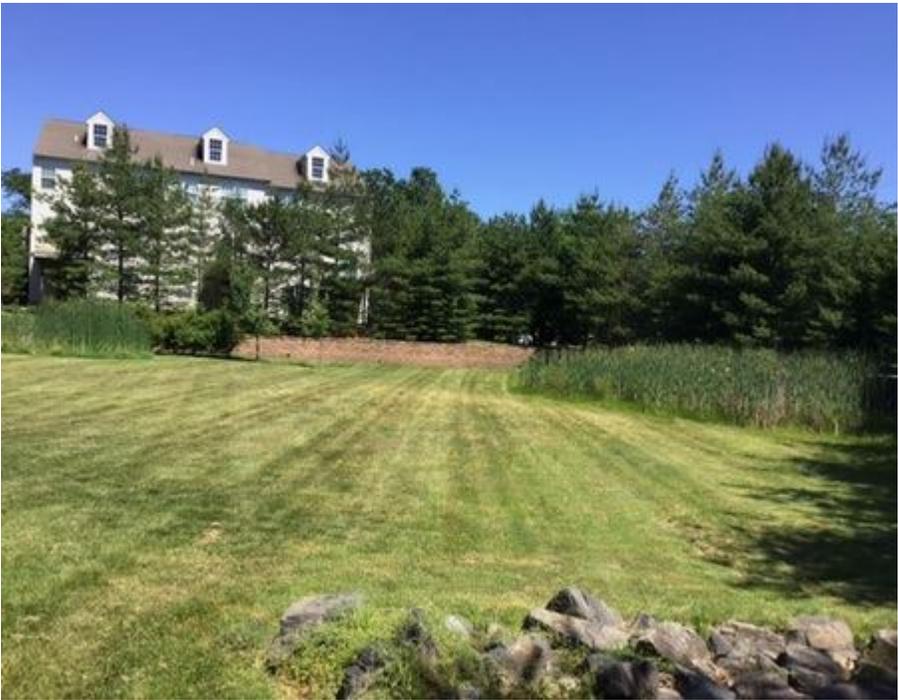
BMP #: 6		BMP Type: Detention Basin	BMP Address: 2000 Mill Rd, Norristown, PA 19403
Photo No. 1	Date: 06/06/2022	Date:	
Description

Overall view of the BMP.			
Violation Type (if applicable):			
Photo No. 2	Date: 06/06/2022	Date:	
Description

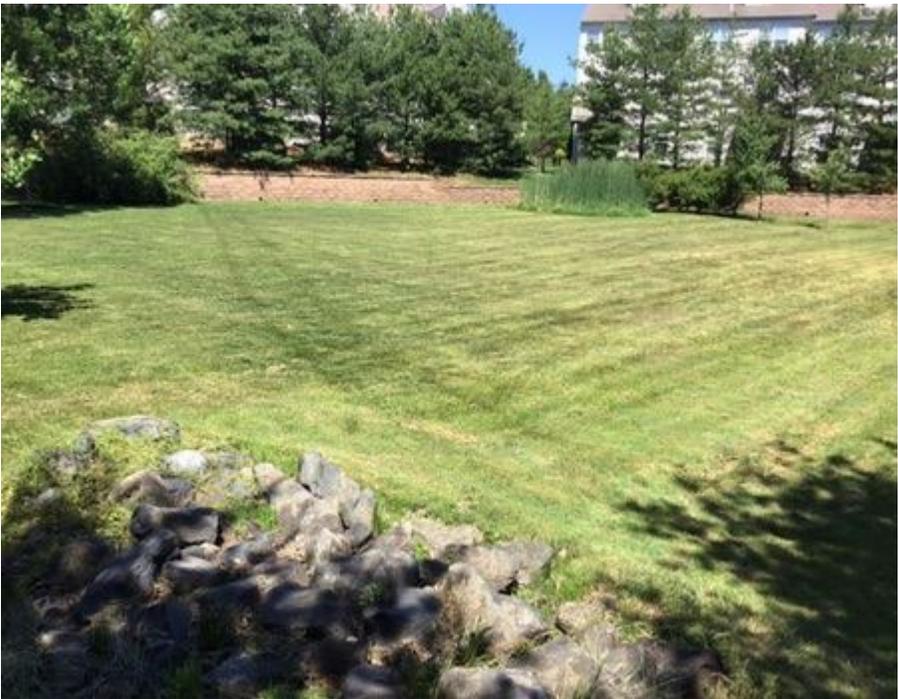
Overall view of the BMP.			
Violation Type (if applicable):

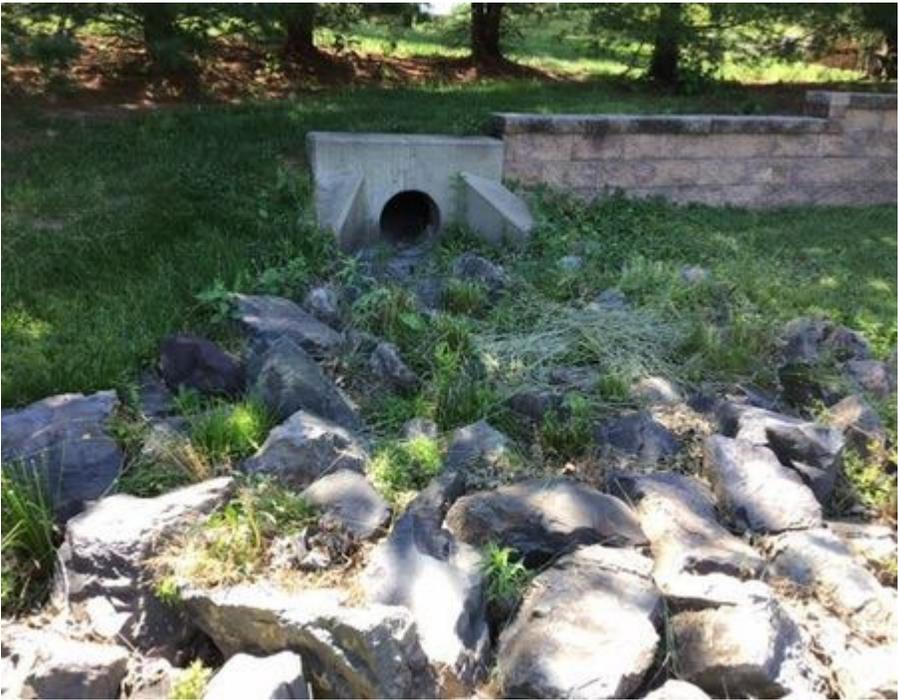
View of the structure leading to the BMP.			
Violation Type (if applicable):

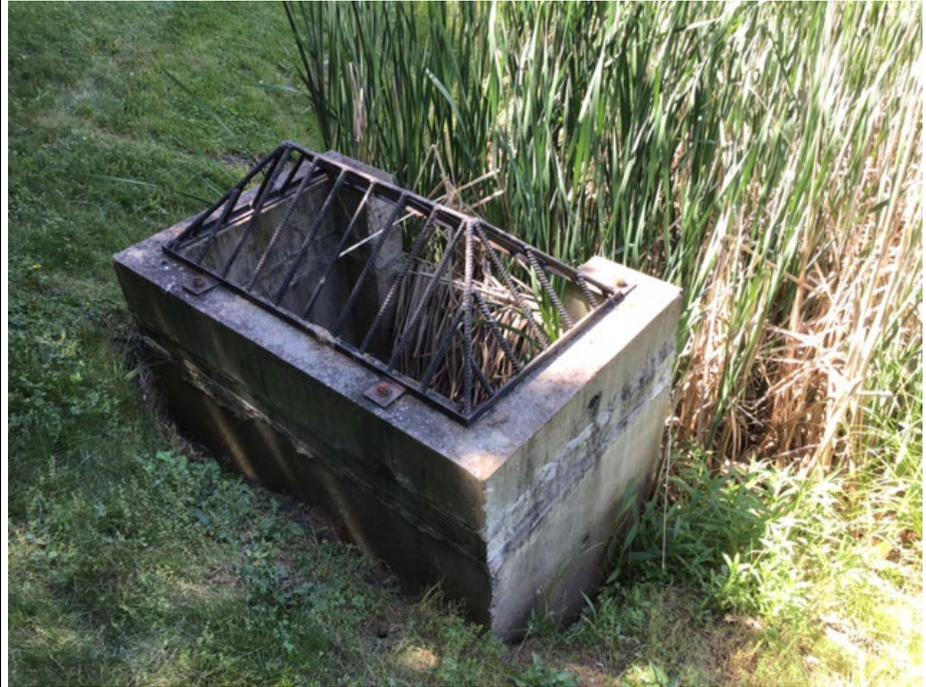
View of the outlet riser.			
Violation Type (if applicable):

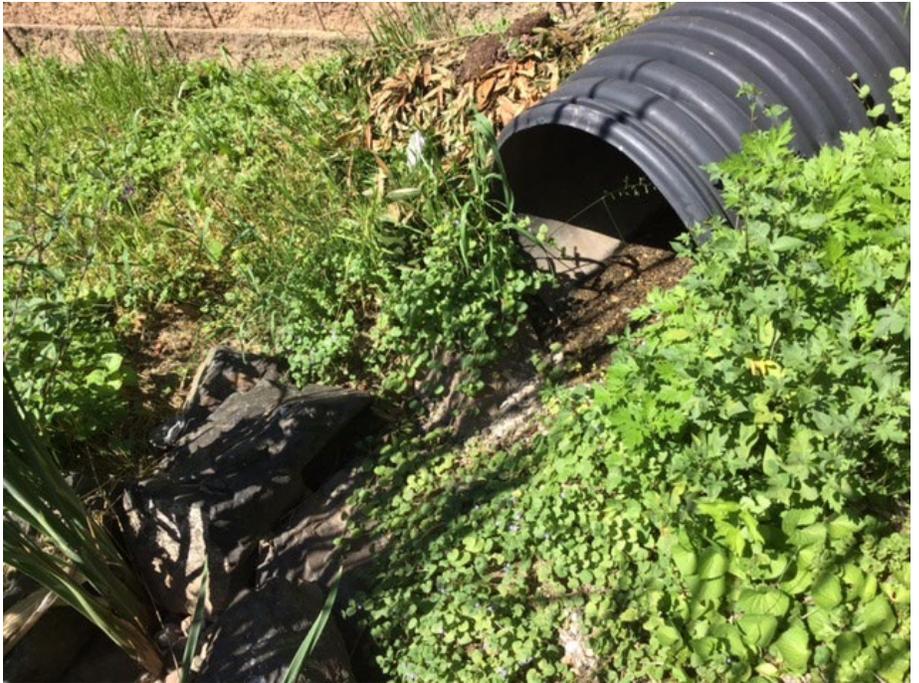
BMP #: 6		BMP Type: Detention Basin	BMP Address: 2000 Mill Rd, Norristown, PA 19403
Photo No. 7	Date: 06/06/2022	Date:	
Description

View of the inflow.			
Violation Type (if applicable):			
Photo No. 8	Date: 06/06/2022	Date:	
Description

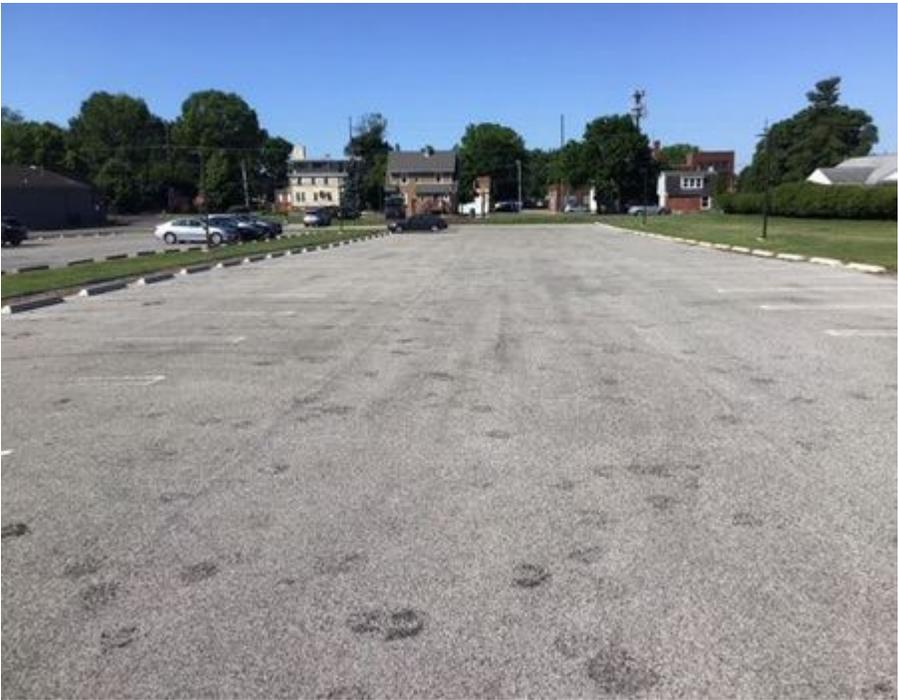
BMP #: 4C		BMP Type: Porous Paving	BMP Address: 1911 W. Marshall St, Norristown, PA 19403
Photo No. 1	Date: 06/06/2022

Description			
Overall view of the BMP.			
Violation Type (if applicable):			
Photo No. 2	Date: 06/06/2022

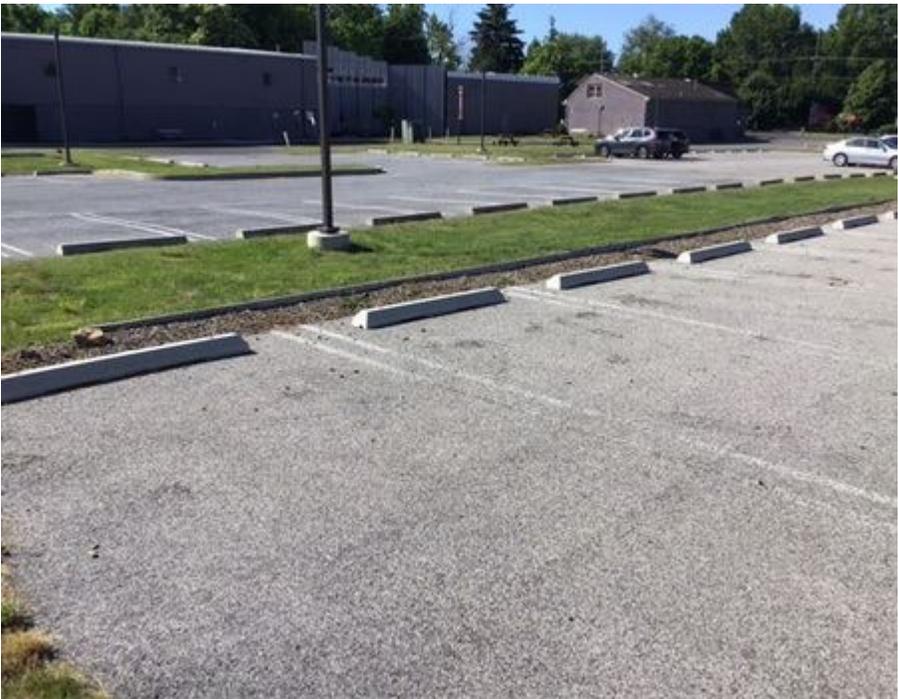
Description			
Overall view of the BMP.			
Violation Type (if applicable):

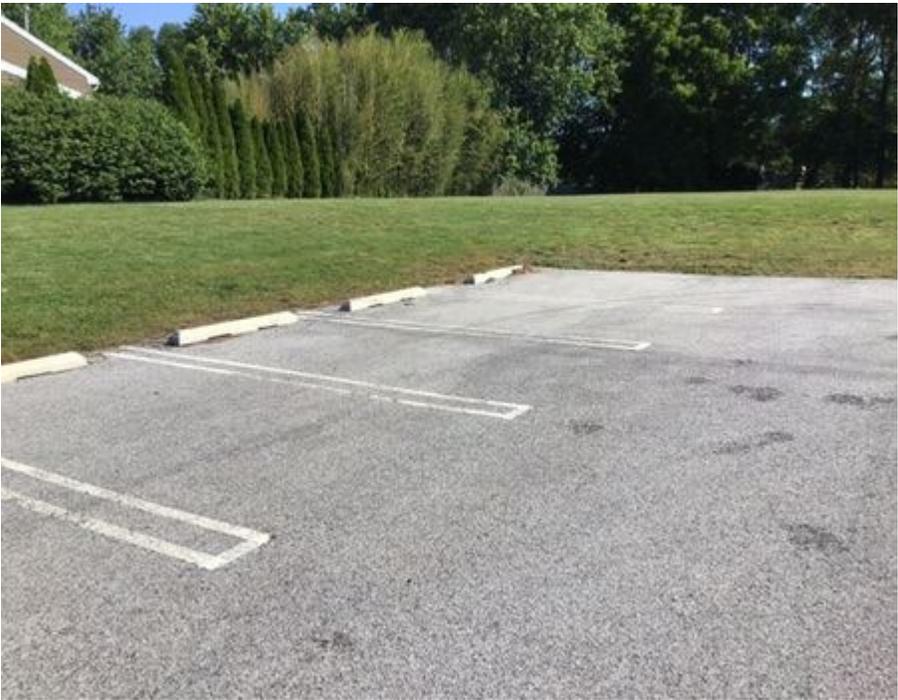
BMP #: 4C		BMP Type: Porous Paving	BMP Address: 1911 W. Marshall St, Norristown, PA 19403
Photo No. 3	Date: 06/06/2022

Description			
View of the contributing drainage area.			
Violation Type (if applicable):			
Photo No. 4	Date: 06/06/2022

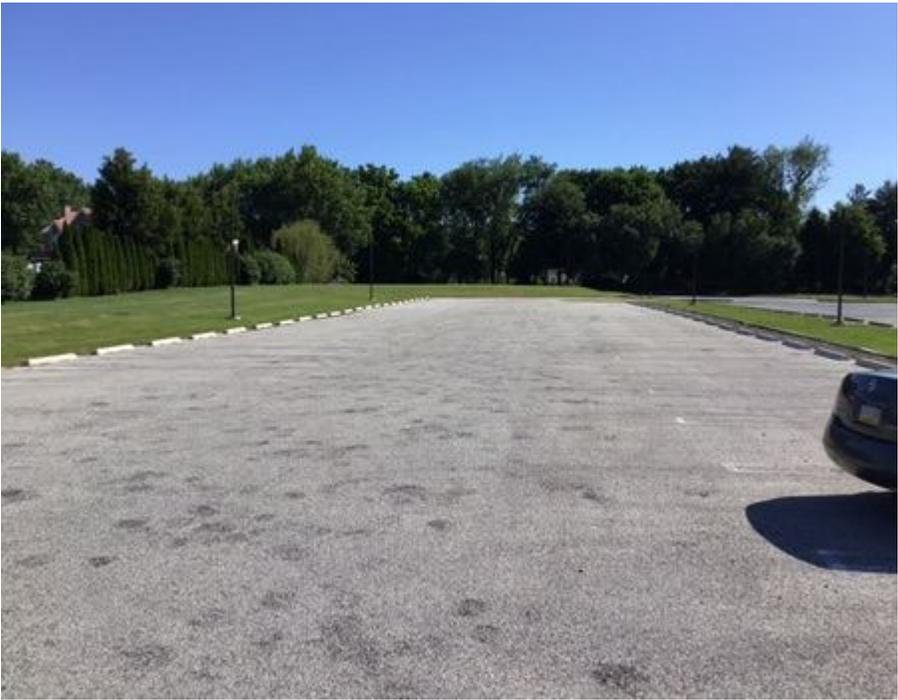
Description			
Overall view of the BMP.			
Violation Type (if applicable):

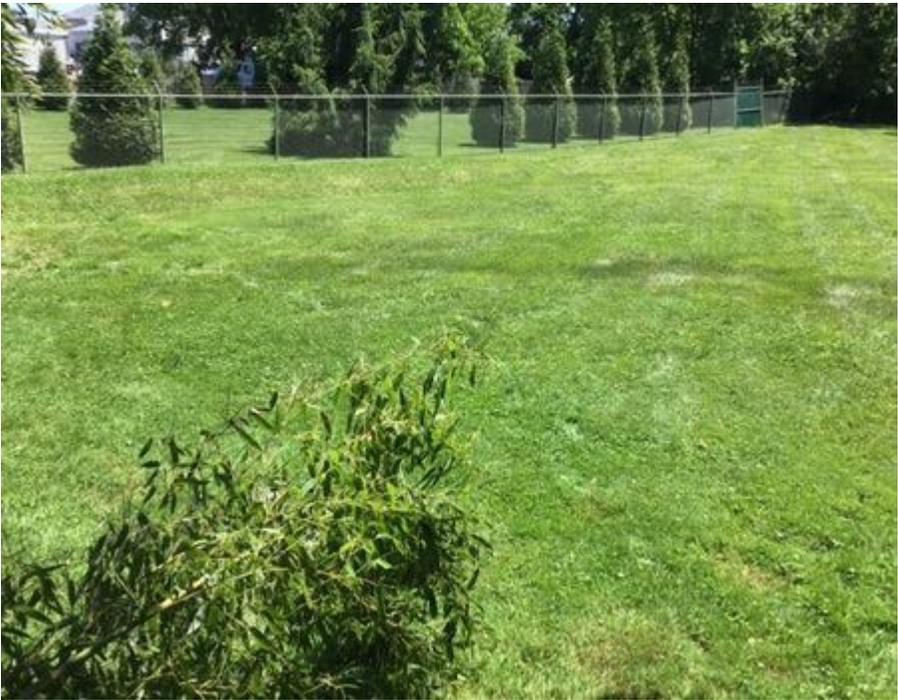
BMP #: 7		BMP Type: Detention Basin	BMP Address: 56 Liberty Ave, Eagleville, PA 19403
Photo No. 1	Date: 06/06/2022

Description			
Overall view of the BMP.			
Violation Type (if applicable):			
Photo No. 2	Date: 06/06/2022

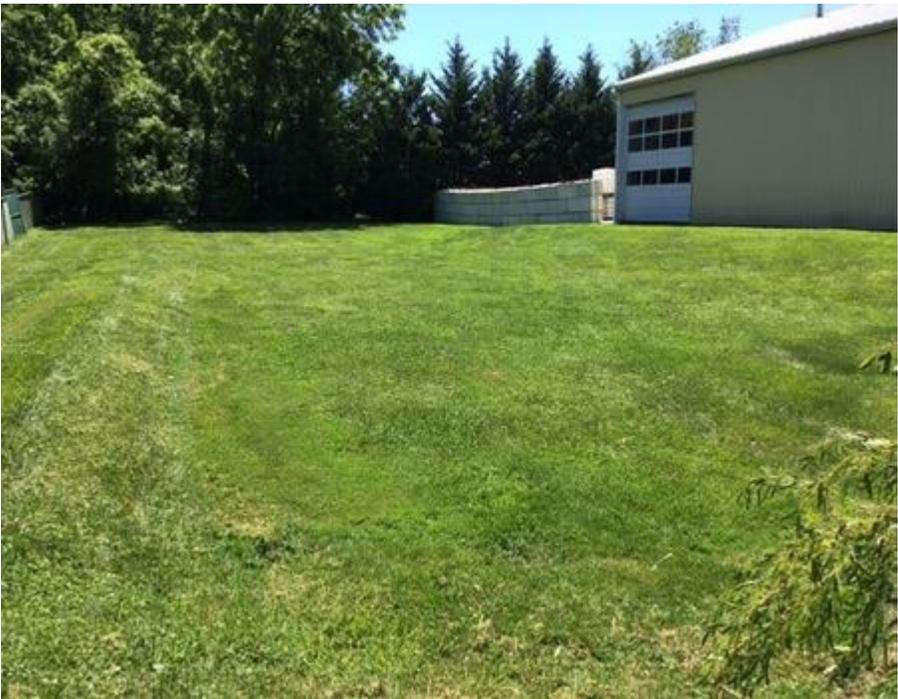
Description			
Overall view of the BMP.			
Violation Type (if applicable):
