RE: West Norriton Township Annual MS4 Status Report
NPDES Permit No. PAG130006
West Norriton Township, Montgomery County
233-22-0007

ANNUAL MUNICIPAL SEPARATE STORM SEWER SYSTEM (MS4) STATUS REPORT

West Norriton Township

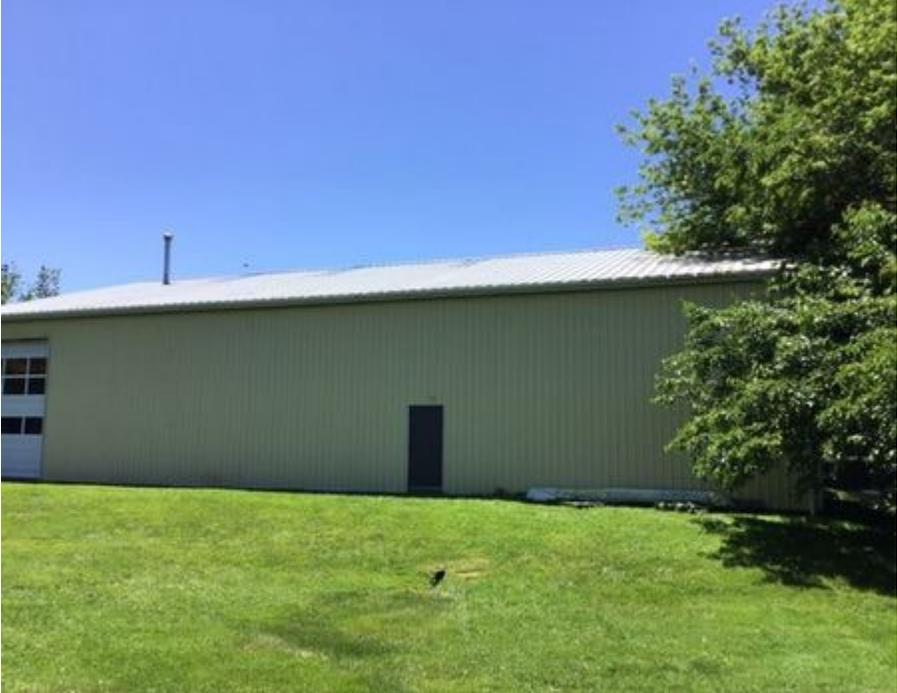
BMP #: 7		BMP Type: Detention Basin	BMP Address: 56 Liberty Ave, Eagleville, PA 19403
Photo No. 3	Date: 06/06/2022

Description			
View of the contributing drainage area.			
Violation Type (if applicable):			
Photo No. 4	Date: 06/06/2022

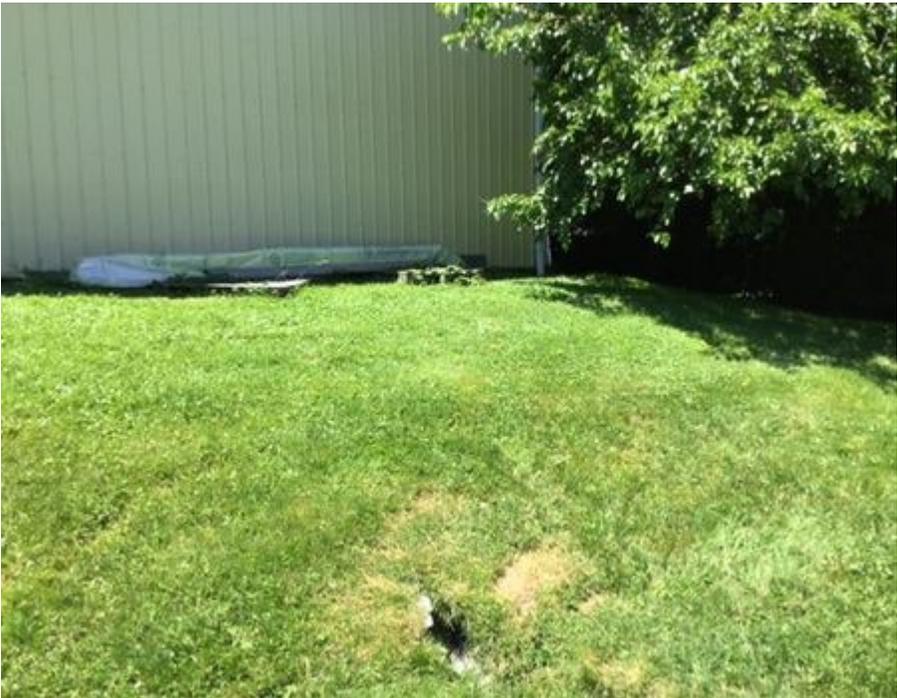
Description			
View of the connected downspouts to the system.			
Violation Type (if applicable):

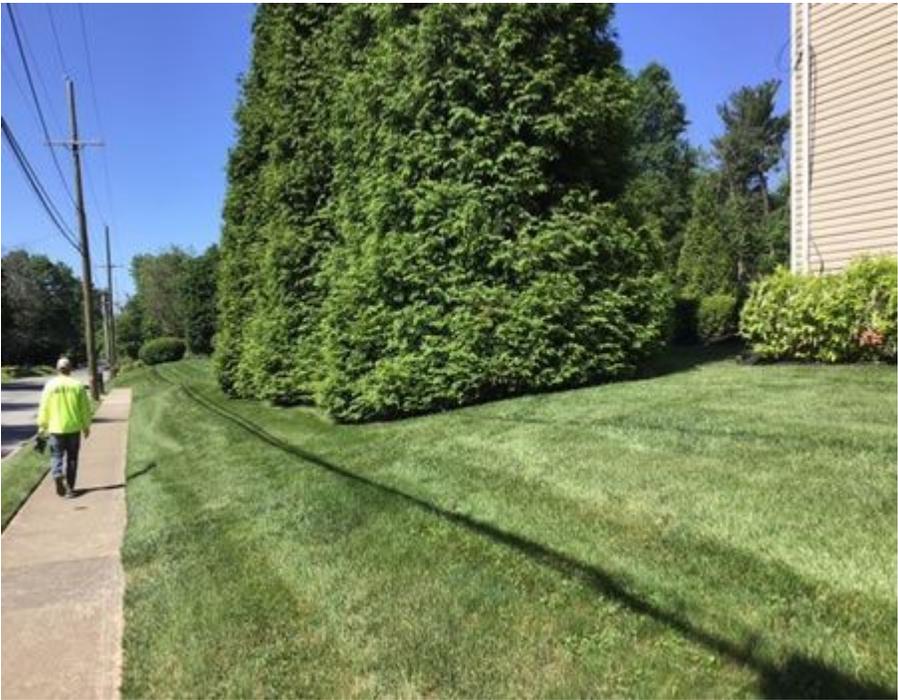
BMP #: 8		BMP Type: Underground Basin	BMP Address: 2171 Alexander Dr, Norristown, PA 19403
Photo No. 1	Date: 06/06/2022

Description			
Overall view of the BMP.			
Violation Type (if applicable):			
Photo No. 2	Date: 06/06/2022

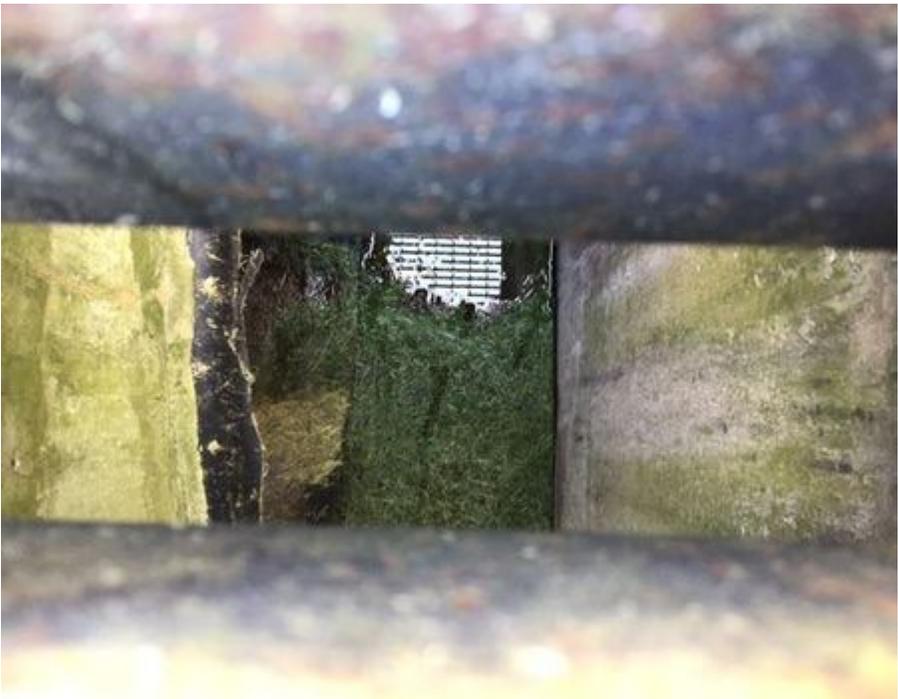
Description			
Inside the observation inlet.			
Violation Type (if applicable):

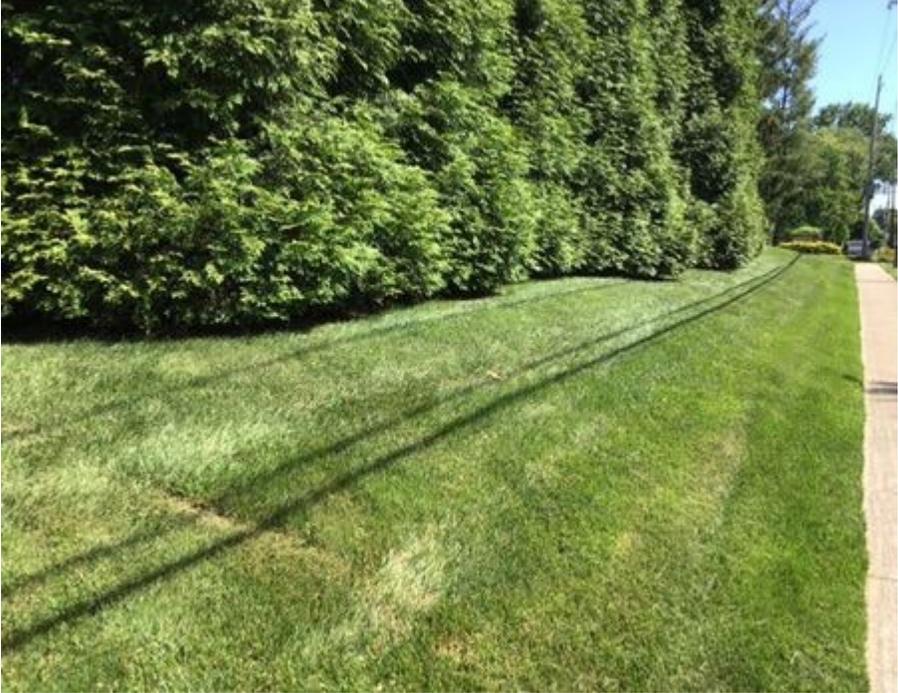
BMP #: 8		BMP Type: Underground Basin	BMP Address: 2171 Alexander Dr, Norristown, PA 19403
Photo No. 3	Date: 06/06/2022

Description			
View of the location of the underground BMP.			
Violation Type (if applicable):			
Photo No. 4	Date: 06/06/2022

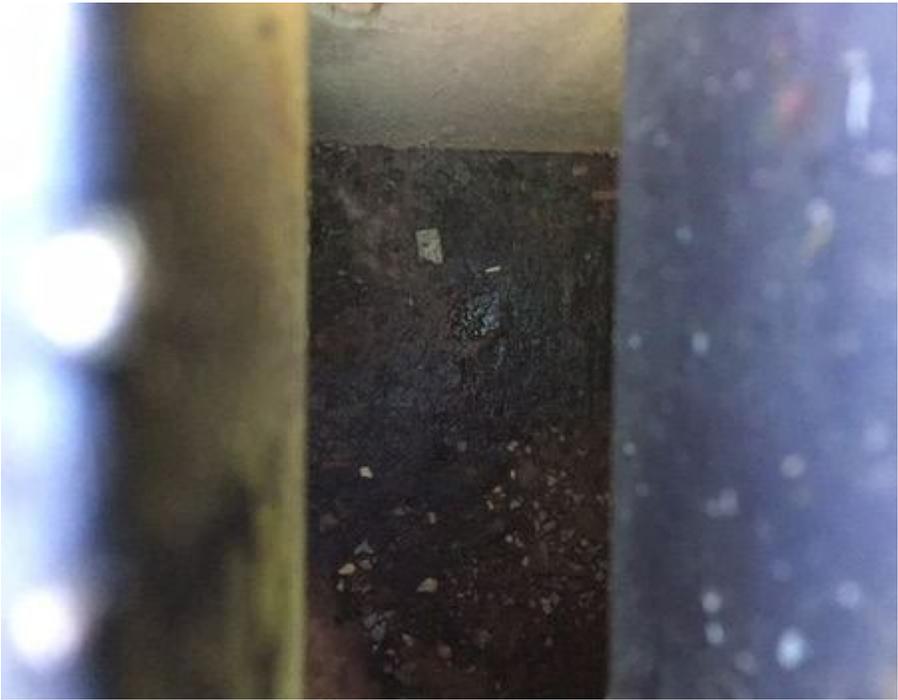
Description			
View inside the second observation inlet on the far side of the property.			
Violation Type (if applicable):

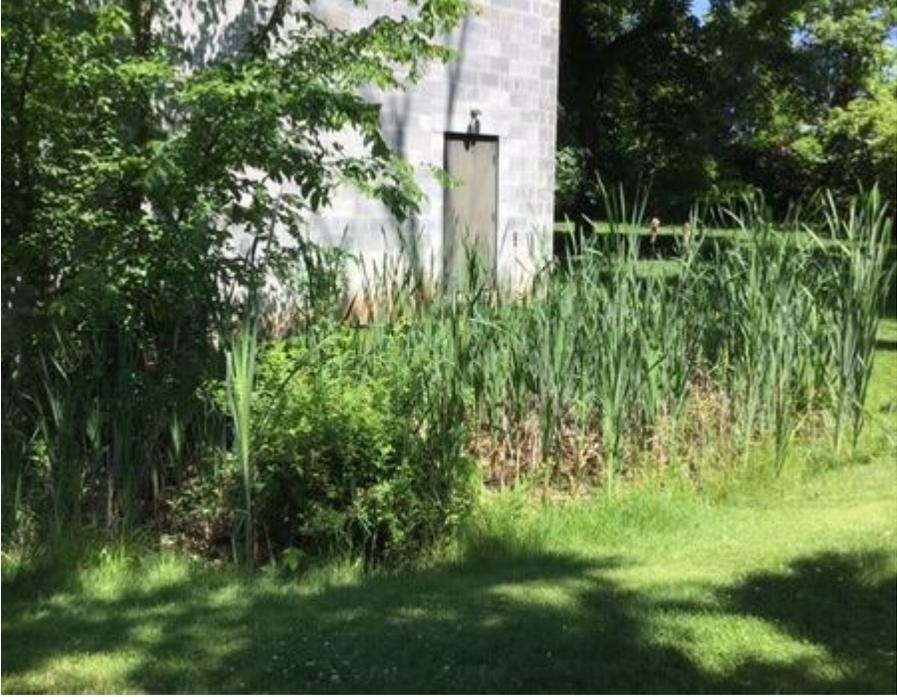
BMP #: 9		BMP Type: Detention Basin	BMP Address: 48 S. Trooper Rd, Norristown, PA 19403
Photo No. 1	Date: 06/06/2022

Description			
Overview of the BMP.			
Violation Type (if applicable):			
Photo No. 2	Date: 06/06/2022

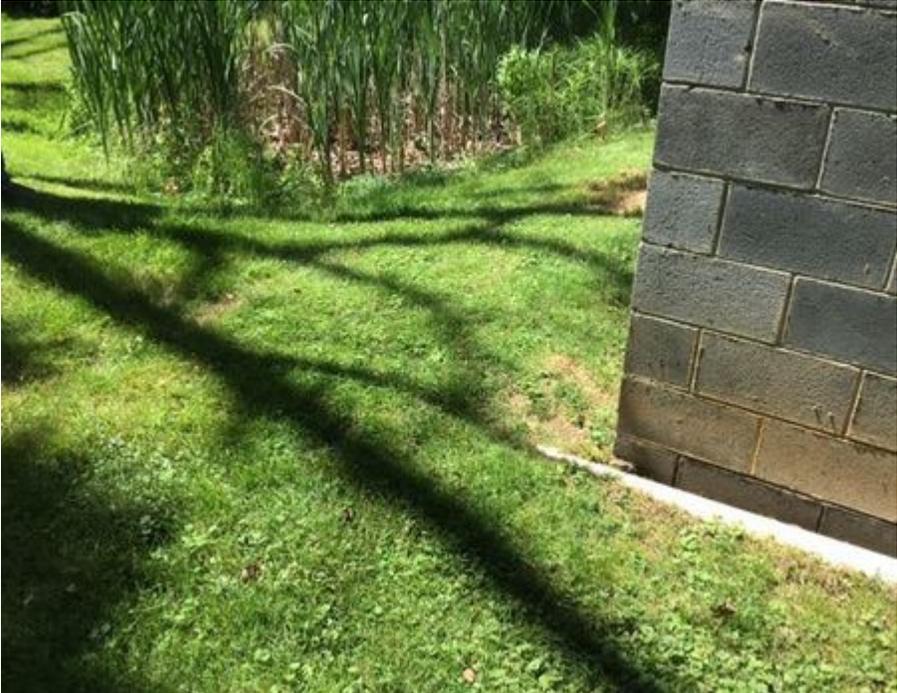
Description			
Connected downspouts.			
Violation Type (if applicable):

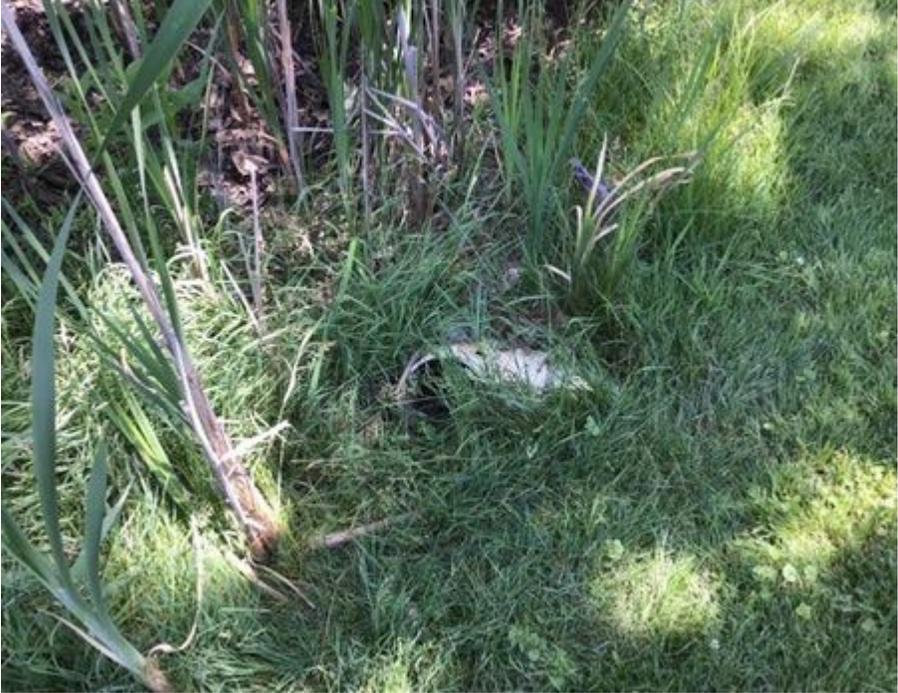
BMP #: 9		BMP Type: Detention Basin	BMP Address: 48 S. Trooper Rd, Norristown, PA 19403
Photo No. 3	Date: 06/06/2022

Description			
View of outlet riser.			
Violation Type (if applicable):			
Photo No. 4	Date: 06/06/2022

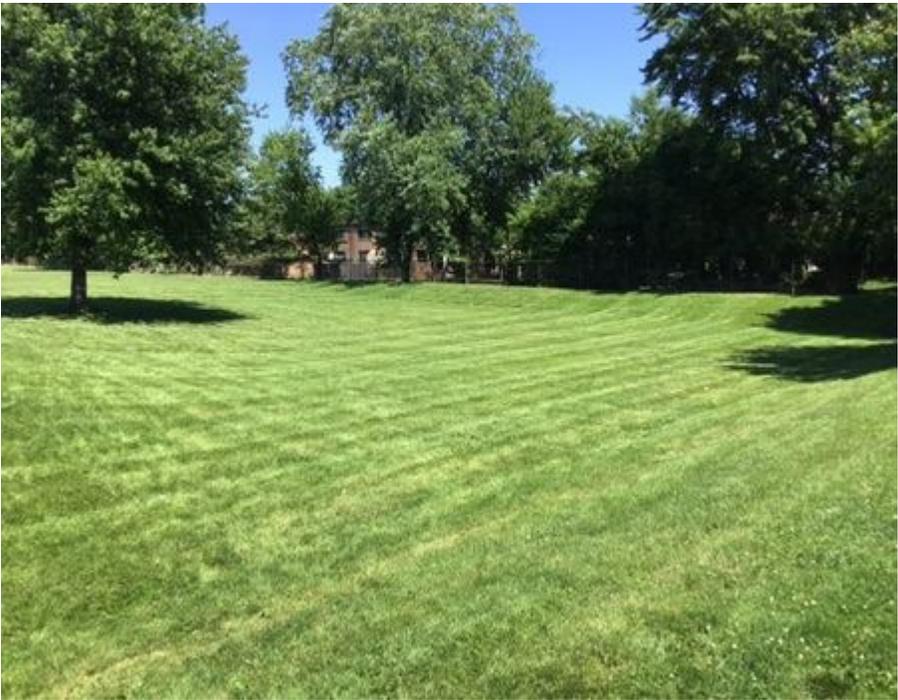
BMP #: 10		BMP Type: Detention Basin	BMP Address: 401 N. Whitehall Rd, Norristown, PA 19403
Photo No. 1	Date: 06/06/2022

Description			
Overall view of the BMP.			
Violation Type (if applicable):			
Photo No. 2	Date: 06/06/2022

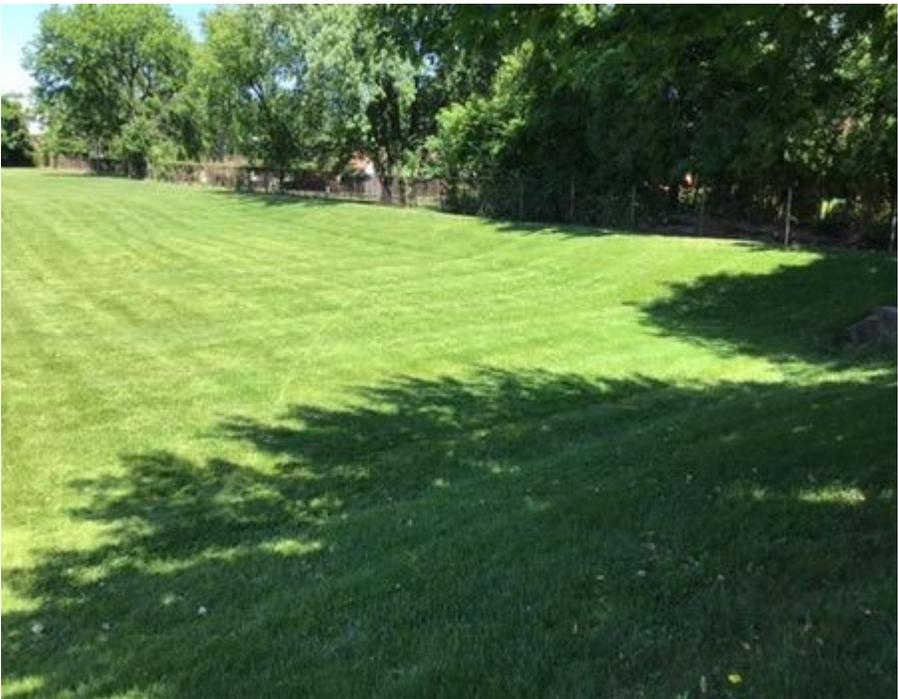
Description			
Overall view of the BMP.			
Violation Type (if applicable):

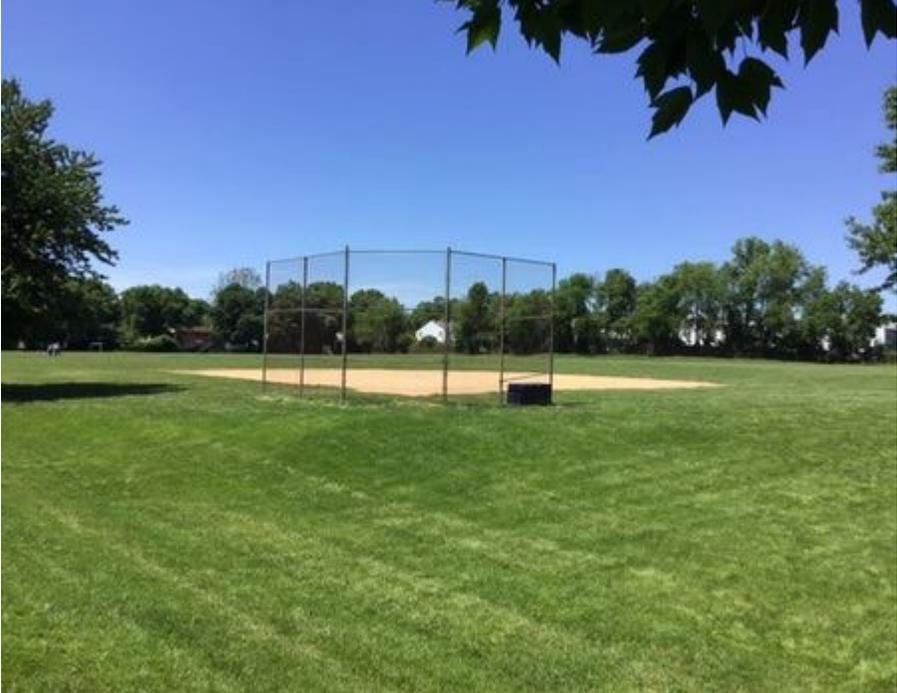
BMP #: 10		BMP Type: Detention Basin	BMP Address: 401 N. Whitehall Rd, Norristown, PA 19403
Photo No. 3	Date: 06/06/2022

Description			
View of the contributing drainage area.			
Violation Type (if applicable):			
Photo No. 4	Date: 06/06/2022

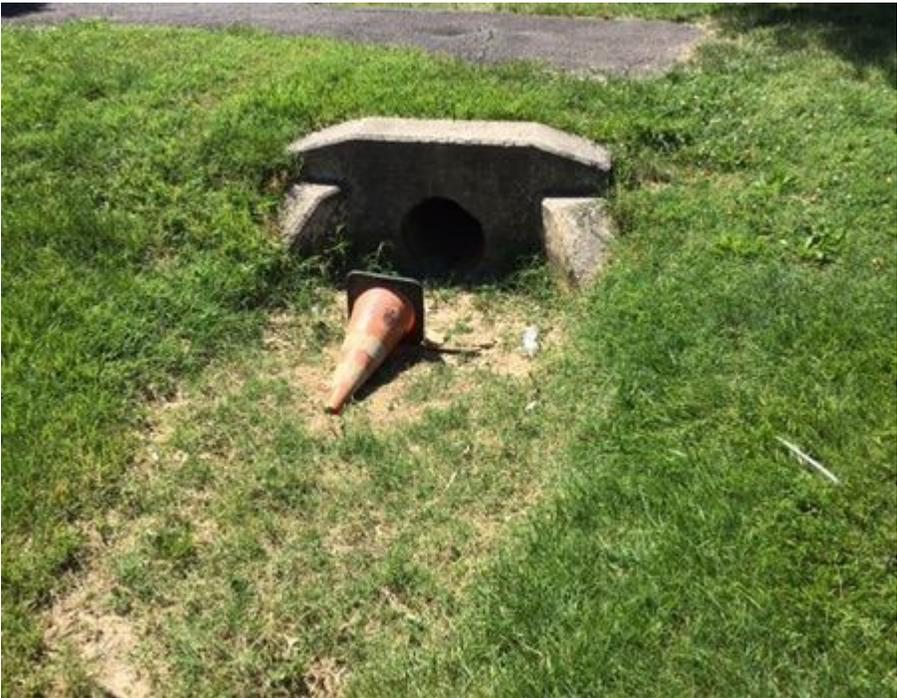
Description			
View of the structure leading to the BMP.			
Violation Type (if applicable):

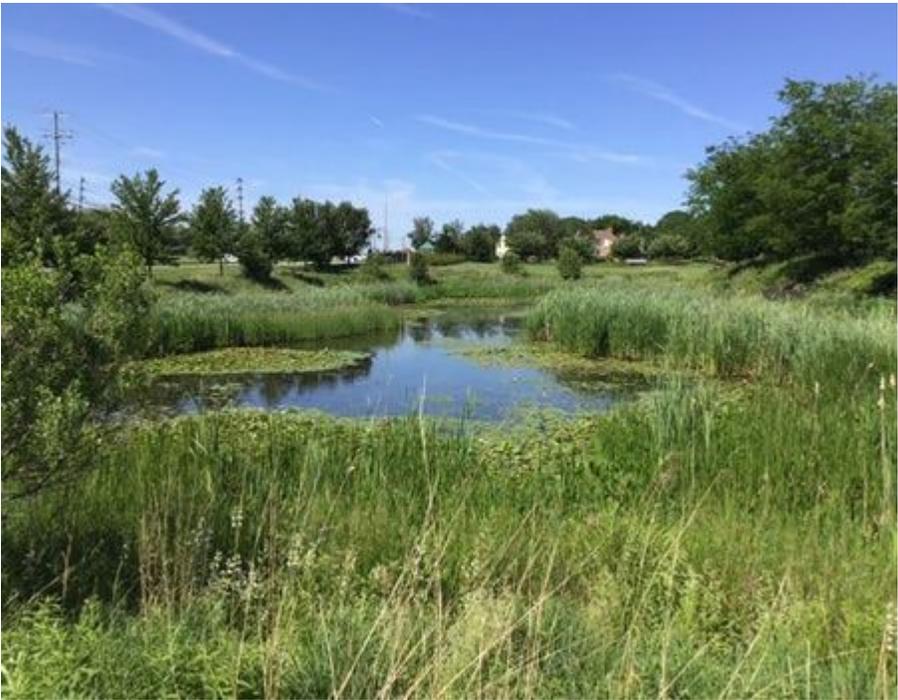
BMP #: 11A		BMP Type: Detention Basin	BMP Address: 900 S. Trooper Rd, Norristown, PA 19403
Photo No. 1	Date: 06/06/2022

Description			
Overall view of the BMP.			
Violation Type (if applicable):			
Photo No. 2	Date: 06/06/2022

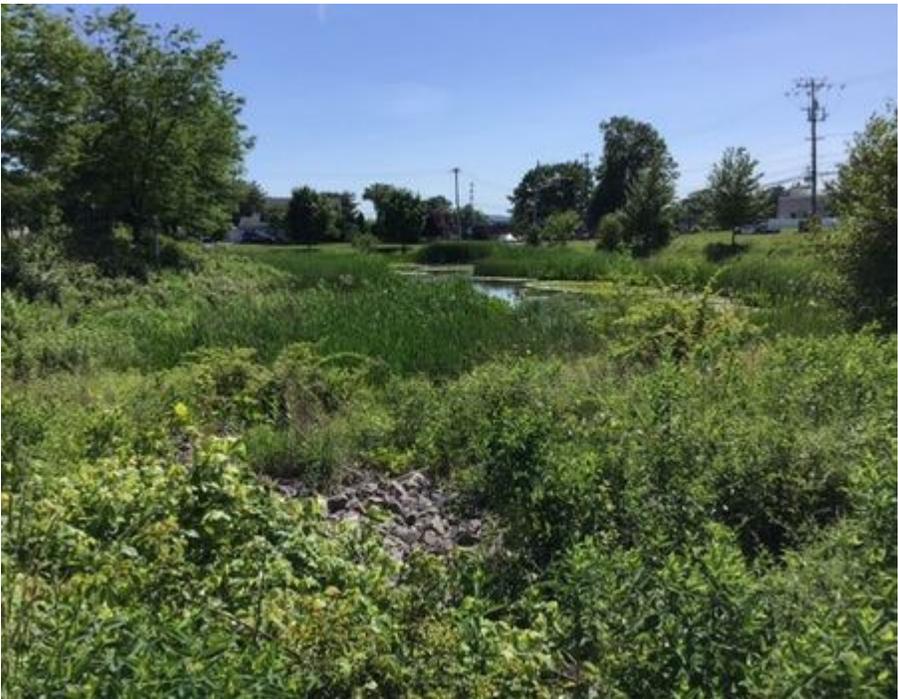
Description			
Overall view of the BMP.			
Violation Type (if applicable):

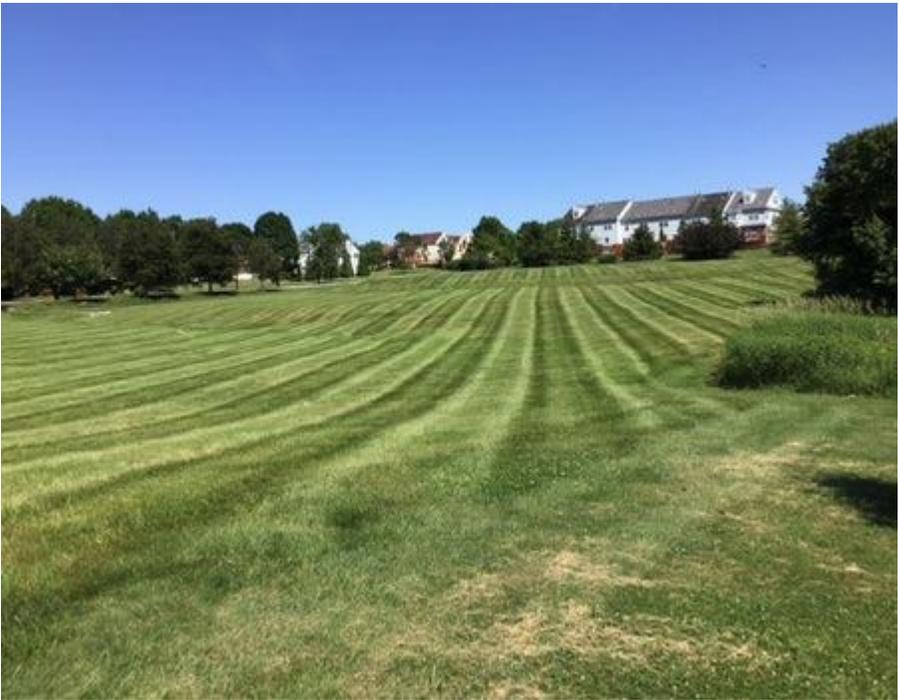
BMP #: 11A		BMP Type: Detention Basin	BMP Address: 900 S. Trooper Rd, Norristown, PA 19403
Photo No. 3	Date: 06/06/2022

Description			
View of the contributing drainage area.			
Violation Type (if applicable):			
Photo No. 4	Date: 06/06/2022

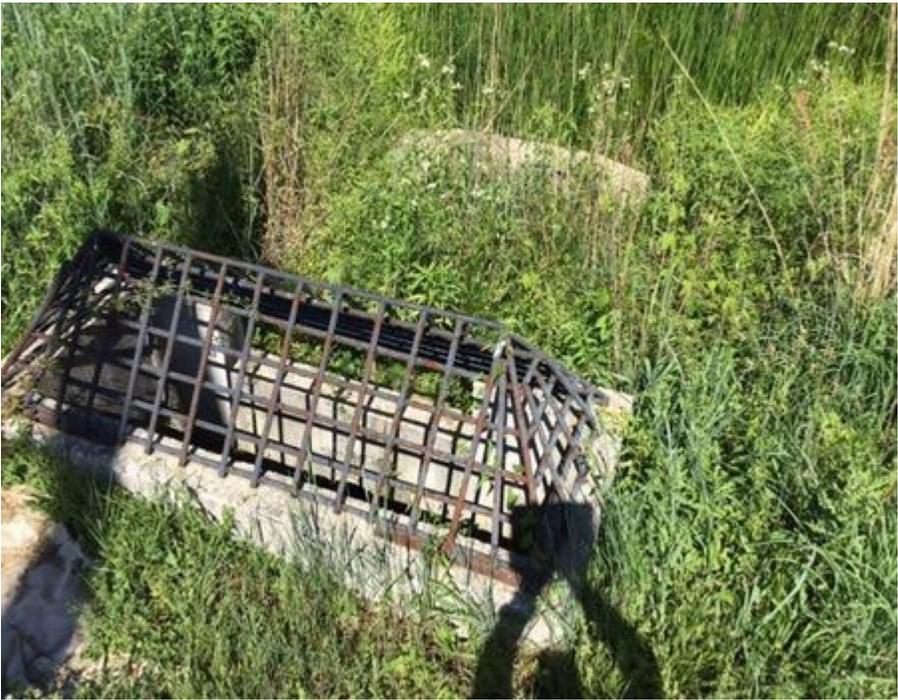
Description			
View of the riser.			
Violation Type (if applicable):

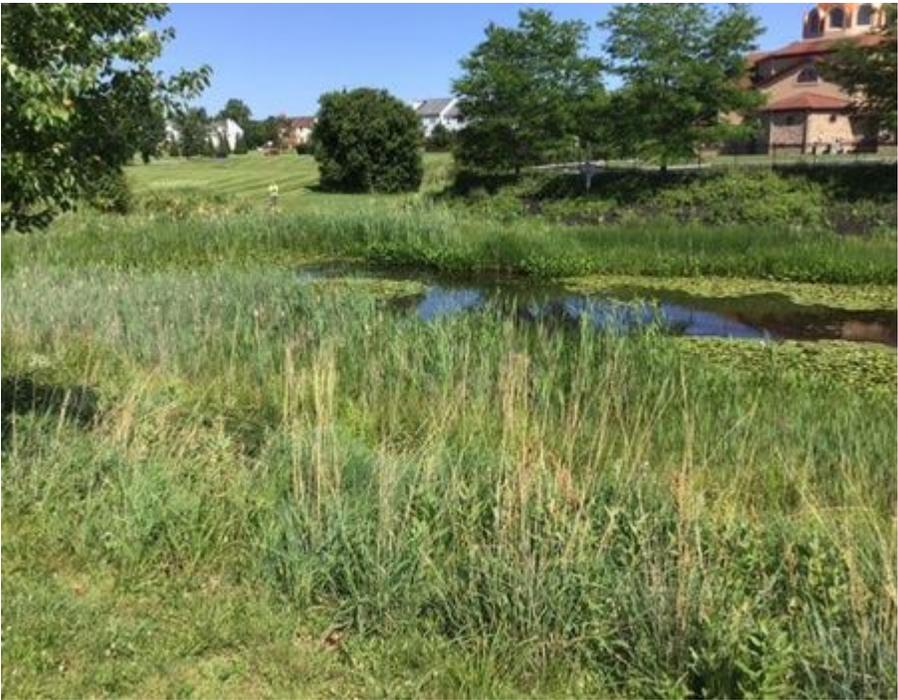
BMP #: 11B1		BMP Type: Bioretention Area	BMP Address: 900 S. Trooper Rd, Norristown, PA 19403
Photo No. 1	Date: 06/06/2022

Description			
Overall view of the BMP.			
Violation Type (if applicable):			
Photo No. 2	Date: 06/06/2022

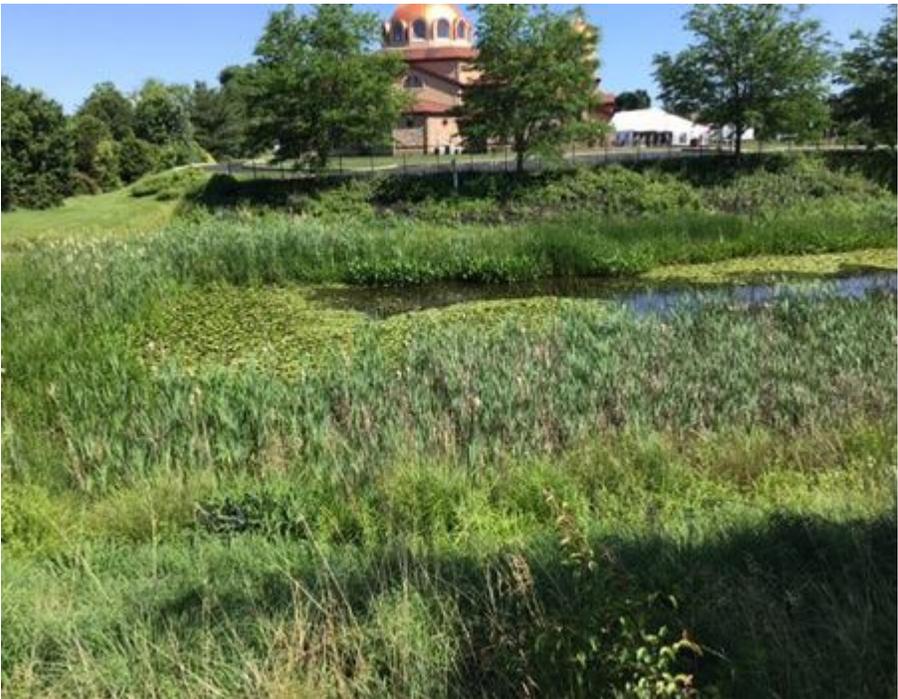
Description			
Overall view of the BMP.			
Violation Type (if applicable):

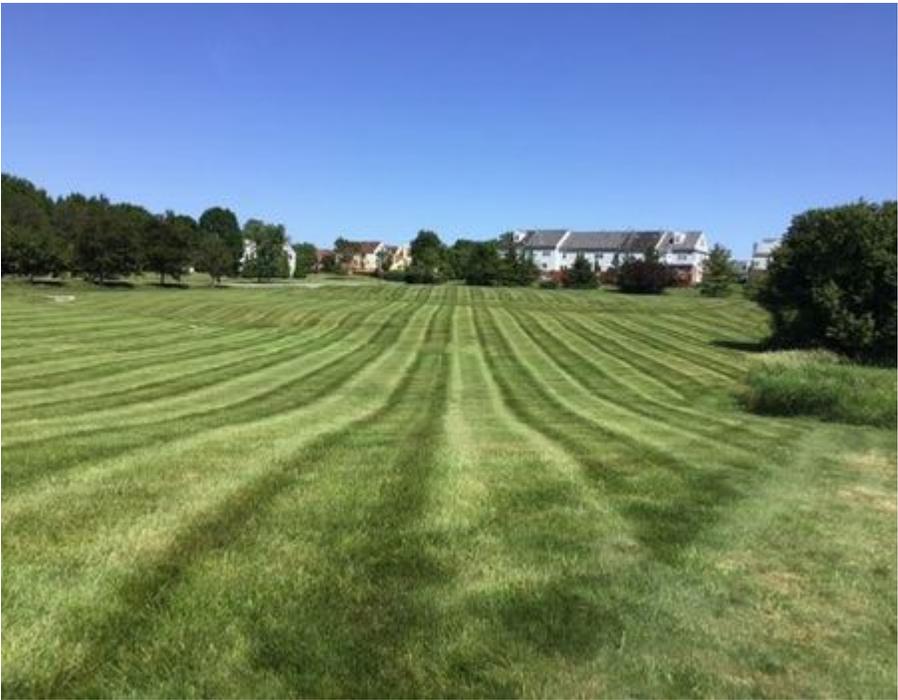
BMP #: 11B1		BMP Type: Bioretention Area	BMP Address: 900 S. Trooper Rd, Norristown, PA 19403
Photo No. 3	Date: 06/06/2022

Description			
View of the contributing drainage area.			
Violation Type (if applicable):			
Photo No. 4	Date: 06/06/2022

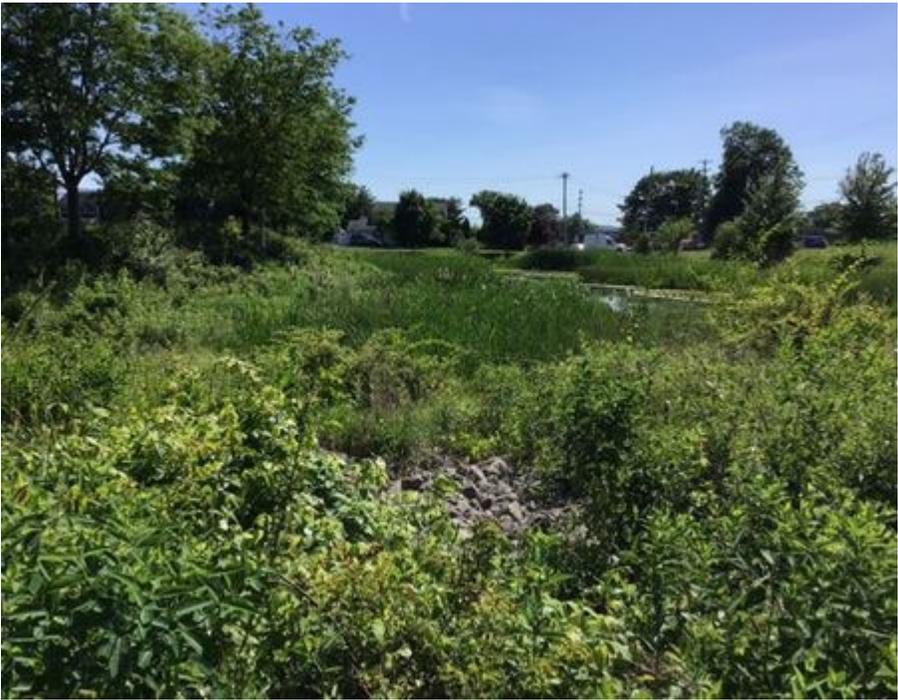
Description			
View of the structure leading to the BMP.			
Violation Type (if applicable):

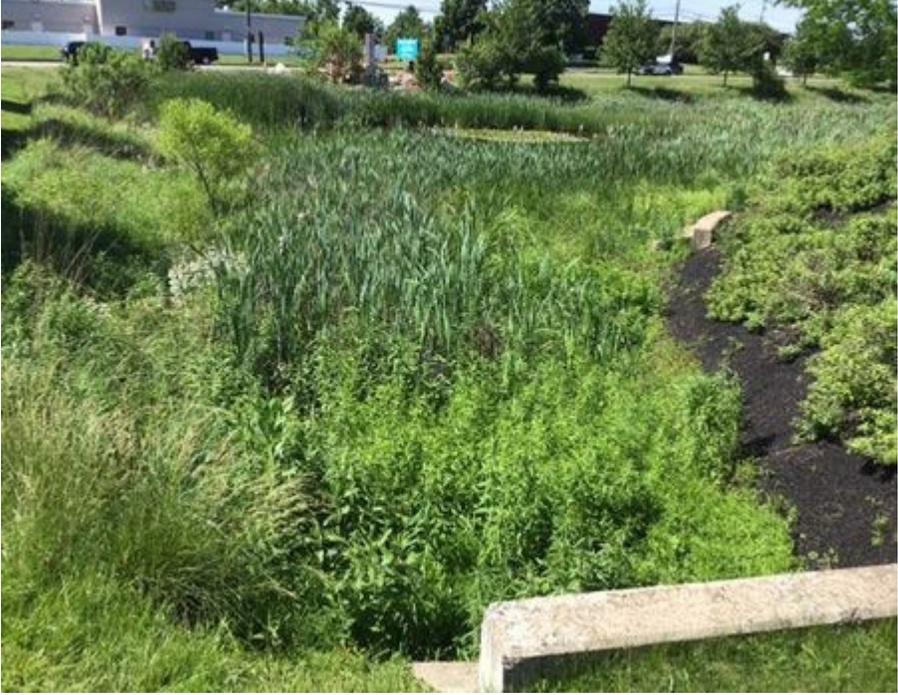
BMP #: 11B2		BMP Type: Bioretention Area	BMP Address: 900 S. Trooper Rd, Norristown, PA 19403
Photo No. 1	Date: 06/06/2022

Description			
Overall view of the BMP.			
Violation Type (if applicable):			
Photo No. 2	Date: 06/06/2022

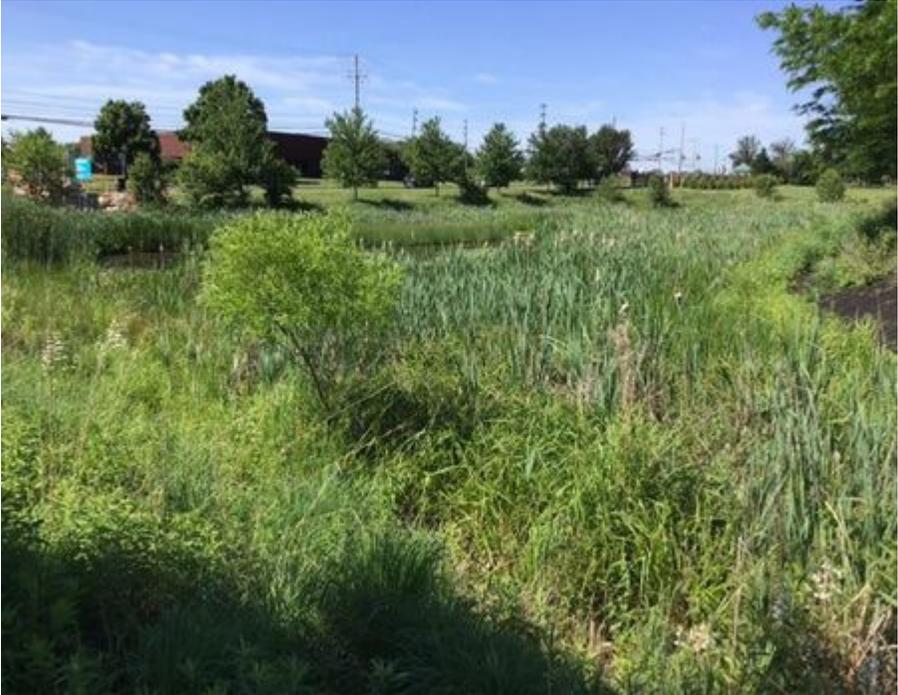
Description			
Overall view of the BMP.			
Violation Type (if applicable):

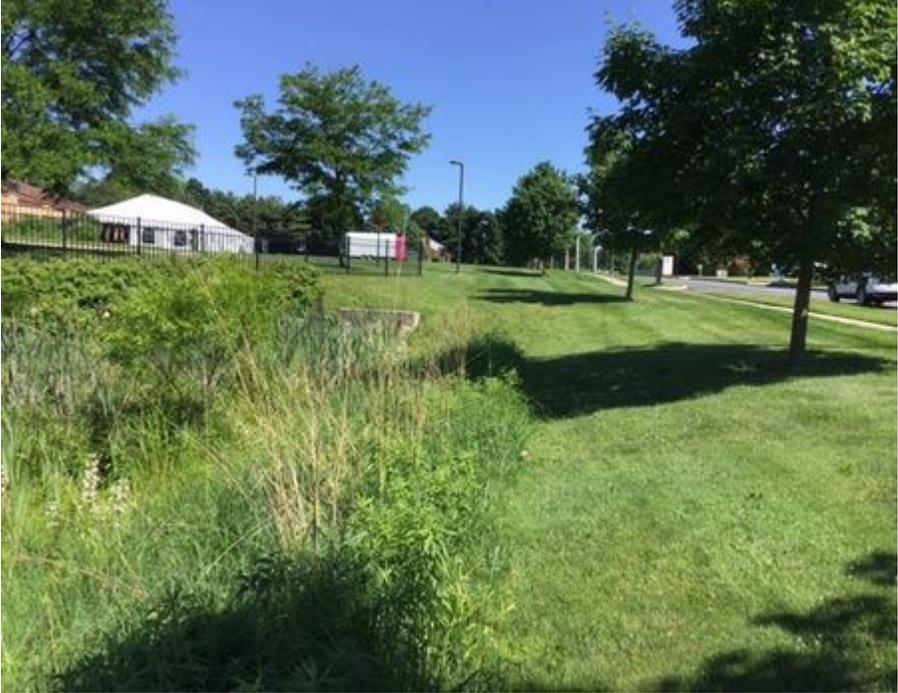
BMP #: 11B2		BMP Type: Bioretention Area	BMP Address: 900 S. Trooper Rd, Norristown, PA 19403
Photo No. 3	Date: 06/06/2022

Description			
View of the contributing drainage area.			
Violation Type (if applicable):			
Photo No. 4	Date: 06/06/2022

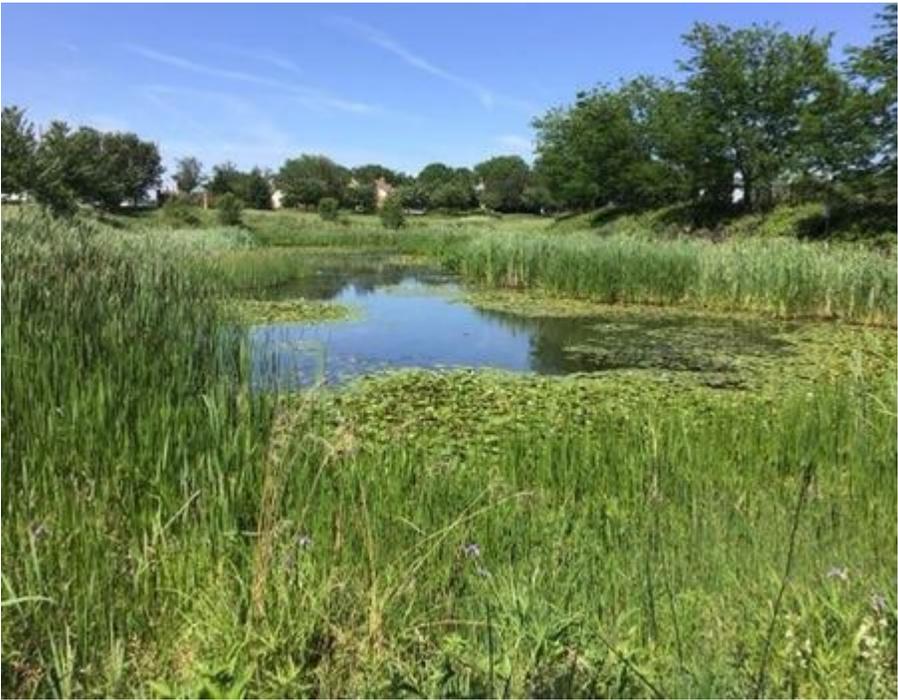
Description			
Overview of Bioretention area.			
Violation Type (if applicable):

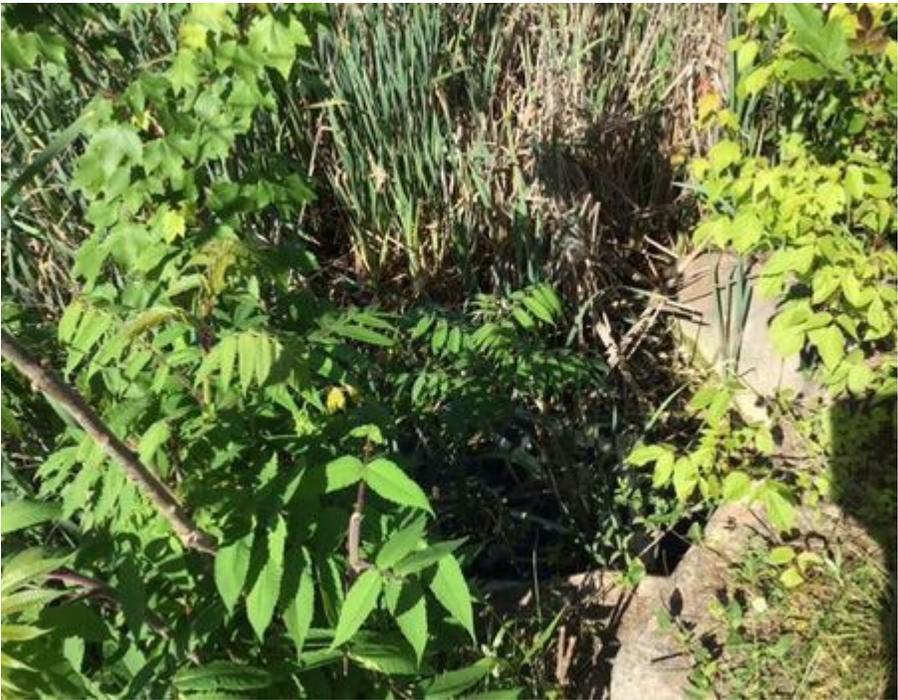
BMP #: 12		BMP Type: Constructed Wetland Basin	BMP Address: 401 N. Whitehall Rd, Norristown, PA 19403
Photo No. 1	Date: 06/06/2022

Description			
View of inlet.			
Violation Type (if applicable):			
Photo No. 2	Date: 06/06/2022

BMP Component	Violations Observed			
Contributing Drainage Area	<input type="checkbox"/> Excessive trash/debris	<input type="checkbox"/> Exposed/bare soil	<input type="checkbox"/> Evidence of accelerated erosion	<input type="checkbox"/> Other:
<input checked="" type="checkbox"/> No violations present at the time of inspection				
Photo No.	Comments:			
Pretreatment: Inlets, Forebays & Inflow	<input type="checkbox"/> Excessive trash/debris/sediment accumulation	<input type="checkbox"/> Evidence of clogging	<input type="checkbox"/> Evidence of accelerated erosion	<input type="checkbox"/> Evidence of ponding, odors, water stains, floating aquatic
<input type="checkbox"/> No violations present at the time of inspection	<input type="checkbox"/> Structural deterioration of inlets, outfalls or pretreatment overflow weirs into facility	<input type="checkbox"/> Maintenance access in need of repair		
	<input type="checkbox"/> Gutters, downspouts and inflow devices	<input type="checkbox"/> Screens, first flush diverters or vents blocked	<input checked="" type="checkbox"/> Other: Vegetation needs to be cleared from inflows

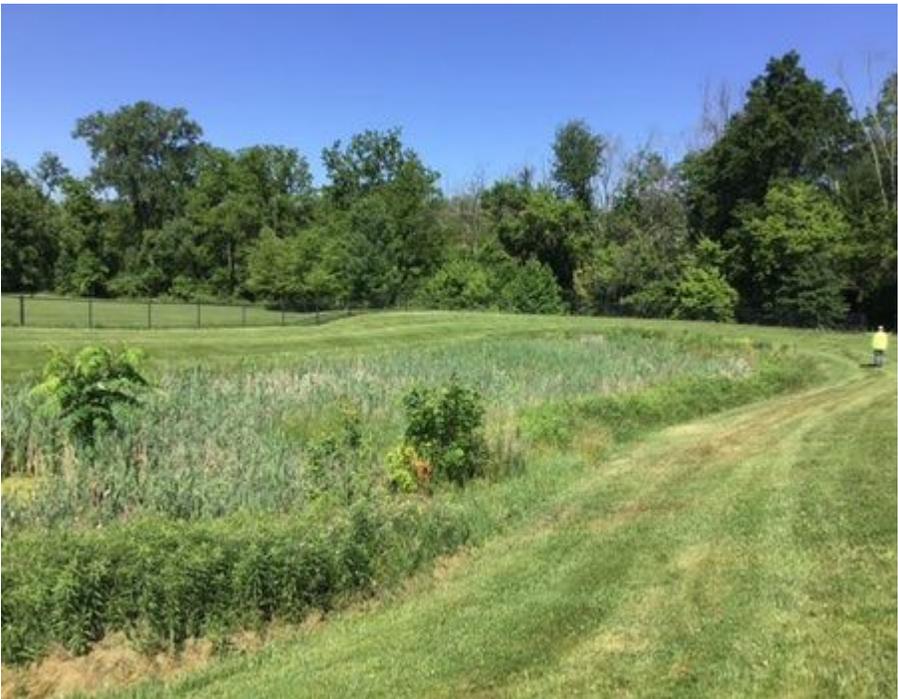
Description			
Overall view of the BMP.			
Violation Type (if applicable):

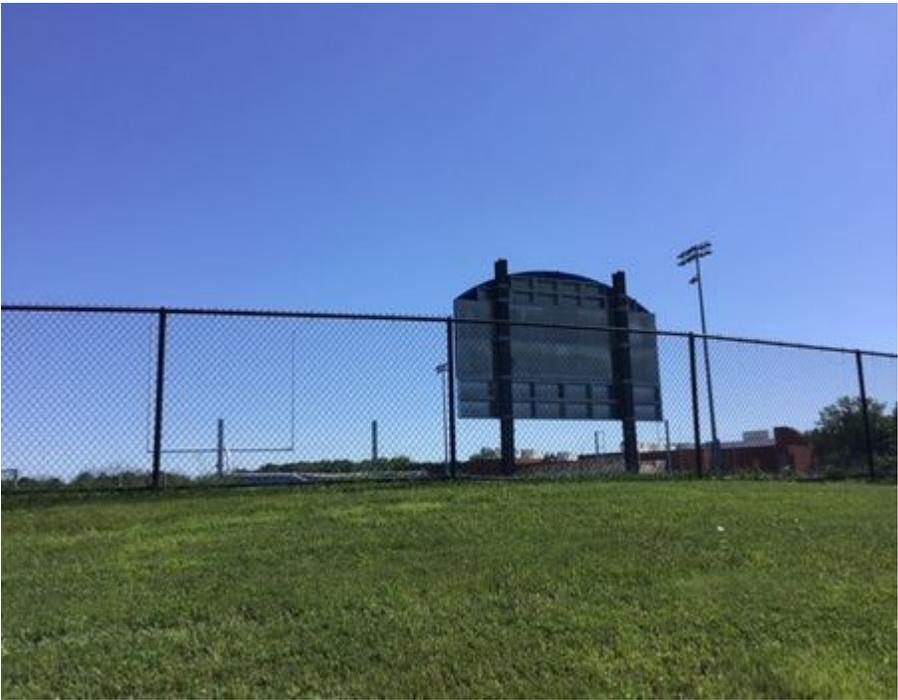
BMP #: 12		BMP Type: Constructed Wetland Basin	BMP Address: 401 N. Whitehall Rd, Norristown, PA 19403
Photo No. 3	Date: 06/06/2022

Description			
View of the contributing drainage area.			
Violation Type (if applicable):			
Photo No. 4	Date: 06/06/2022

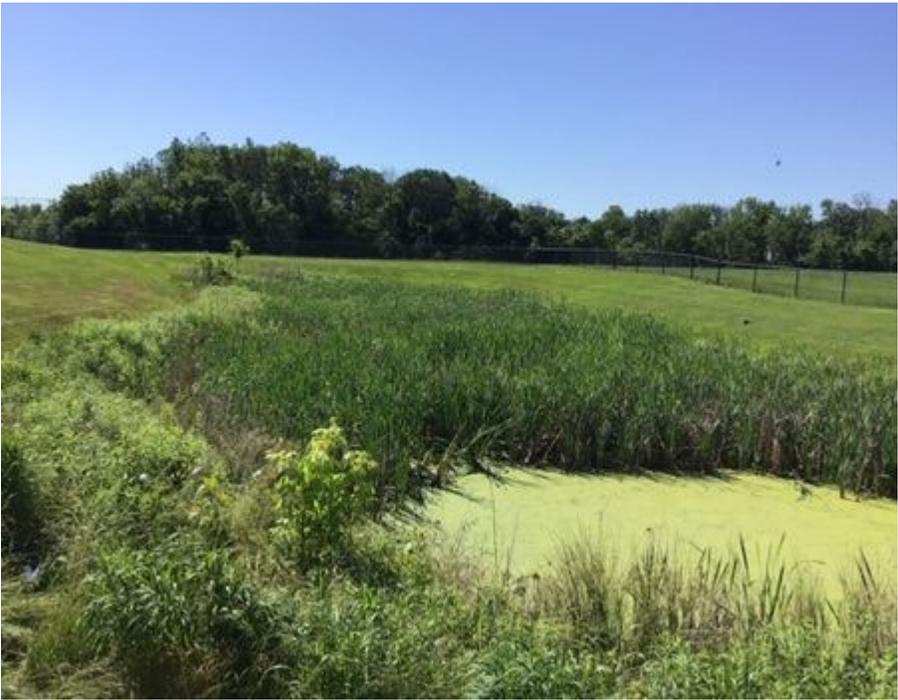
Description			
Overview of BMP.			
Violation Type (if applicable):

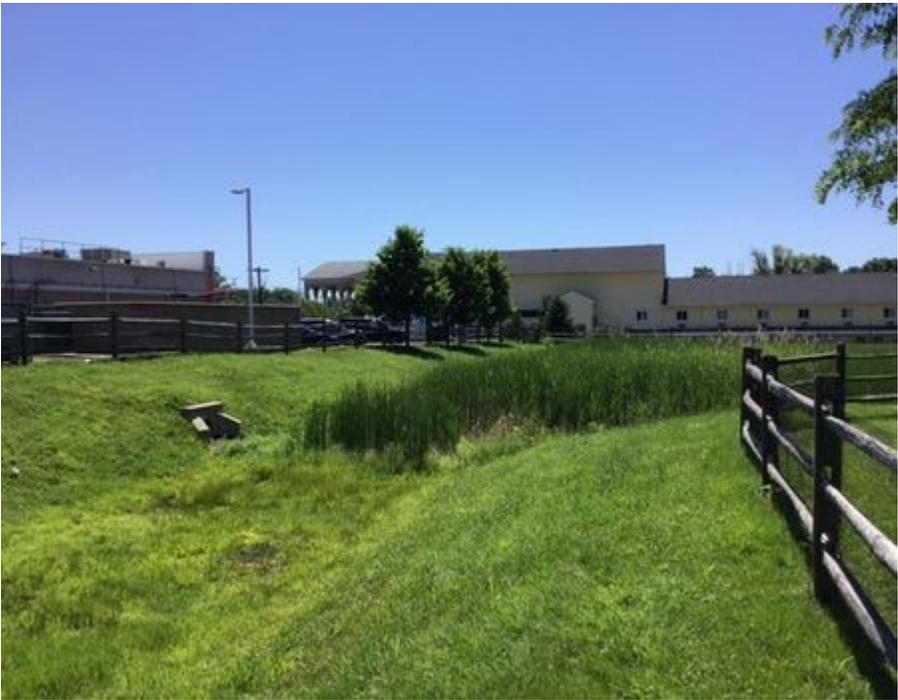
BMP #: 14		BMP Type: Detention Basin	BMP Address: 2544 W Main St, Norristown, PA, 19403
Photo No. 1	Date: 06/06/2022	Date:	
Description

Overview of the BMP.			
Violation Type (if applicable):			
Photo No. 2	Date: 06/06/2022	Date:	
Description

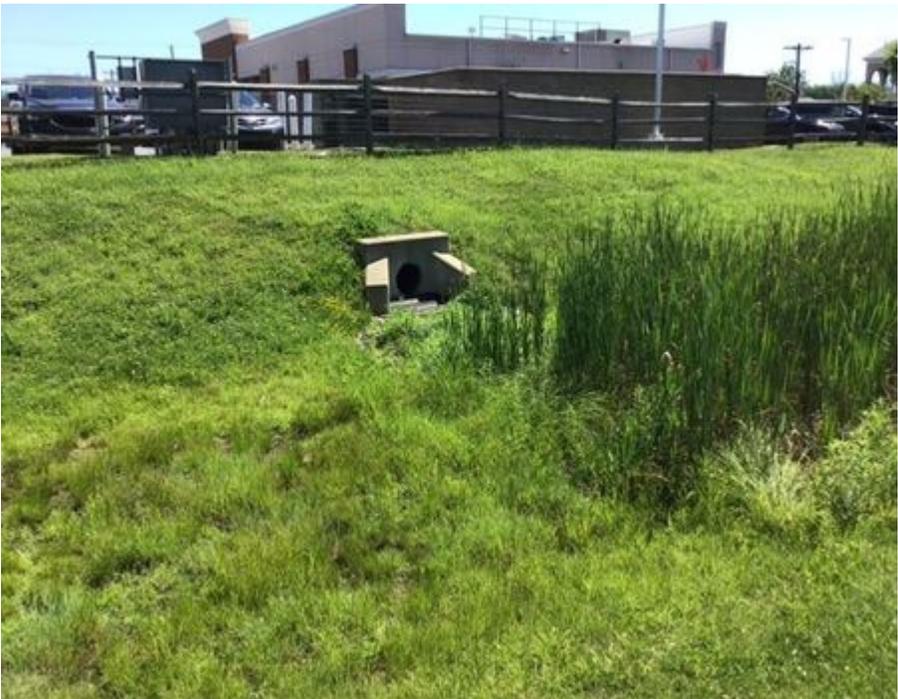
View of the inflow to the basin.			
Violation Type (if applicable):

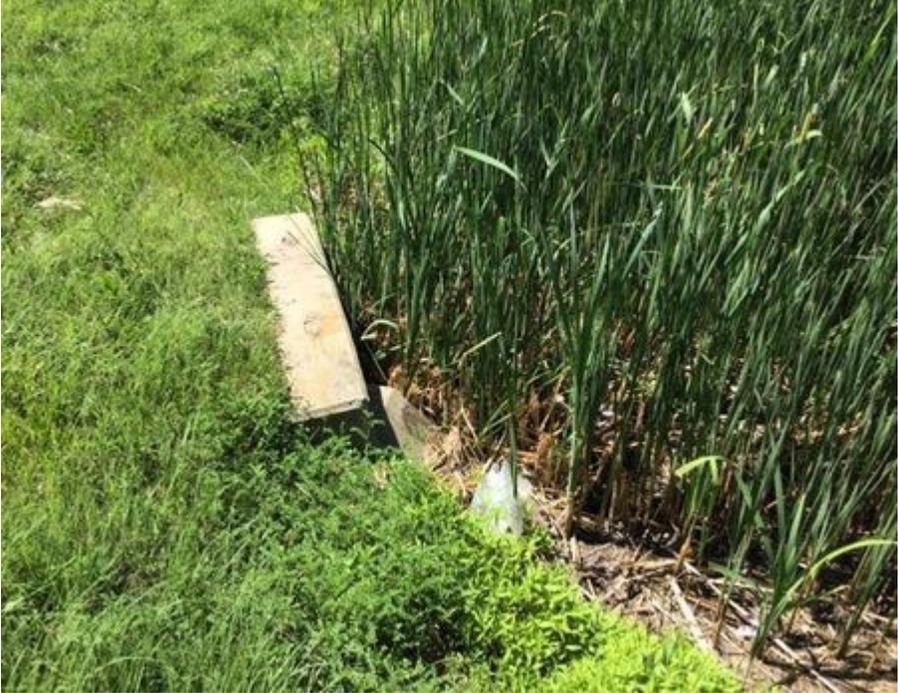
BMP #: 14		BMP Type: Detention Basin	BMP Address: 2544 W Main St, Norristown, PA, 19403
Photo No. 3	Date: 06/06/2022	Date:	
Description

View of the info to the basin.			
Violation Type (if applicable):			
Photo No. 4	Date: 06/06/2022	Date:	
Description

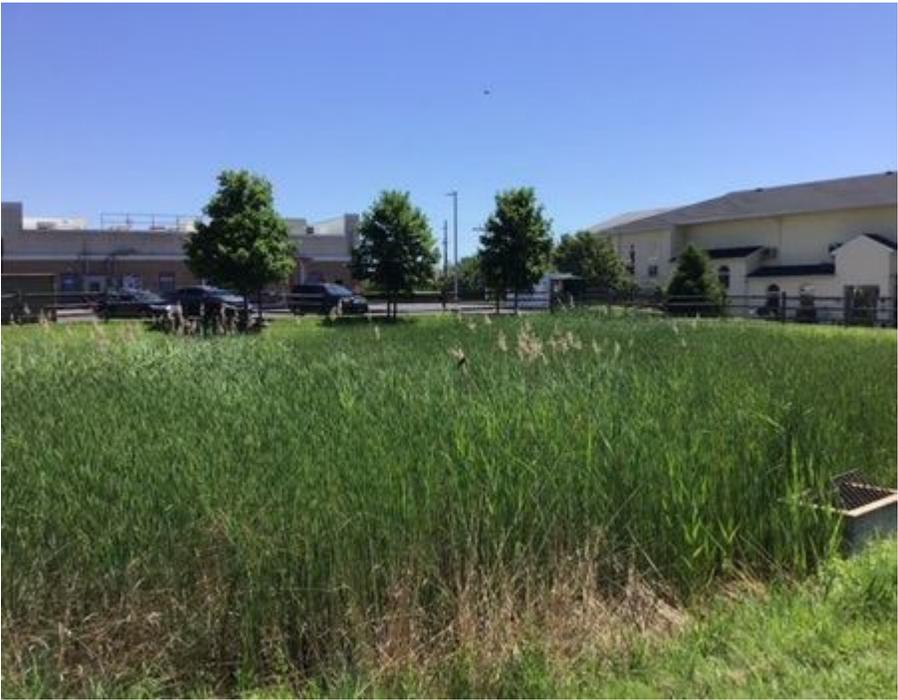
Overview of the basin.			
Violation Type (if applicable):

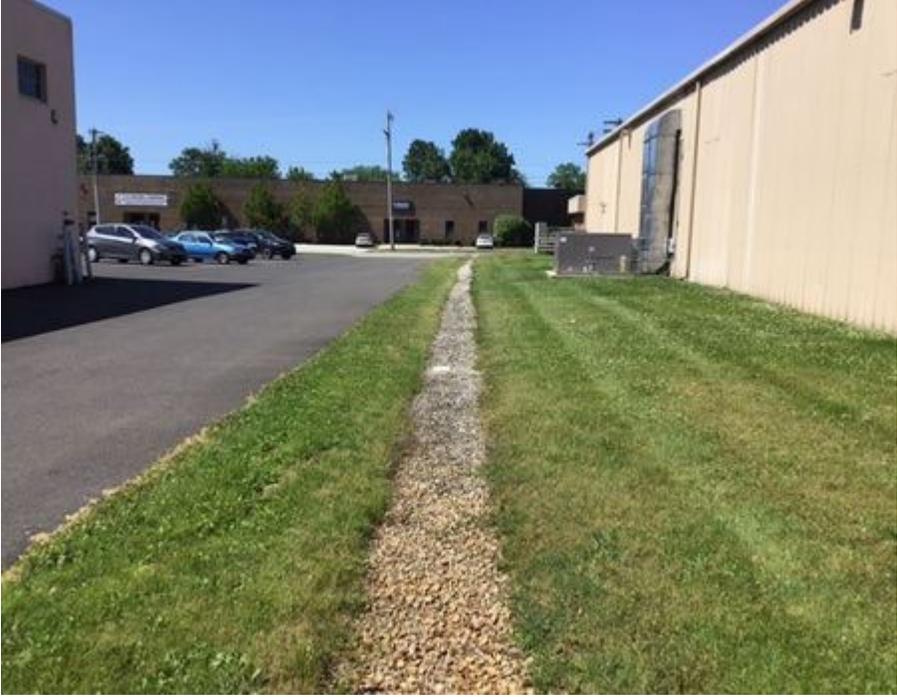
BMP #: 13		BMP Type: Infiltration Trench	BMP Address: 139 Clemens Cir, Jeffersonville, PA 19403
Photo No. 1	Date: 06/06/2022

Description			
Overview of the BMP.			
Violation Type (if applicable):			
Photo No. 2	Date: 06/06/2022
