RE: West Norriton Township Annual MS4 Status Report
NPDES Permit No. PAG130006
West Norriton Township, Montgomery County
233-22-0007

ANNUAL MUNICIPAL SEPARATE STORM SEWER SYSTEM (MS4) STATUS REPORT

West Norriton Township

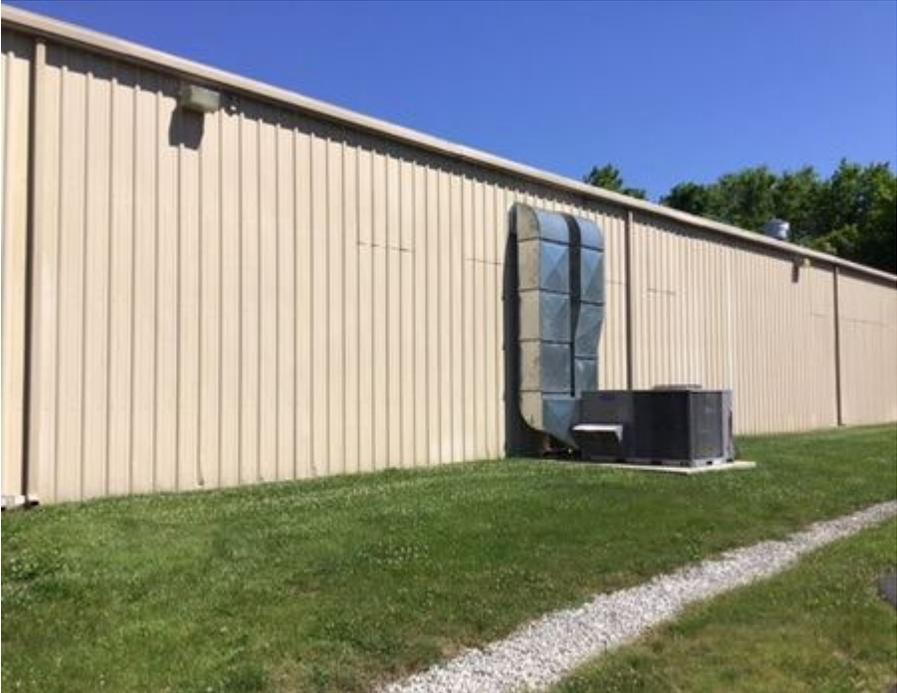
Description			
Contributing drainage area.			
Violation Type (if applicable):

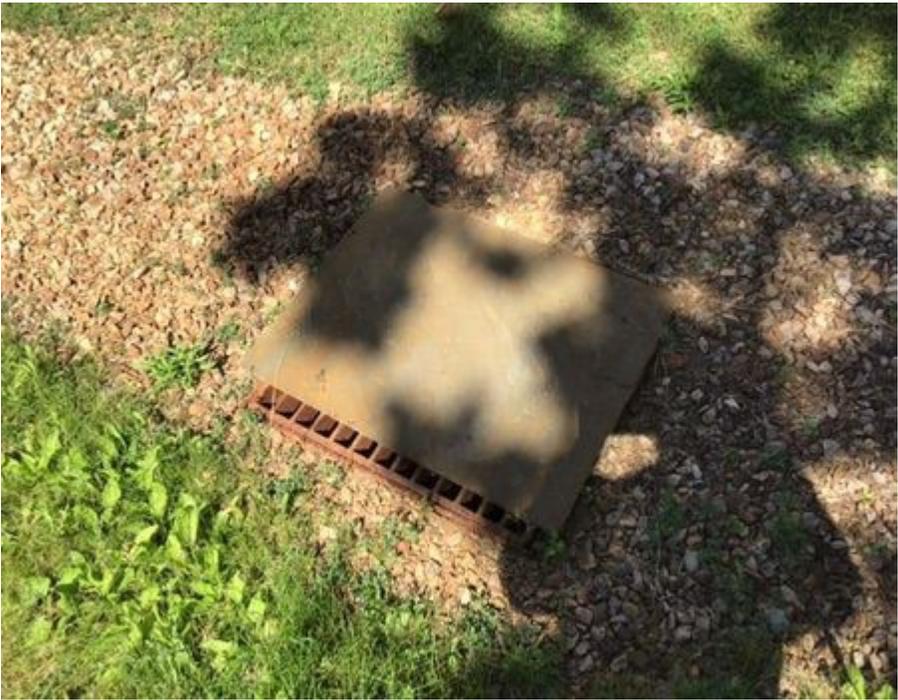
Description			
View of inlet.			
Violation Type (if applicable):

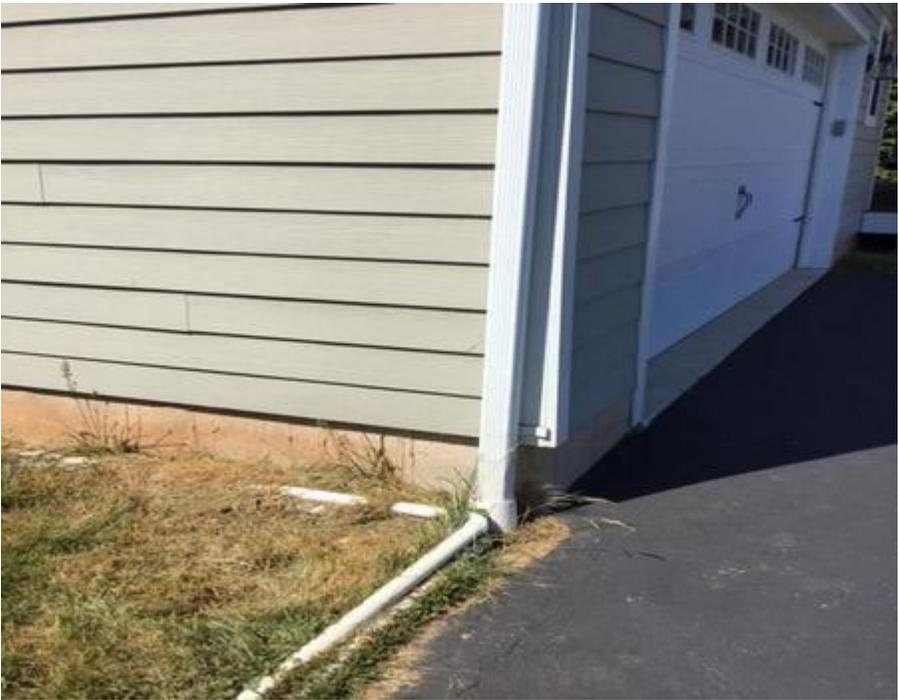
BMP #: 15		BMP Type: Seepage Bed	BMP Address: 519 Port Indian Rd, Norristown, PA 19403
Photo No. 1	Date: 06/06/2022

Description			
Connected downspout to the system.			
Violation Type (if applicable):			
Photo No. 2	Date: 06/06/2022

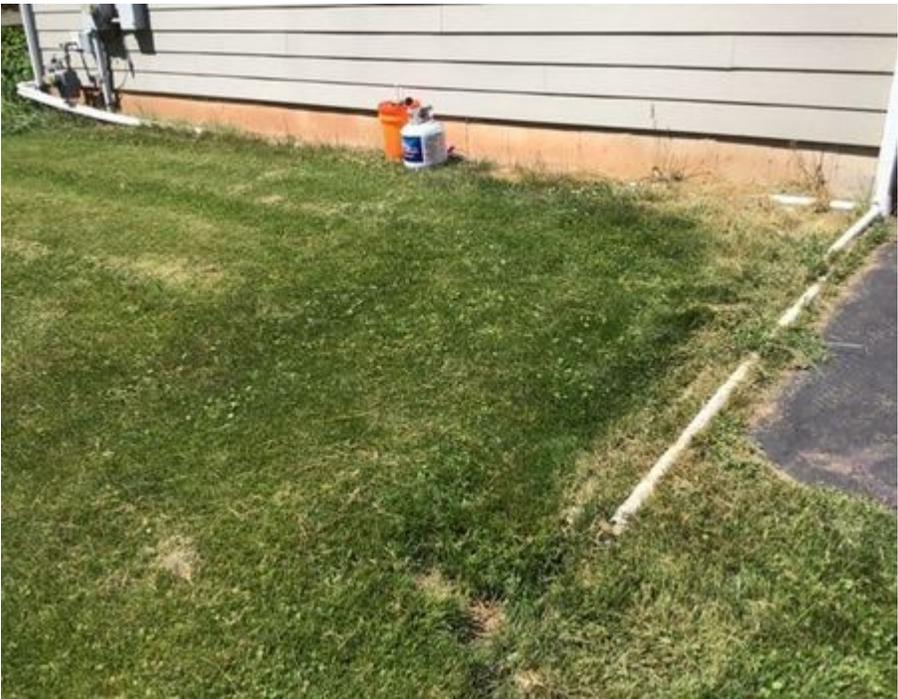
Description			
Disconnected downspout.			
Violation Type (if applicable): Disconnected downspout to the underground system.

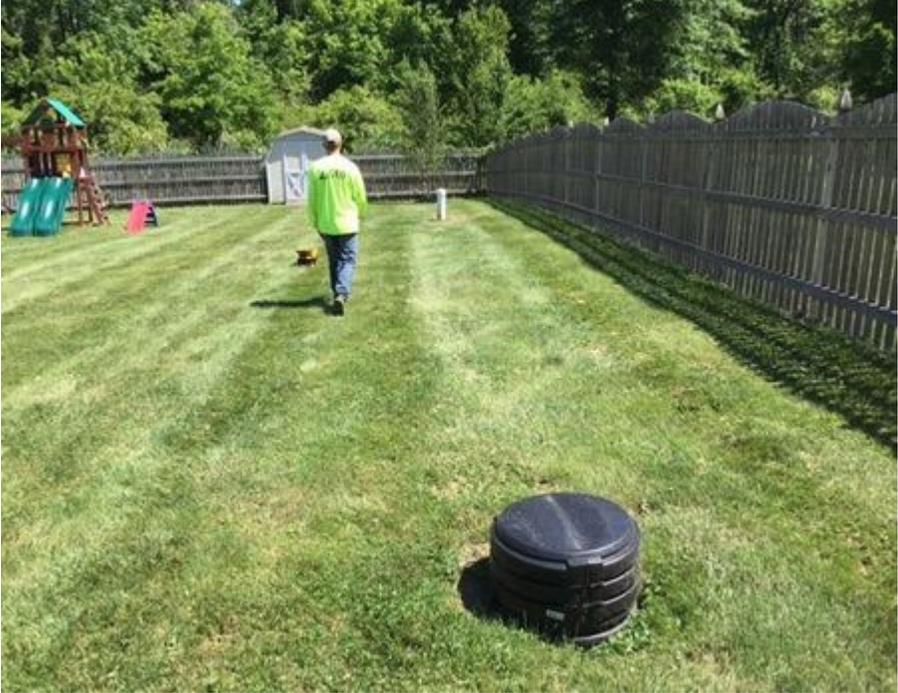
BMP #: 16		BMP Type: Underground Stone Infiltration Pit	BMP Address: 139 Clemens Cir, Jeffersonville, PA 19403
Photo No. 1	Date: 06/06/2022

Description			
Overview of the BMP.			
Violation Type (if applicable):			
Photo No. 2	Date: 06/06/2022

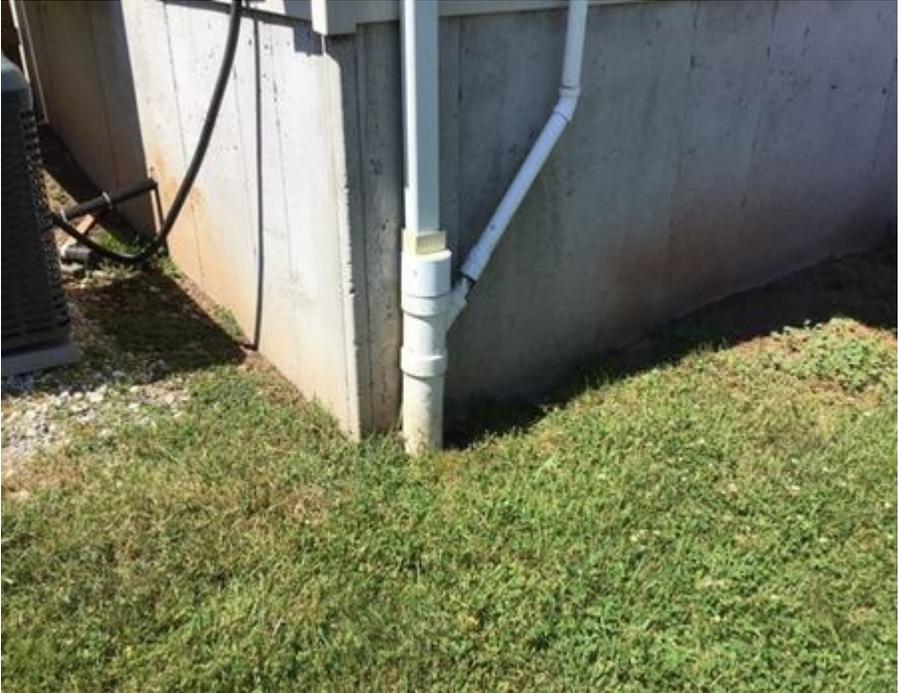
Description			
Connected downspouts.			
Violation Type (if applicable):

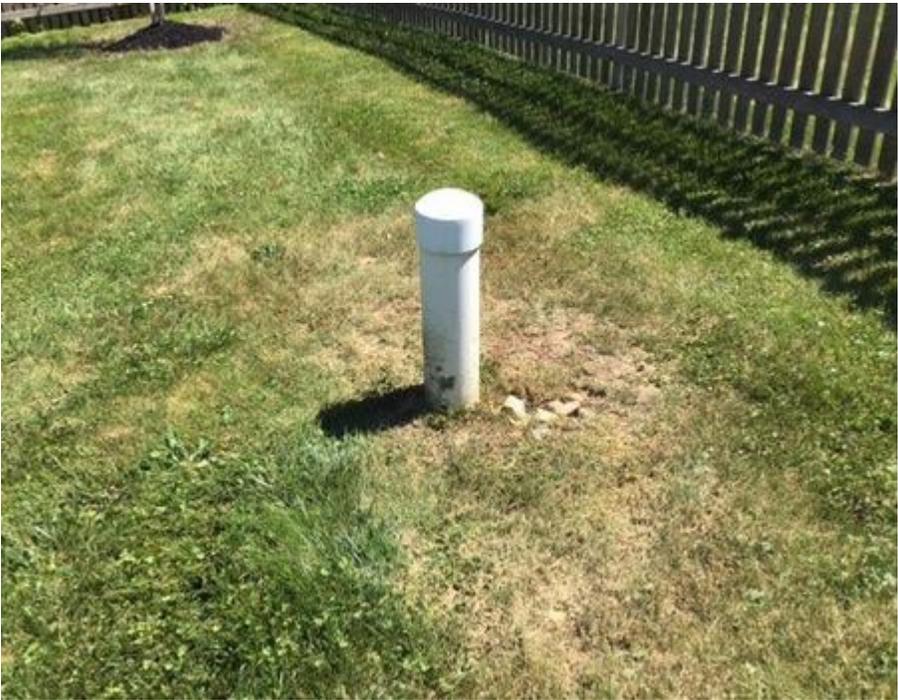
BMP #: 16		BMP Type: Underground Stone Infiltration Pit	BMP Address: 139 Clemens Cir, Jeffersonville, PA 19403
Photo No. 3	Date: 06/06/2022

Description			
View of the cleanout.			
Violation Type (if applicable):			
Photo No. 4	Date: 06/06/2022		
Description			
Violation Type (if applicable):

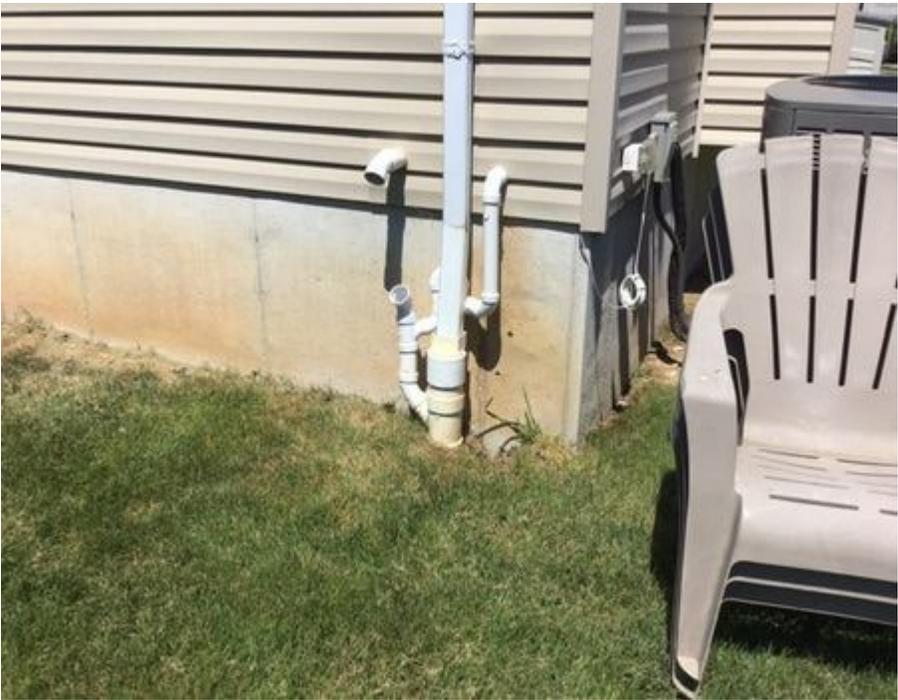
BMP #: 17		BMP Type: Underground Stone Infiltration Pit	BMP Address: 137 Clemens Cir, Norristown, PA 19403
Photo No. 1	Date: 06/06/2022

Description			
Connected downspout.			
Violation Type (if applicable):			
Photo No. 2	Date: 06/06/2022

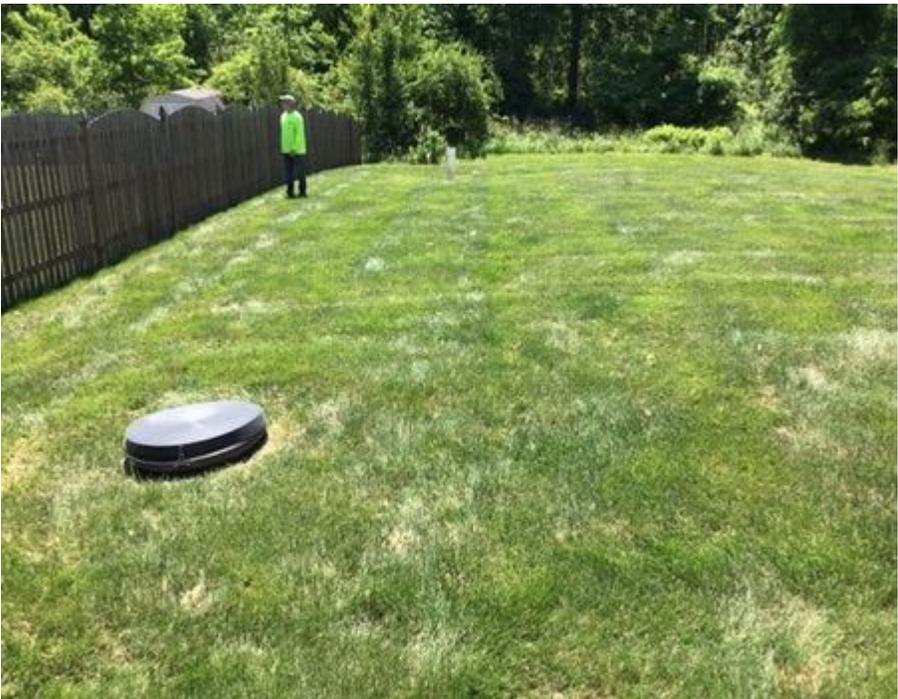
Description			
Overview of BMP.			
Violation Type (if applicable):

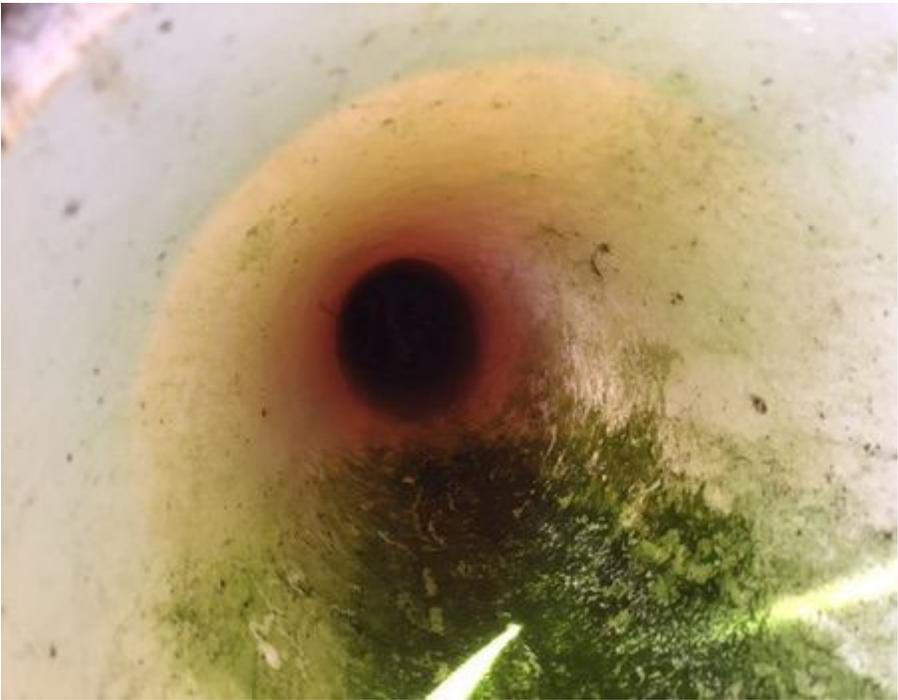
BMP #: 17		BMP Type: Underground Stone Infiltration Pit	BMP Address: 137 Clemens Cir, Norristown, PA 19403
Photo No. 3	Date: 06/06/2022

Description			
View of the cleanout.			
Violation Type (if applicable):			
Photo No. 4	Date: 06/06/2022		
Description			
Violation Type (if applicable):

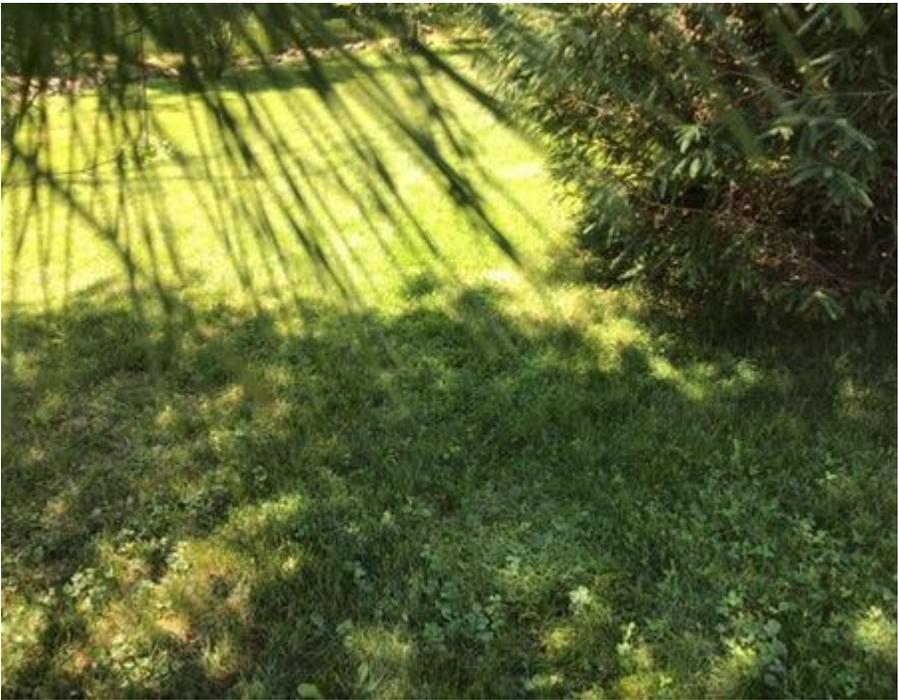
BMP #: 18		BMP Type: Underground Stone Infiltration Pit	BMP Address: 135 Clemens Cir, Norristown, PA 19403
Photo No. 1	Date: 06/06/2022

Description			
Overview of the BMP.			
Violation Type (if applicable):			
Photo No. 2	Date: 06/06/2022

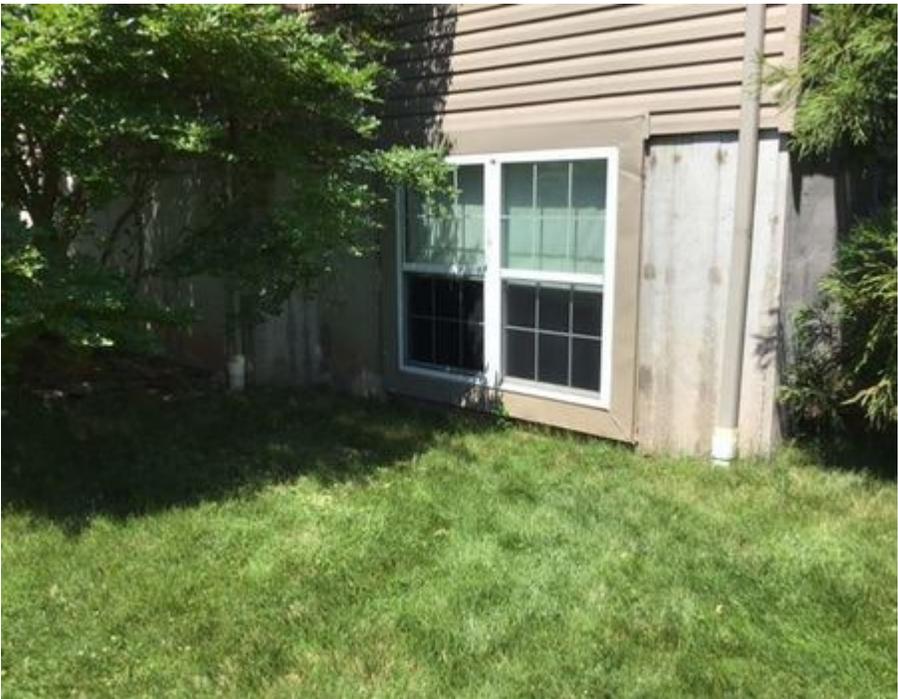
Description			
Connected downspouts.			
Violation Type (if applicable):

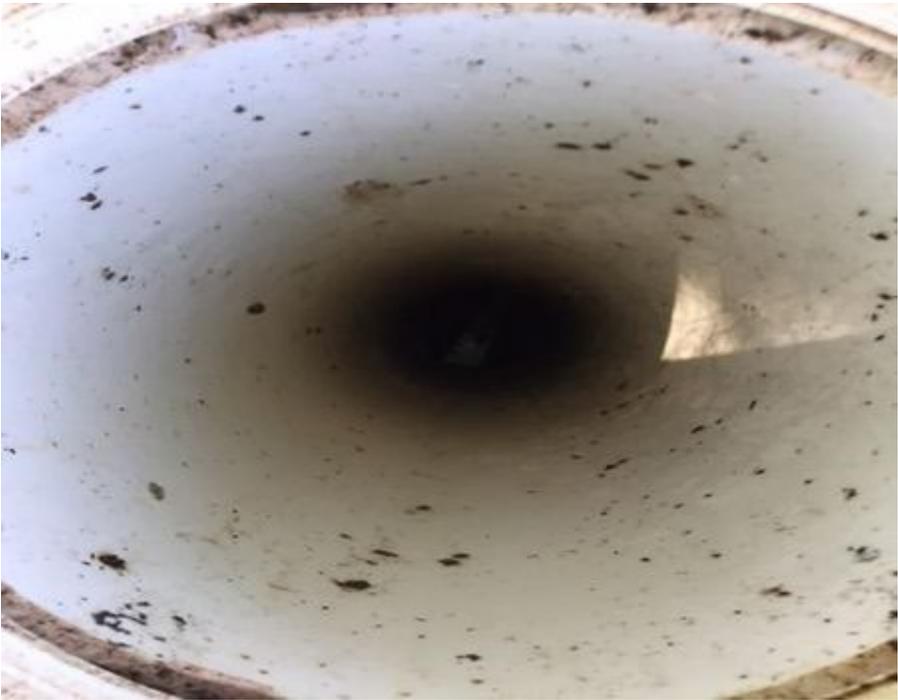
BMP #: 18		BMP Type: Underground Stone Infiltration Pit	BMP Address: 135 Clemens Cir, Norristown, PA 19403
Photo No. 3	Date: 06/06/2022

Description			
View of the cleanout.			
Violation Type (if applicable):			
Photo No. 4	Date: 06/06/2022		
Description			
Violation Type (if applicable):

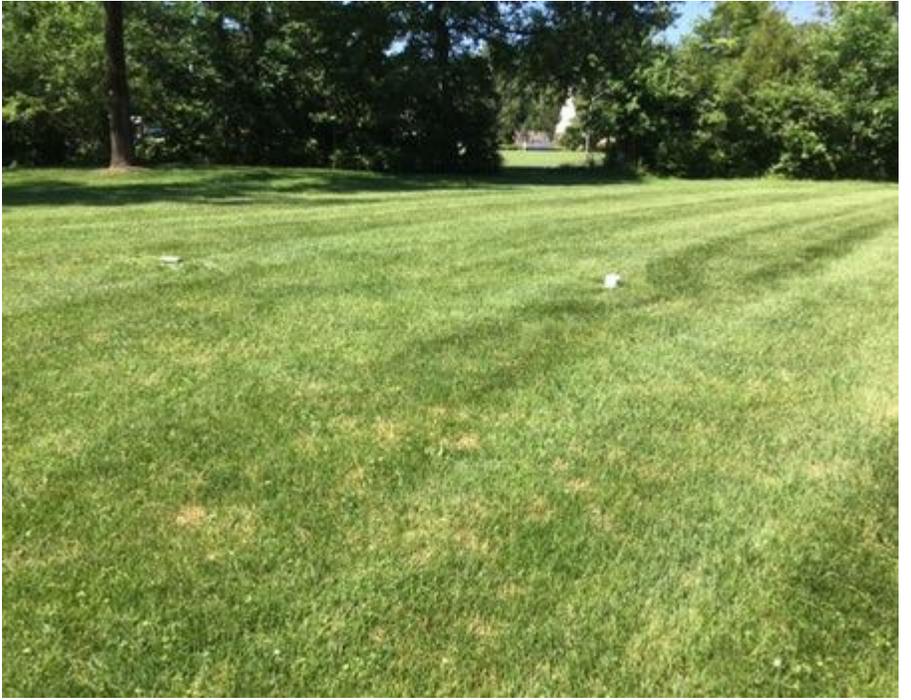
BMP #: 19		BMP Type: Seepage Bed	BMP Address: 2171 Alexander Dr, Eagleville, PA 19403
Photo No. 1	Date: 06/06/2022

Description			
Overall view of the BMP.			
Violation Type (if applicable):			
Photo No. 2	Date: 06/06/2022

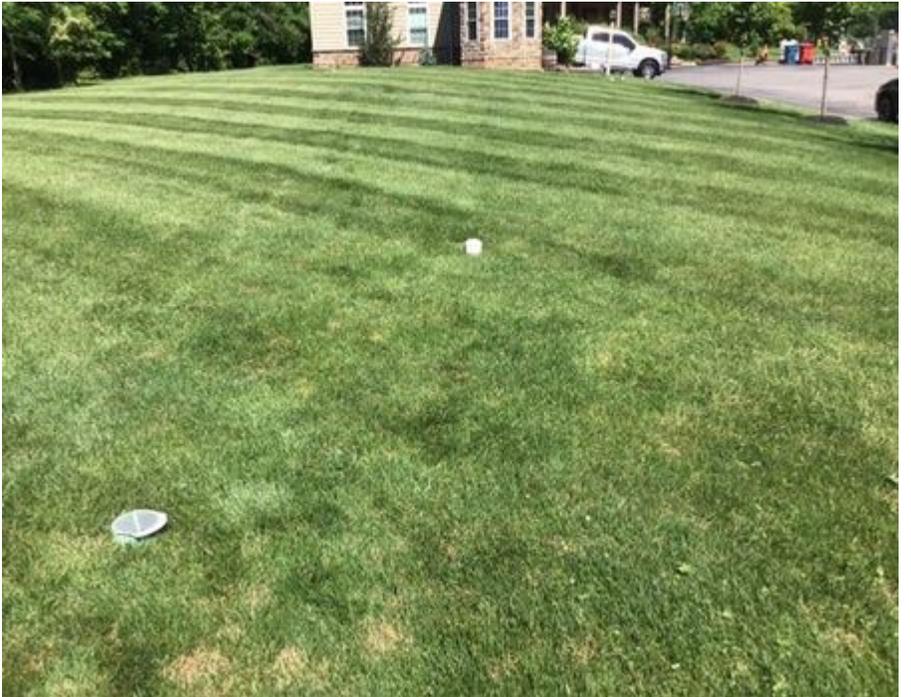
Description			
Overall view of the BMP.			
Violation Type (if applicable):

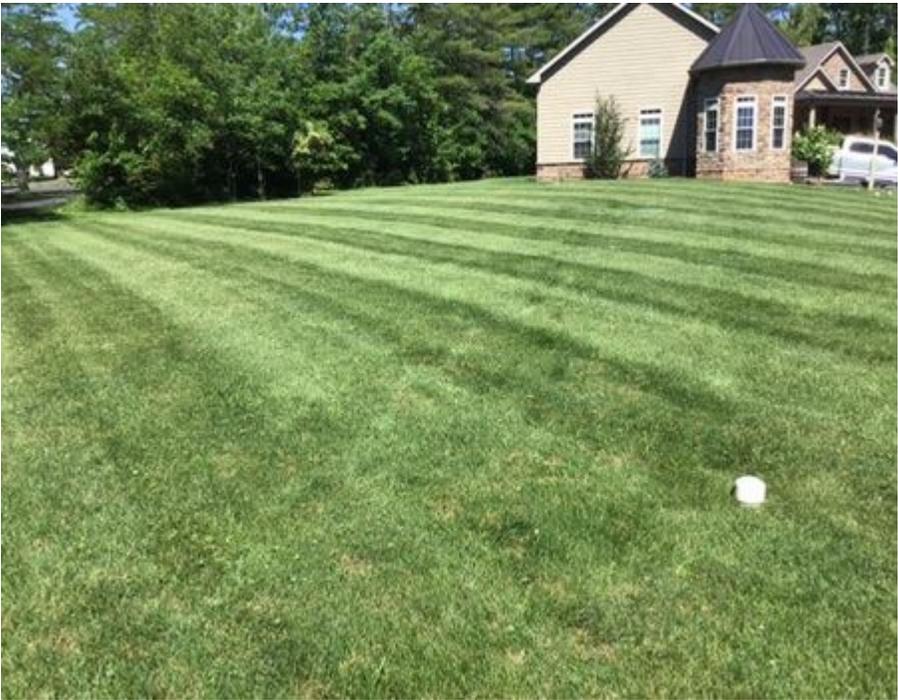
BMP #: 19		BMP Type: Seepage Bed	BMP Address: 2171 Alexander Dr, Eagleville, PA 19403
Photo No. 3	Date: 06/06/2022

Description			
View of the contributing drainage area.			
Violation Type (if applicable):			
Photo No. 4	Date: 06/06/2022

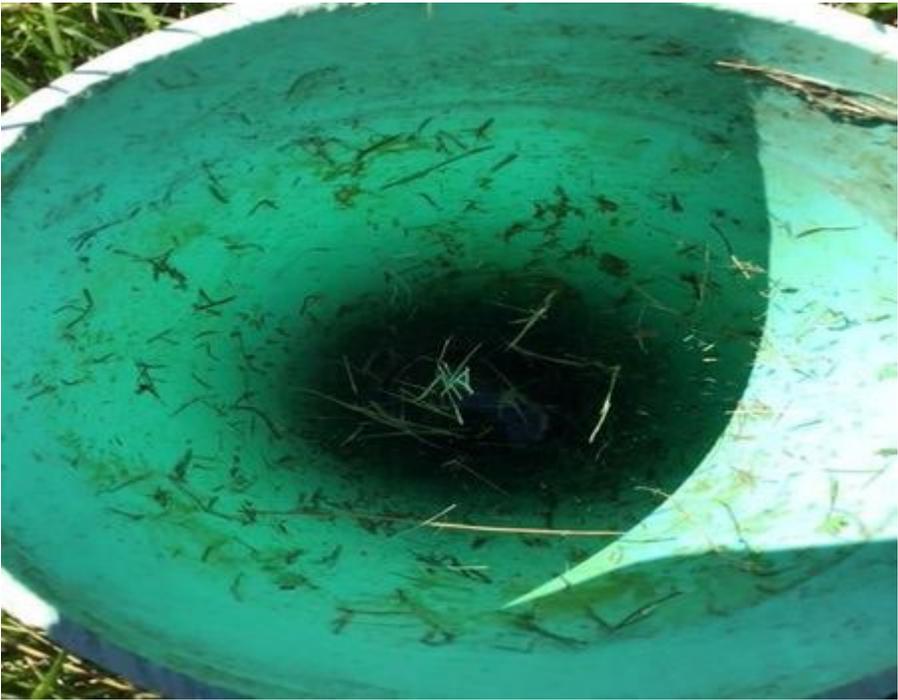
Description			
View inside the observation well.			
Violation Type (if applicable):

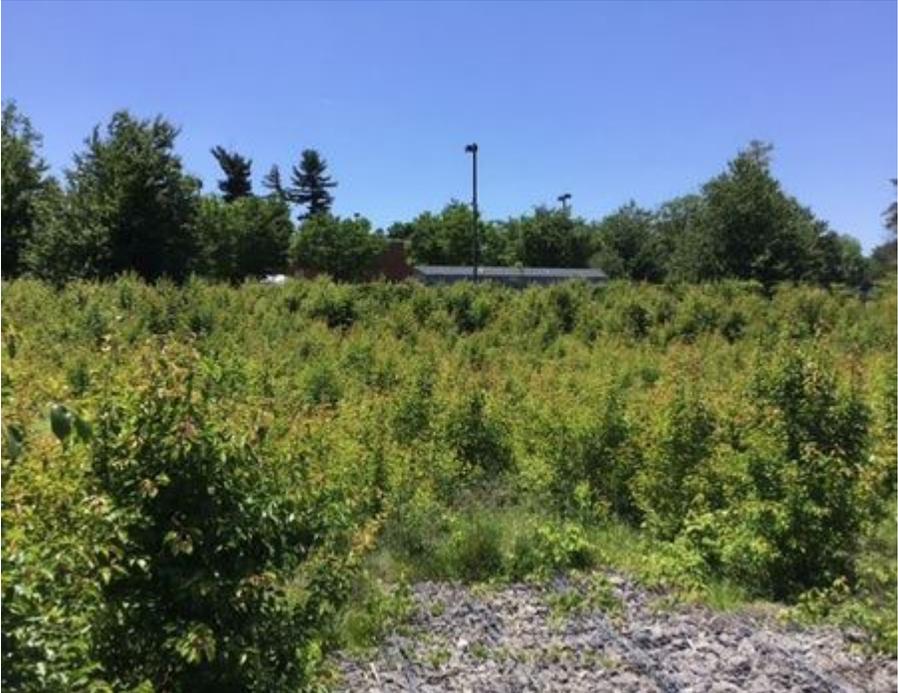
Description			
Overall view of the BMP.			
Violation Type (if applicable):

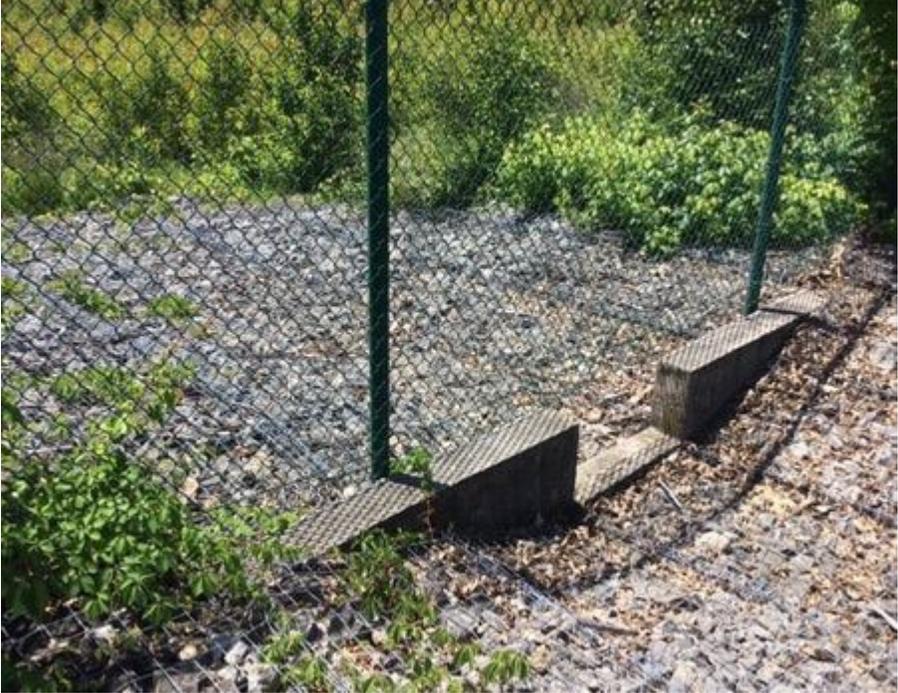
BMP #: 21		BMP Type: Detention Basin	BMP Address: 1001 Sterigere St, Norristown PA 19403
Photo No. 3	Date: 06/06/2022

Description			
View of the overflow structure.			
Violation Type (if applicable):			
Photo No. 4	Date: 06/06/2022

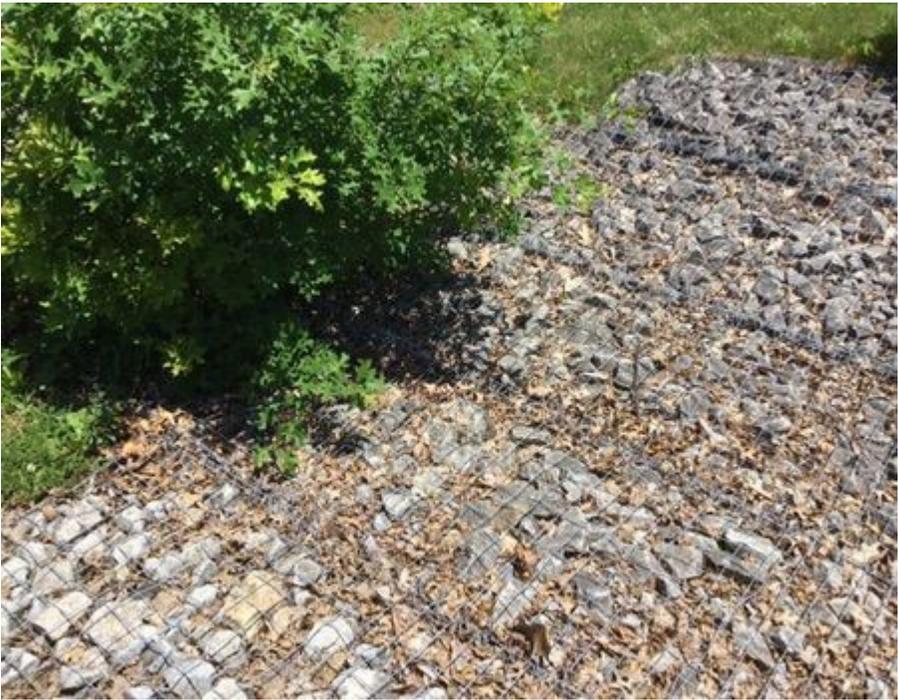
Description			
View of the rock overflow structure.			
Violation Type (if applicable):

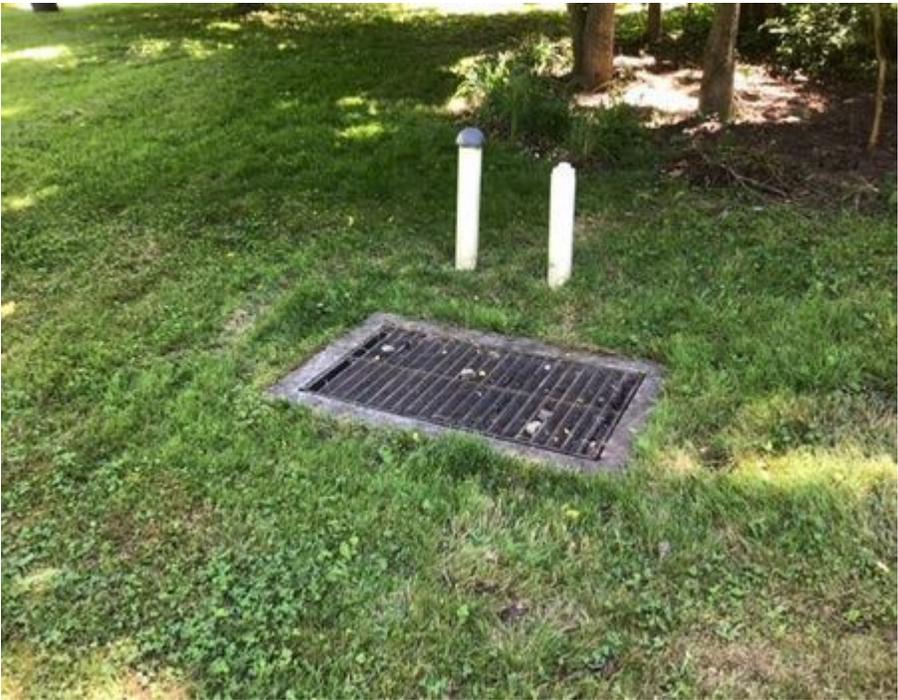
BMP #: 22		BMP Type: Seepage Bed	BMP Address: 51 S. Montgomery Ave, Norristown, PA 19403
Photo No. 1	Date: 06/06/2022

Description			
Overall view of the BMP.			
Violation Type (if applicable):			
Photo No. 2	Date: 06/06/2022

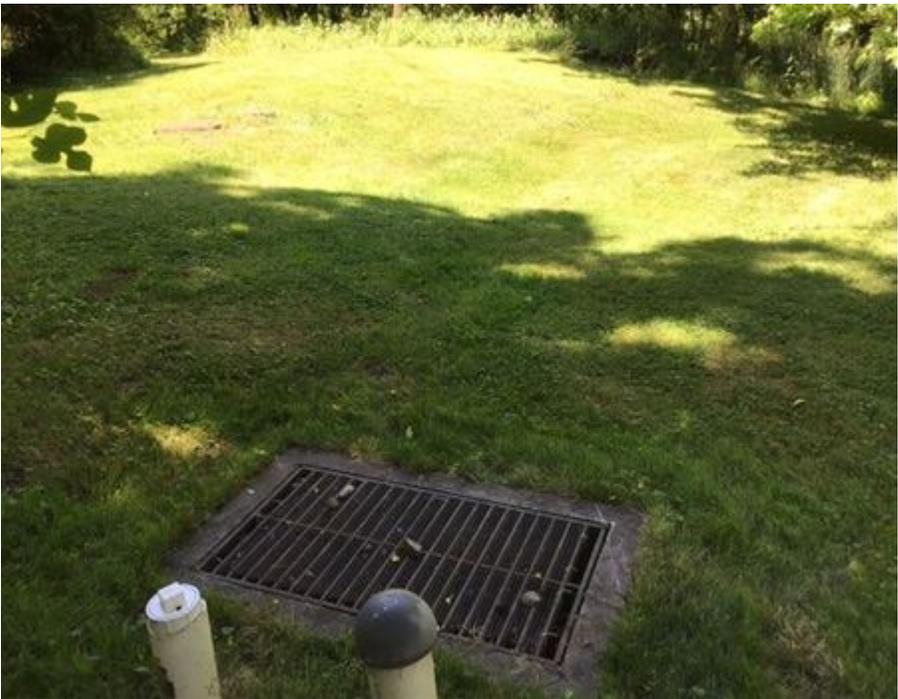
Description			
Overall view of the BMP.			
Violation Type (if applicable):

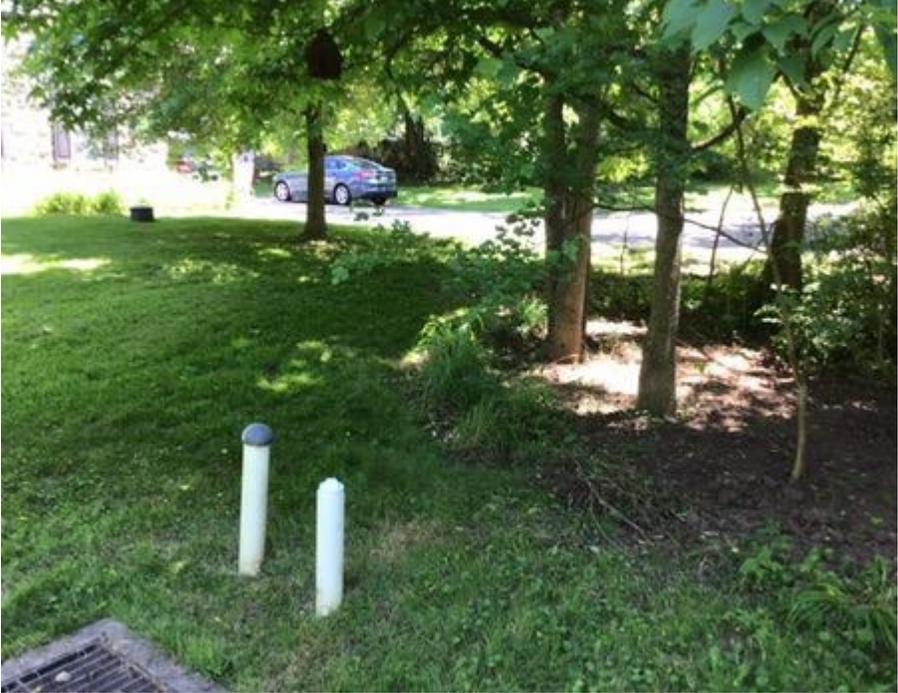
BMP #: 22		BMP Type: Seepage Bed	BMP Address: 51 S. Montgomery Ave, Norristown, PA 19403
Photo No. 3	Date: 06/06/2022

Description			
View of the contributing drainage area.			
Violation Type (if applicable):			
Photo No. 4	Date: 06/06/2022

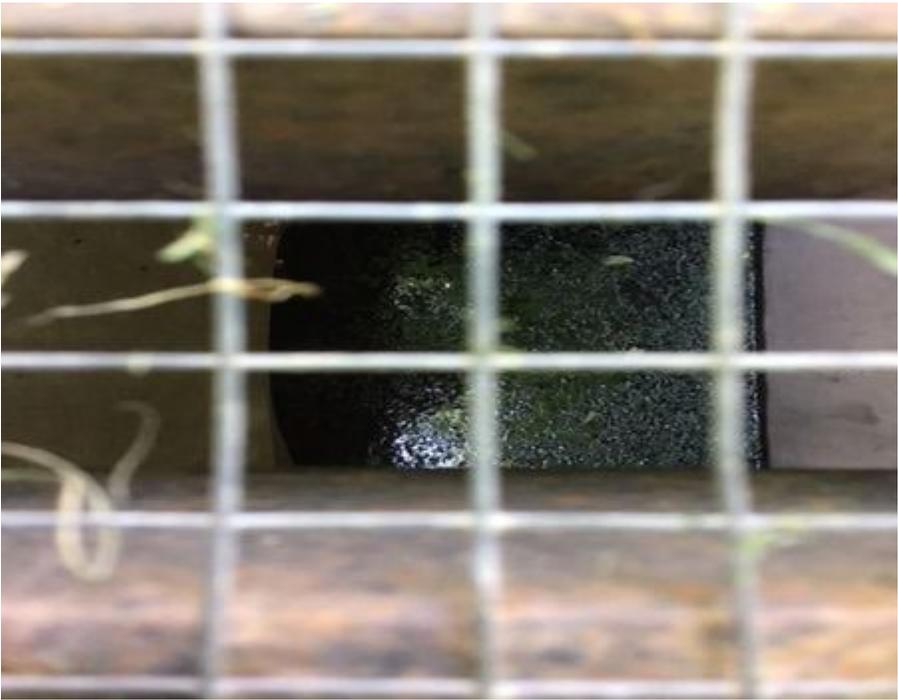
Description			
View of the observation inlet.			
Violation Type (if applicable):

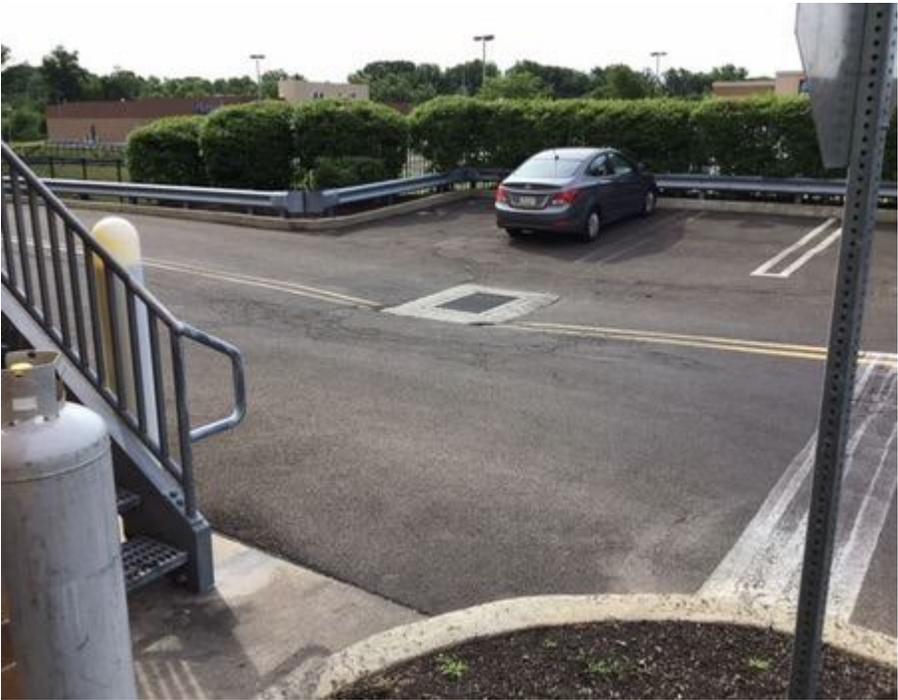
BMP #: 23A		BMP Type: Underground Detention Facility	BMP Address: 432 Egypt Rd, Norristown, PA 19403
Photo No. 1	Date: 06/21/2022

Description			
Overall view of the BMP.			
Violation Type (if applicable):			
Photo No. 2	Date: 06/21/2022

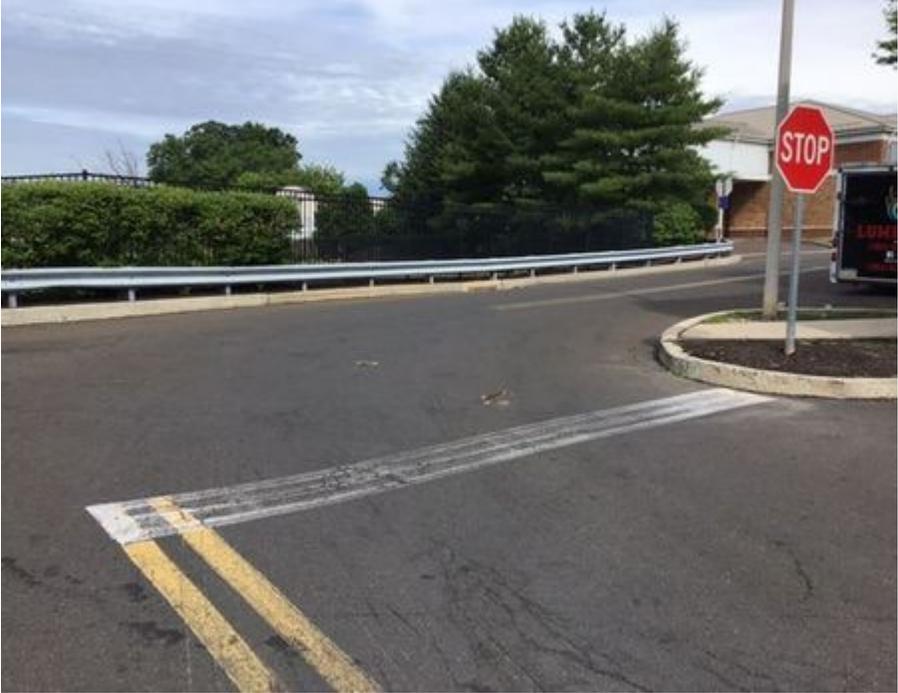
BMP #: 23A		BMP Type: Underground Detention Facility	BMP Address: 432 Egypt Rd, Norristown, PA 19403
Photo No. 3	Date: 06/21/2022

Description			
View of the contributing drainage area.			
Violation Type (if applicable):			
Photo No. 4	Date: 06/21/2022

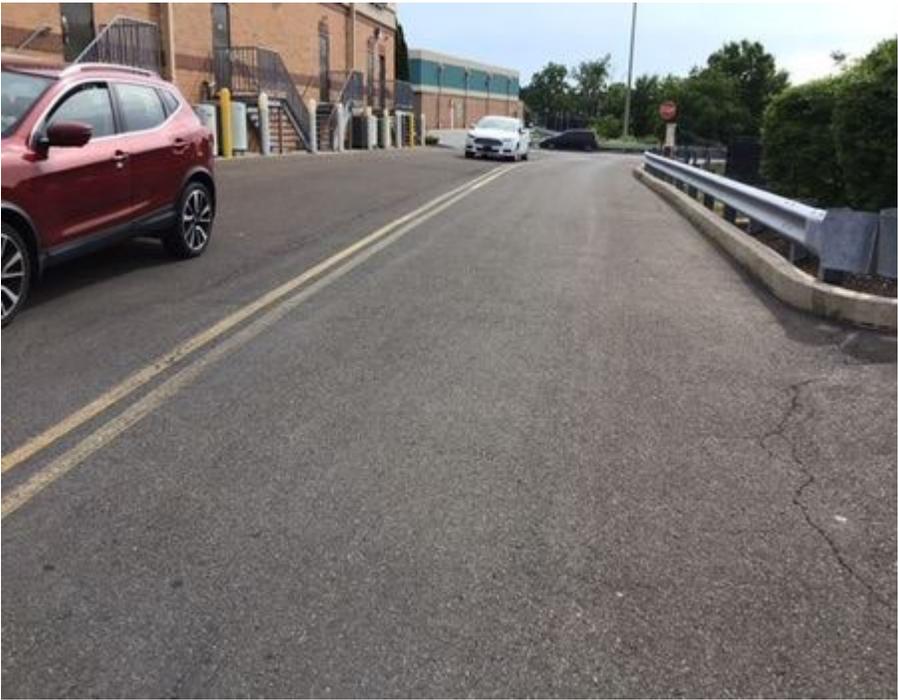
Description			
View of contributing drainage area.			
Violation Type (if applicable):

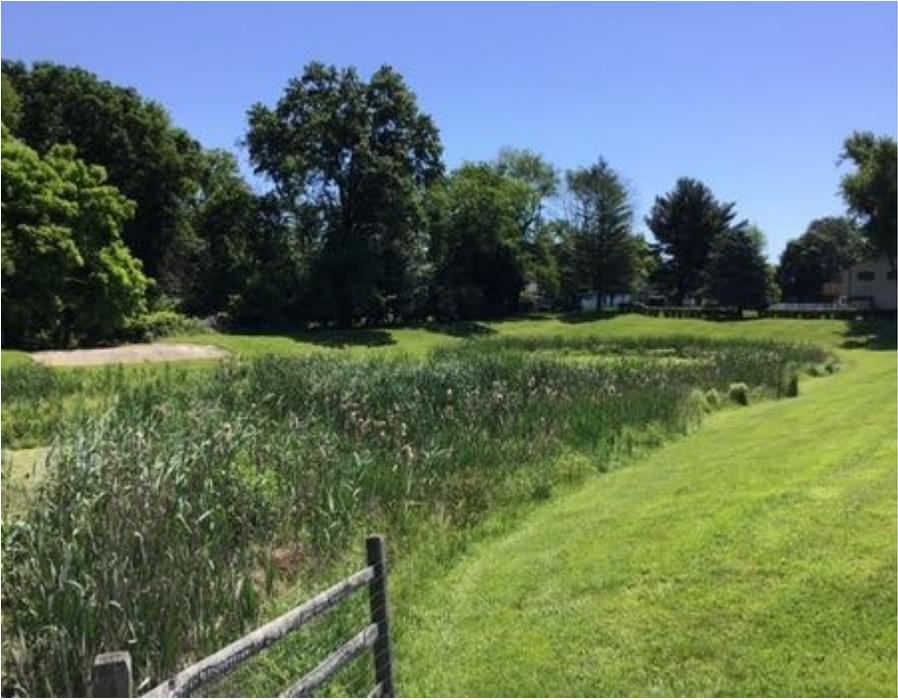
BMP #: 24		BMP Type: Detention Basin	BMP Address: 1630 W Marshall St.
Photo No. 1	Date: 06/06/2022

Description			
Overall view of the BMP.			
Violation Type (if applicable):			
Photo No. 2	Date: 06/06/2022

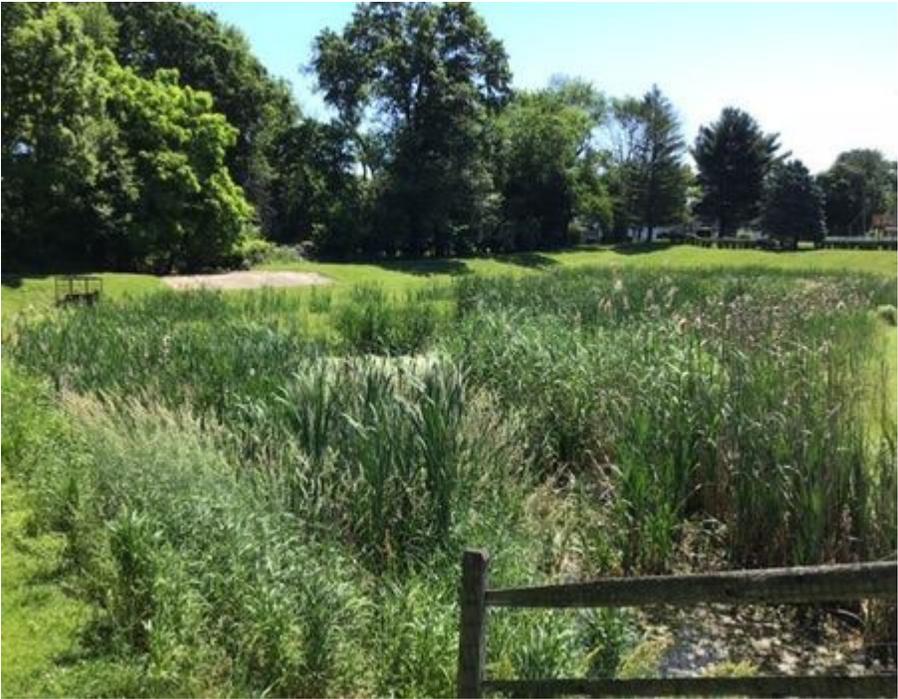
Description			
Overall view of the BMP.			
Violation Type (if applicable):

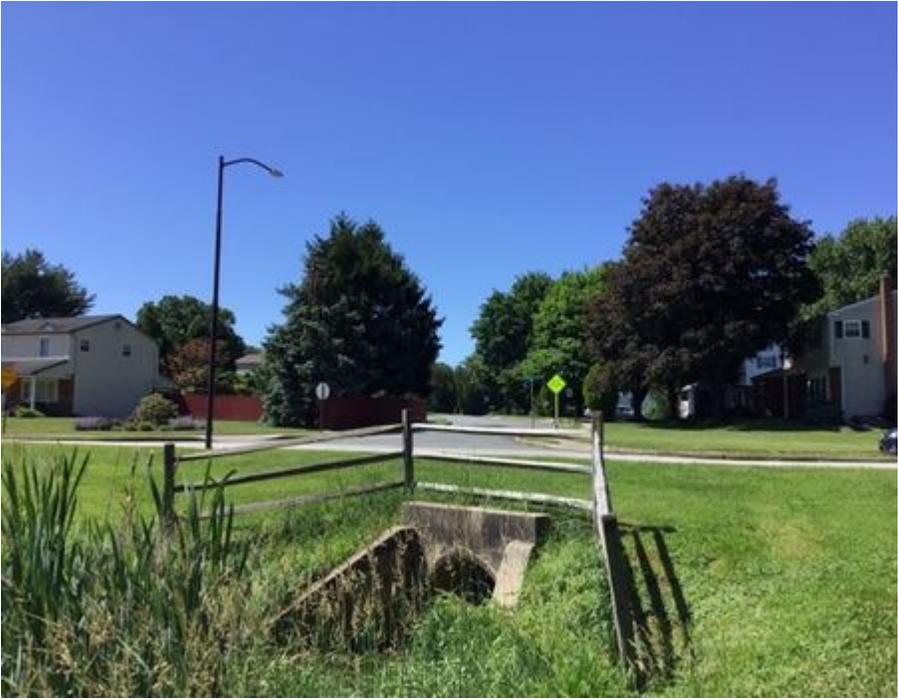
BMP #: 24		BMP Type: Detention Basin	BMP Address: 1630 W Marshall St.
Photo No. 3	Date: 06/06/2022

Description			
View of the contributing drainage area.			
Violation Type (if applicable):			
Photo No. 4	Date: 06/06/2022

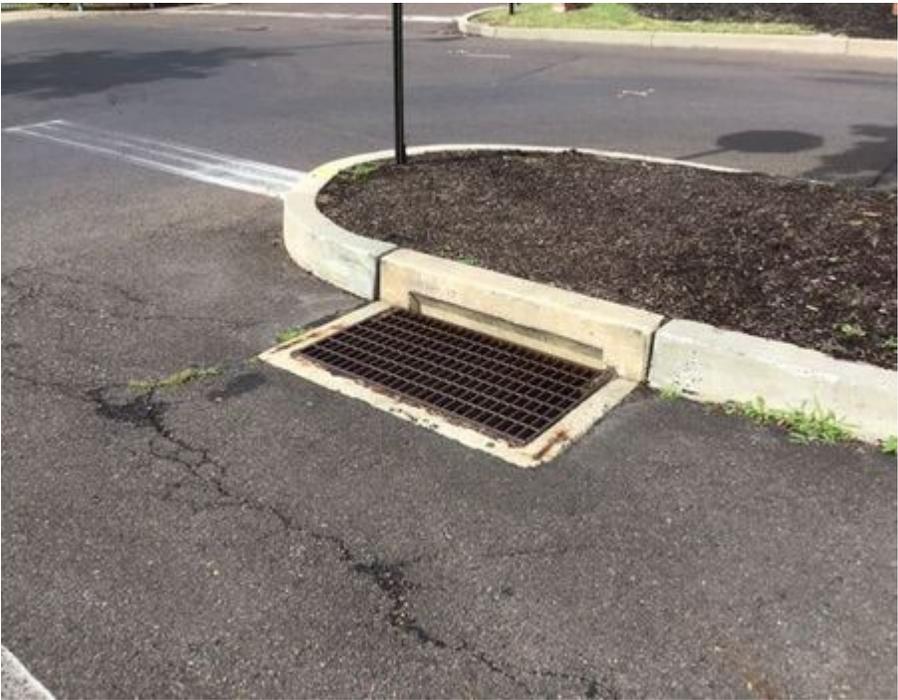
BMP #: 23B		BMP Type: Seepage Bed	BMP Address: 432 Egypt Rd, Norristown, PA 19403
Photo No. 1	Date: 06/21/2022

Description			
Overall view of the BMP.			
Violation Type (if applicable):			
Photo No. 2	Date: 06/21/2022

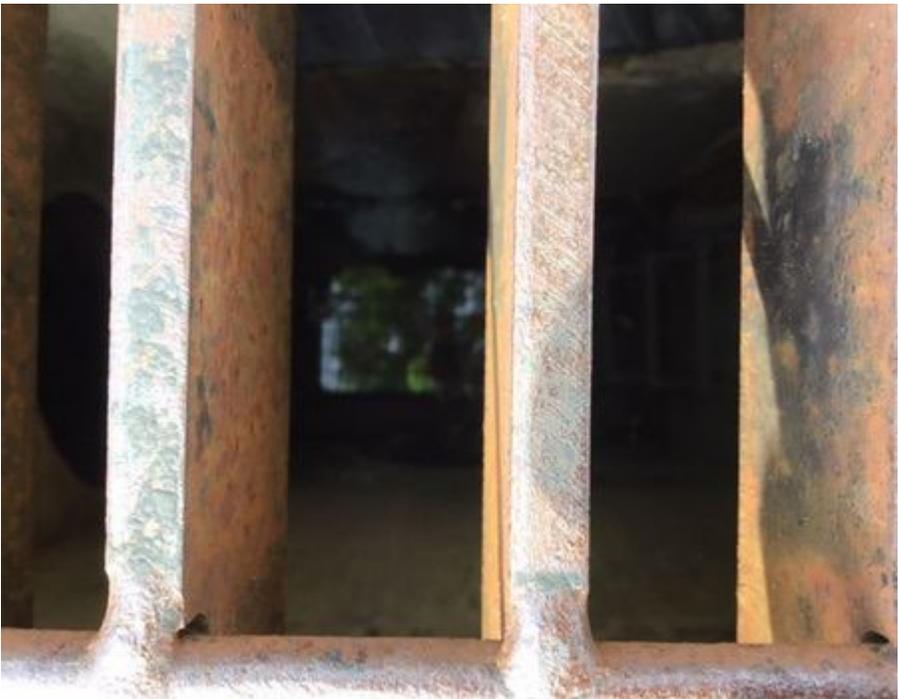
Description			
Inlet observation view of the BMP.			
Violation Type (if applicable):

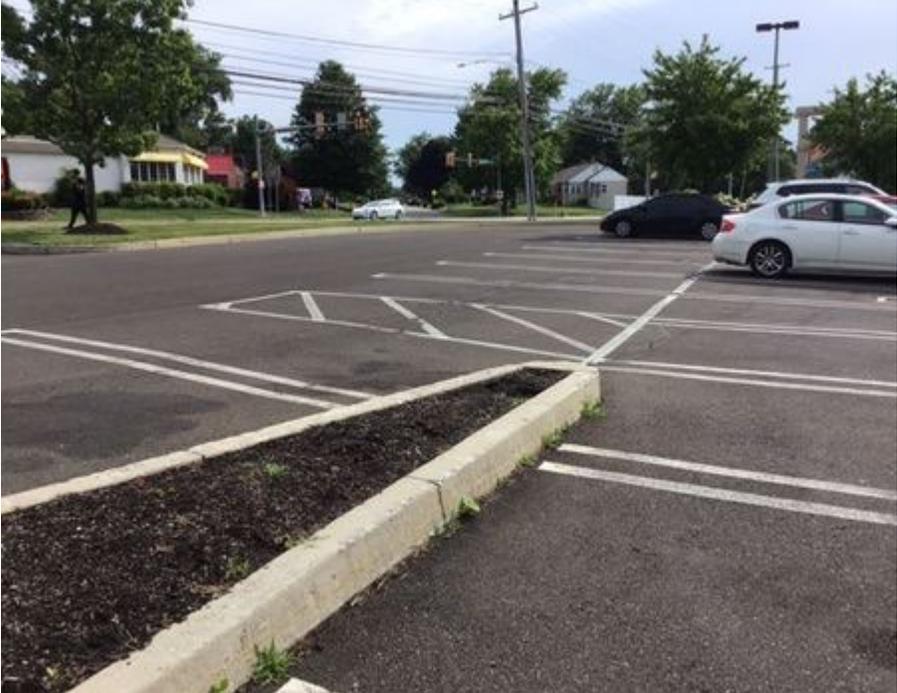
BMP #: 23B		BMP Type: Seepage Bed	BMP Address: 432 Egypt Rd, Norristown, PA 19403
Photo No. 3	Date: 06/21/2022

Description			
View of the contributing drainage area.			
Violation Type (if applicable):			
Photo No. 4	Date: 06/21/2022

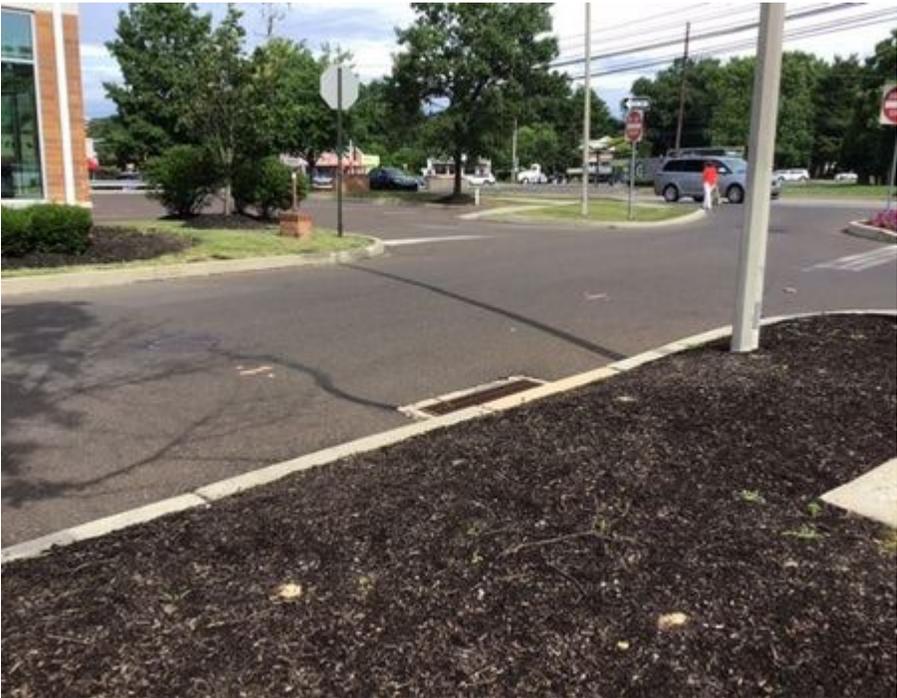
Description			
View of the structure leading to the BMP.			
Violation Type (if applicable):
