RE: West Norriton Township Annual MS4 Status Report
NPDES Permit No. PAG130006
West Norriton Township, Montgomery County
233-22-0007

ANNUAL MUNICIPAL SEPARATE STORM SEWER SYSTEM (MS4) STATUS REPORT

West Norriton Township

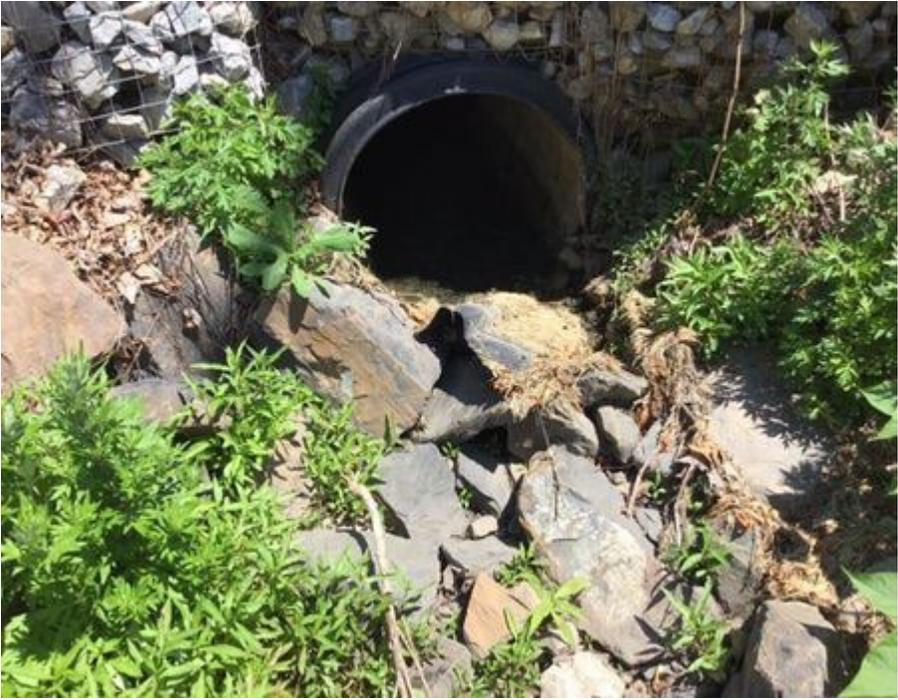
BMP #: Hole 17/18		BMP Type: Stream Restoration	BMP Address: 2400 W Main Street
Photo No. 1	Date: 06/06/2022

Description			
View of inflow to the BMP.			
Violation Type (if applicable): Debris is blocking the inflow.			
Photo No. 2	Date: 06/06/2022

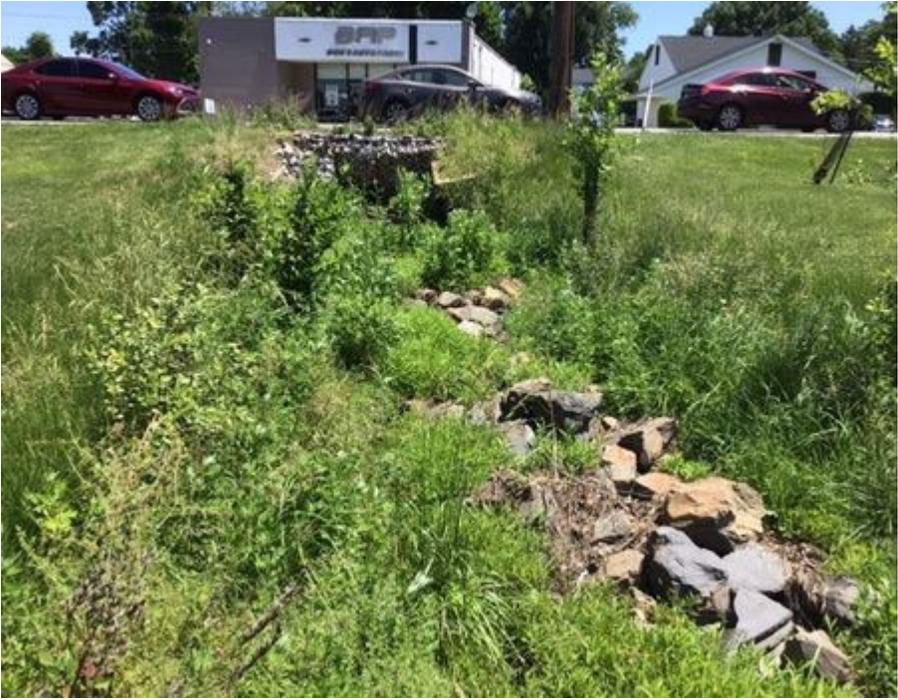
BMP #: Hole 17/18		BMP Type: Stream Restoration	BMP Address: 2400 W Main Street
Photo No. 3	Date: 06/06/2022

Description			
Overview of structure.			
Violation Type (if applicable):			
Photo No. 4	Date: 06/06/2022

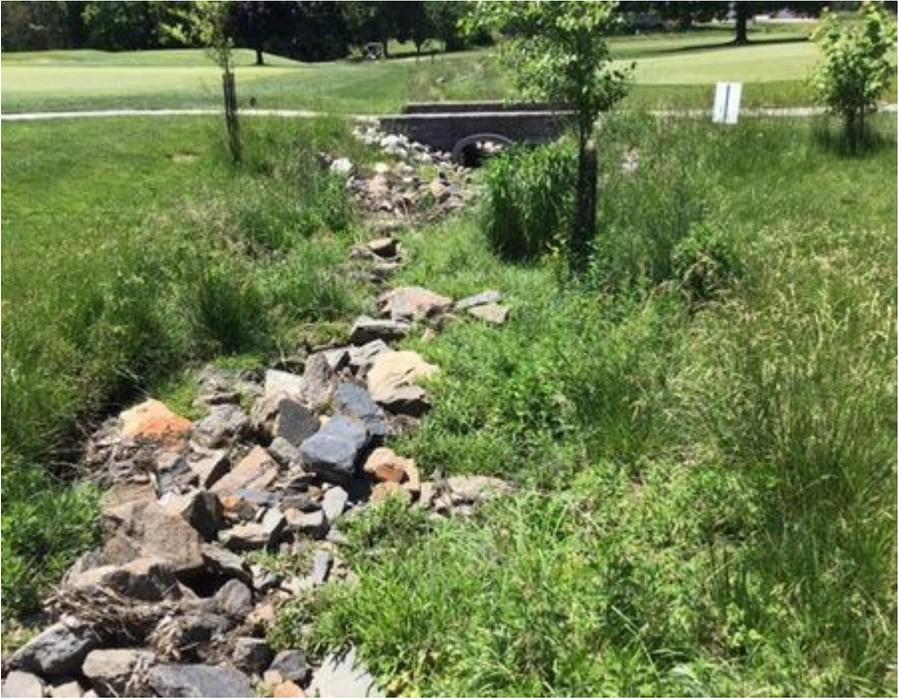
Description			
Overview of structure.			
Violation Type (if applicable):

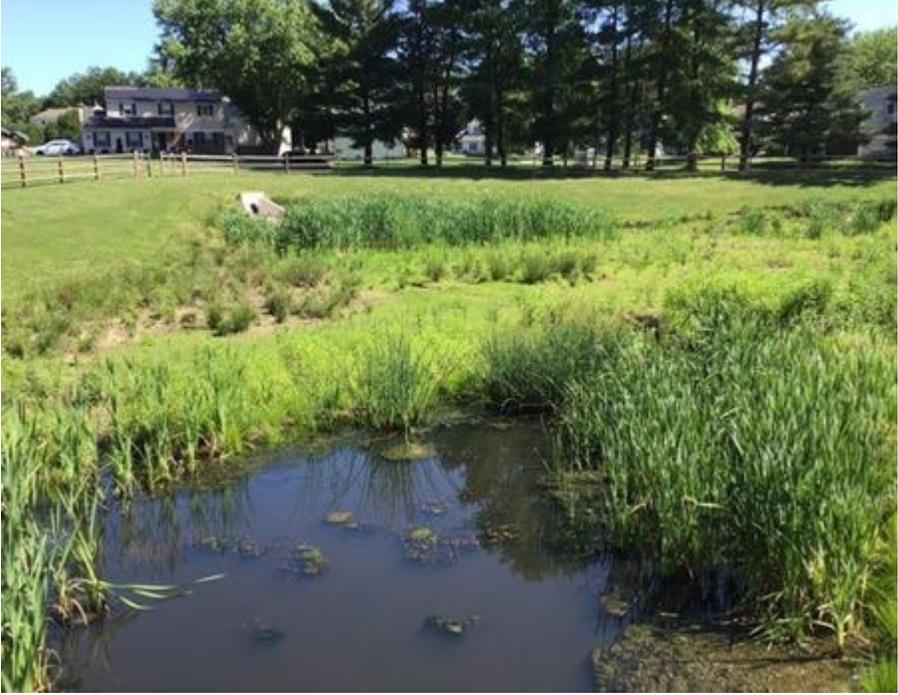
BMP #: X		BMP Type: Detention Basin	BMP Address: Alexander Dr. & Burnside Blvd
Photo No. 1	Date: 06/06/2022

Description			
Overall view of the BMP.			
Violation Type (if applicable):			
Photo No. 2	Date: 06/06/2022

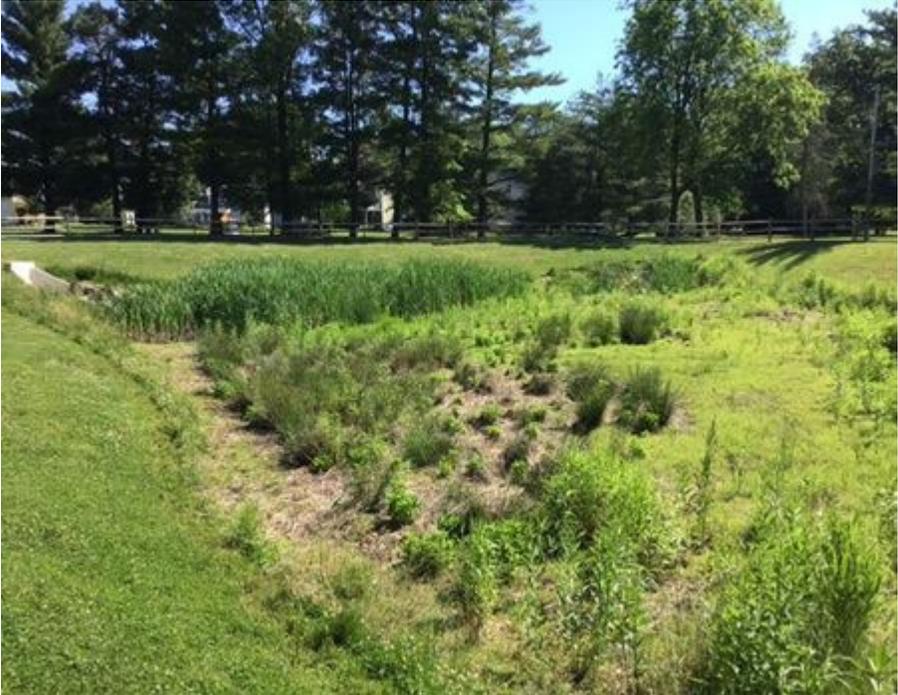
Description			
Overall view of the BMP.			
Violation Type (if applicable):

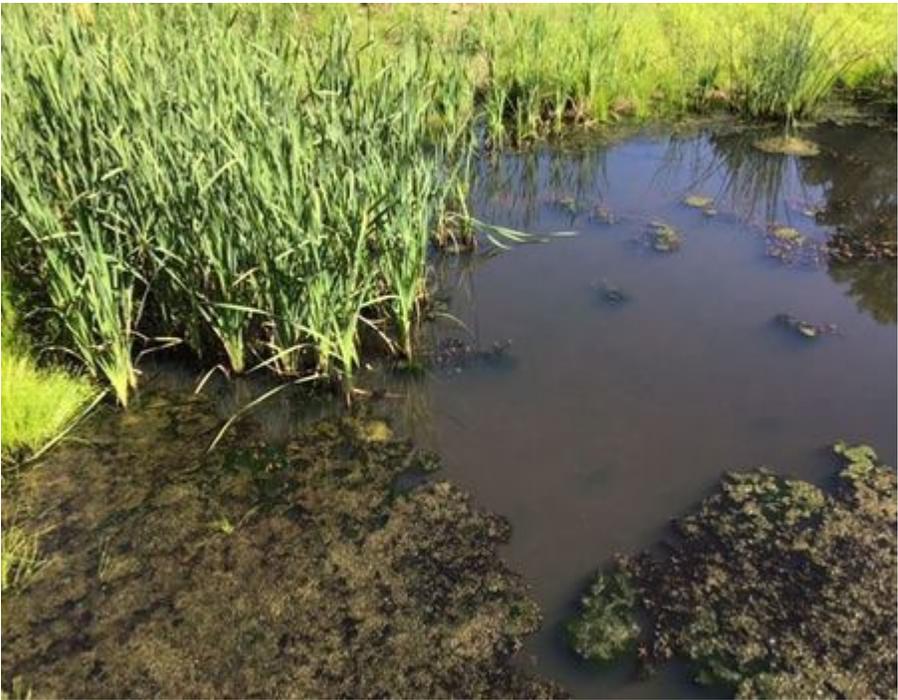
BMP #: X		BMP Type: Detention Basin	BMP Address: Alexander Dr. & Burnside Blvd
Photo No. 3	Date: 06/06/2022

Description			
View of the micro pools.			
Violation Type (if applicable):			
Photo No. 4	Date: 06/06/2022

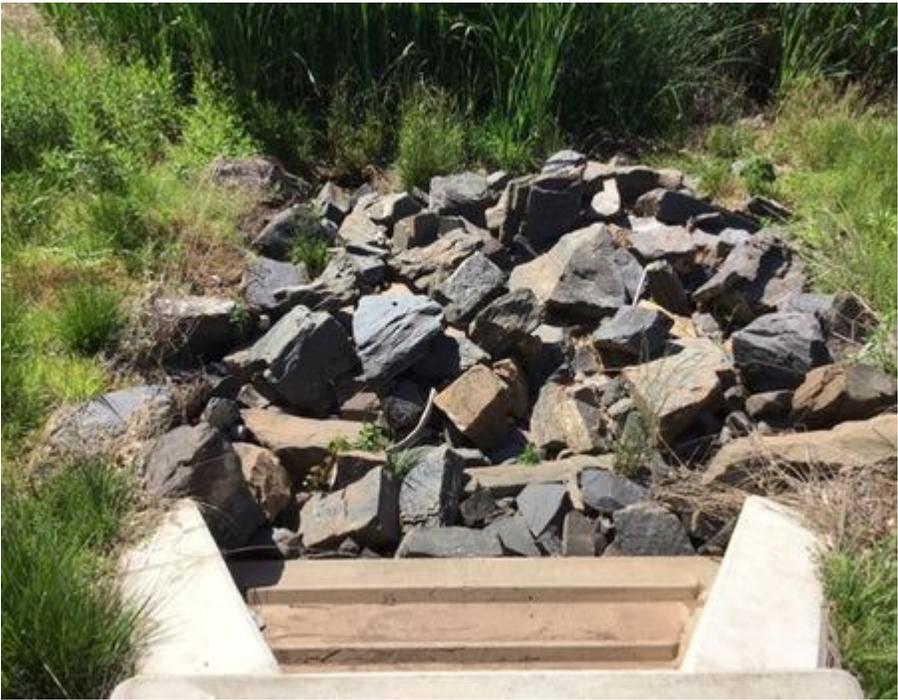
Description			
View of the inflow to the basin.			
Violation Type (if applicable):

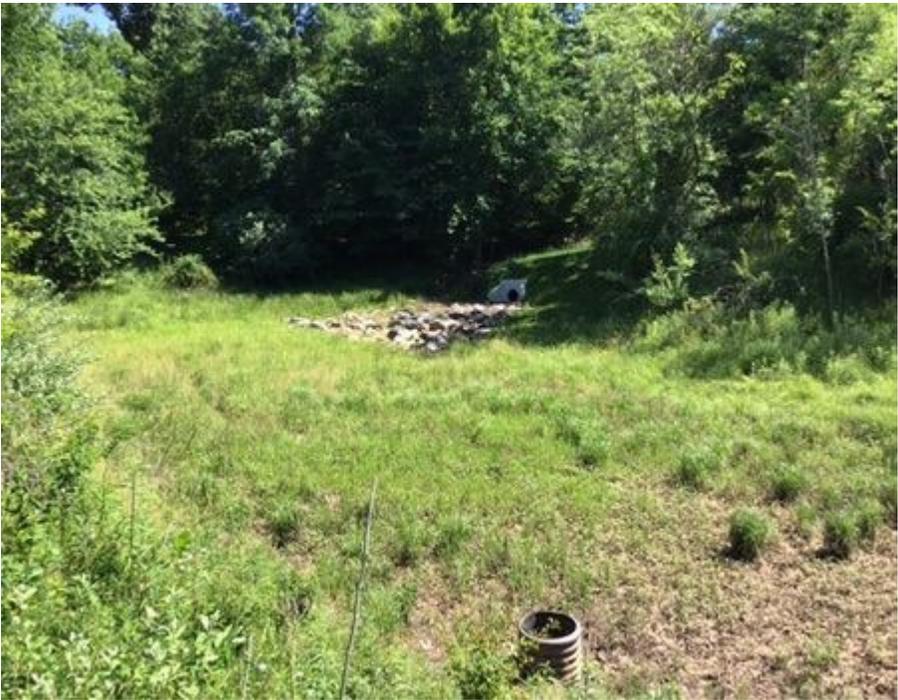
BMP #: X		BMP Type: Basin	BMP Address: 2421 Boulevard of the Generals
Photo No. 1	Date: 06/06/2022

Description			
Overall view of the basin.			
Violation Type (if applicable):			
Photo No. 2	Date: 06/06/2022

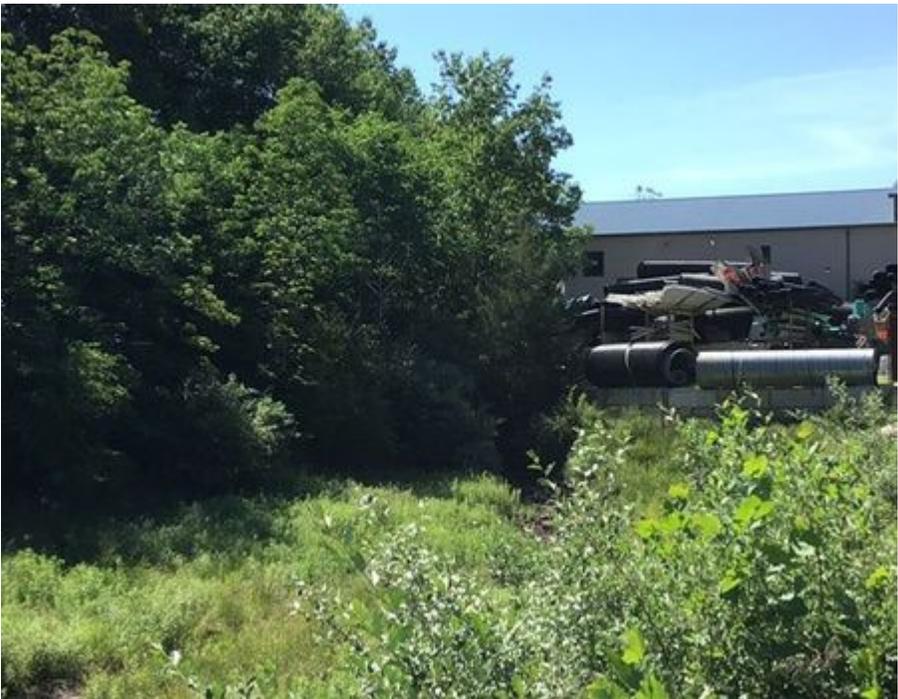
Description			
View facing the inflow swale to the basin.			
Violation Type (if applicable):

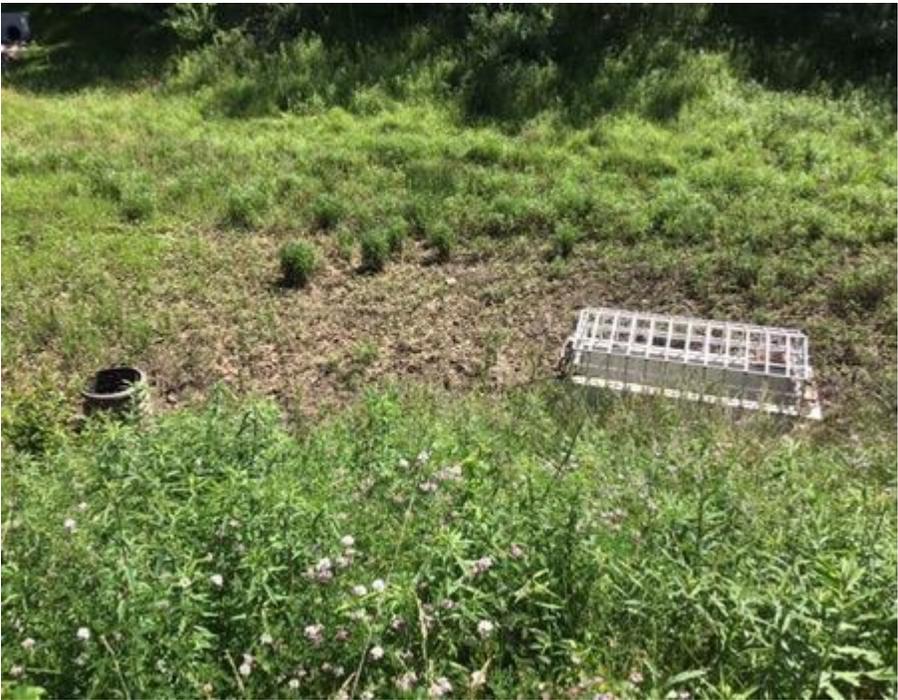
BMP #: X		BMP Type: Basin	BMP Address: 2421 Boulevard of the Generals
Photo No. 3	Date: 06/06/2022

Description			
View of the riser.			
Violation Type (if applicable):			
Photo No. 4	Date: 06/06/2022
